## **N.C. Division of Forest Resources**

# **Stream Restoration Post-Implementation Annual Monitoring Report: Year 1 - 2009**

For the N.C. Clean Water Management Trust Fund (CWMTF)  
Project #2004A-411:  
“Rendezvous Mountain Purlear Creek Stream Restoration”

January 2010  
[www.dfr.nc.gov](http://www.dfr.nc.gov)

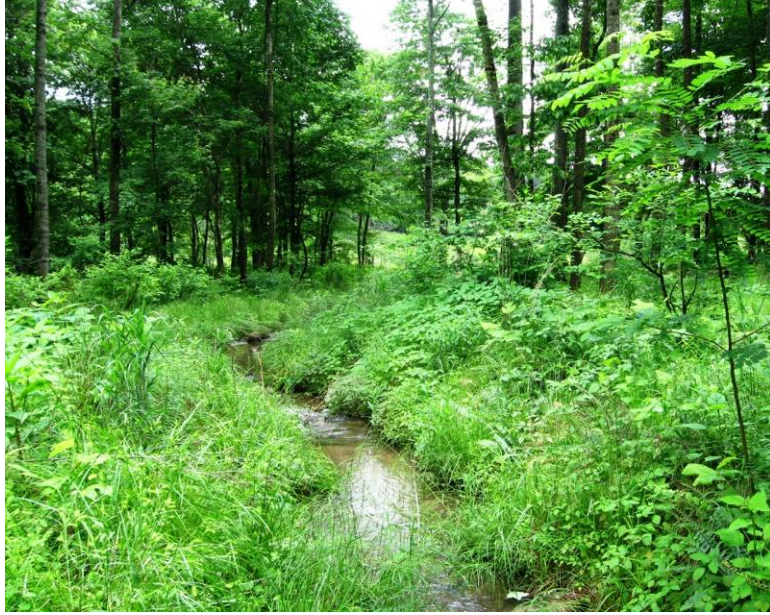
Woody vegetation appears to be well-established within the riparian corridor. In addition, growth of naturally-germinated tree seedlings ("volunteers") from the nearby forested area have contributed to the overall species diversity of the restoration area. Several observations and visual monitoring of the vegetation growth have been performed, but no plots or seedling survival counts have yet been conducted. This decision is due to the extreme planting conditions encountered during this project. During that period (2006, 2007 & 2008), a prolonged drought coupled with intense deer browse of newly-planted seedlings was thought to have a negative effect on the long-term survival of planted seedlings and shrubs. With 1 to 2 growing seasons now concluded, we feel that enough time has lapsed to obtain a reliable estimate of the density and species of woody vegetation on the project site.

Figure 1: Overview of vegetation along Phase 1, shown here May 2009.

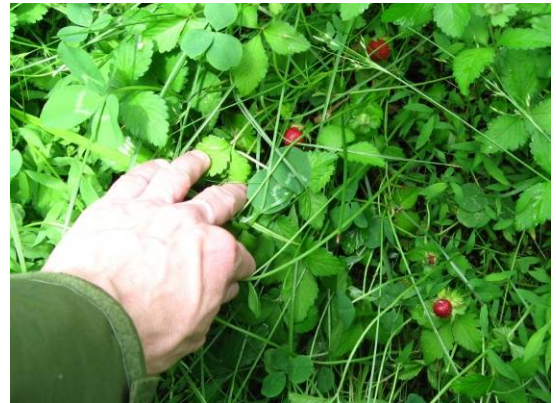
Figure 2: Wild strawberry volunteer growth along Phase 1, shown here May 2009.

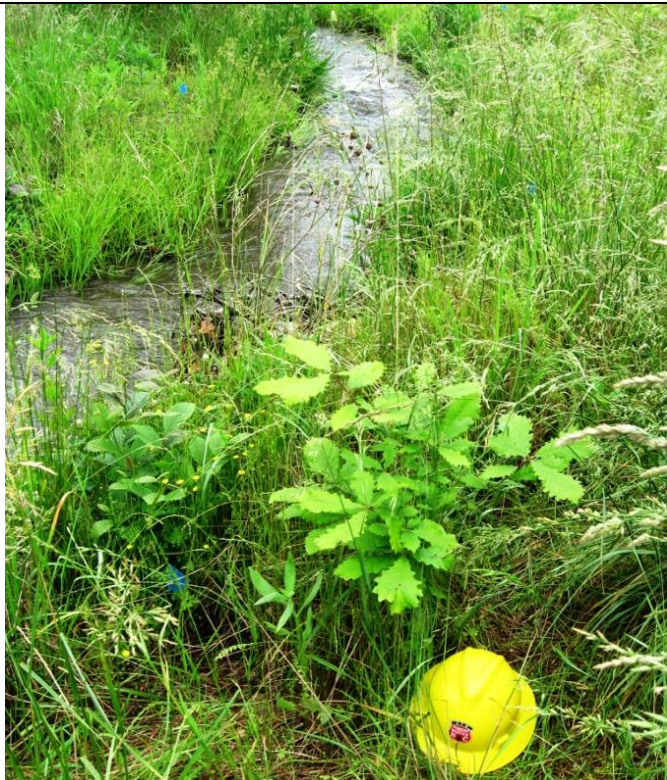
Figure 3: Swamp chestnut oak seedling along Phase 2: Planted February 2008, shown here May 2009.

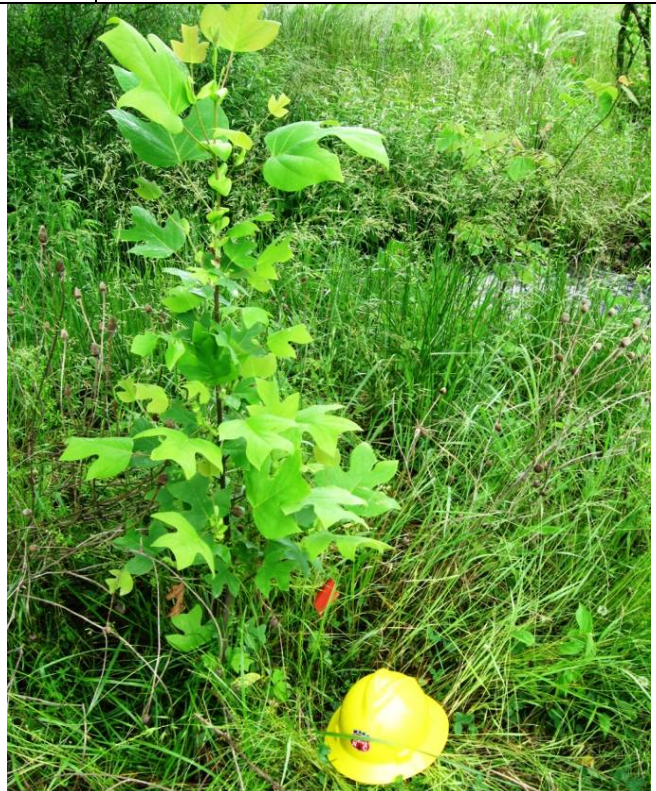
Figure 4: Yellow-poplar seedling along Phase 2: Planted February 2008, shown here May 2009.
