Area of Concern – Site: P08

Map Grid Location: D11 Site visit date/ team): 4/13/15/ BK, JZ Drainage Area (Sq. Mi.): < 0.1
Name & Location: Drainage across Burnt Mountain Trail

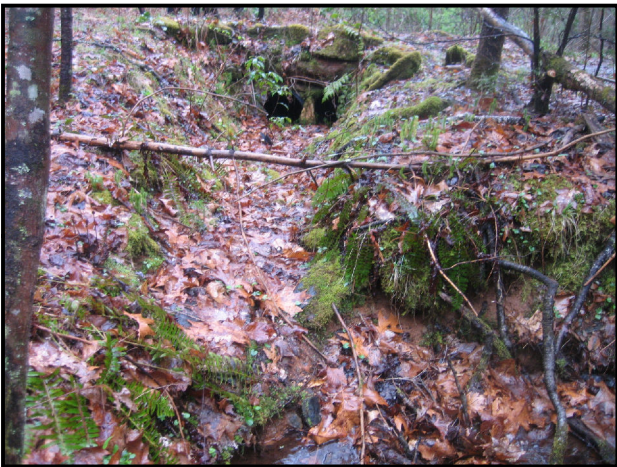
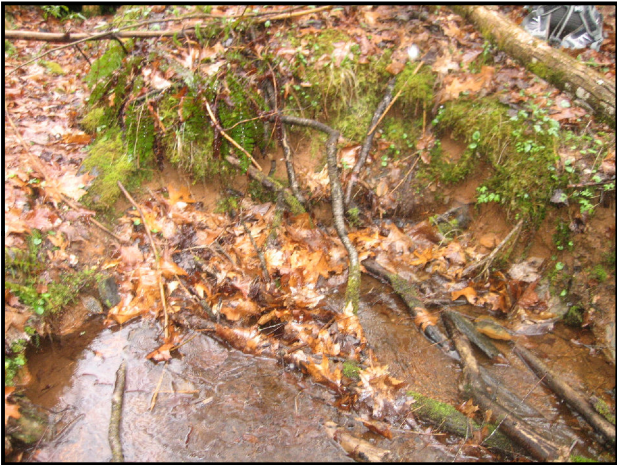
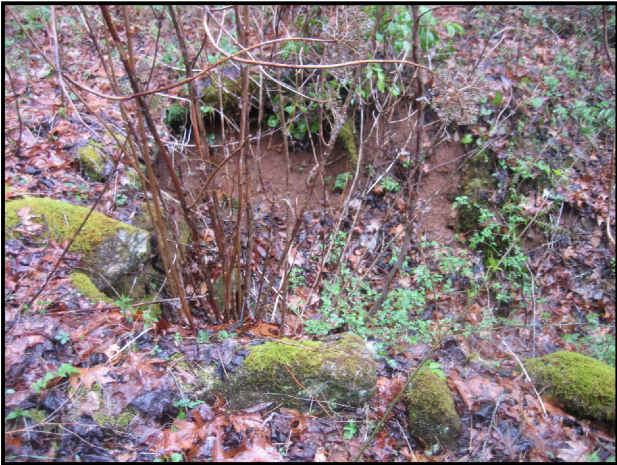
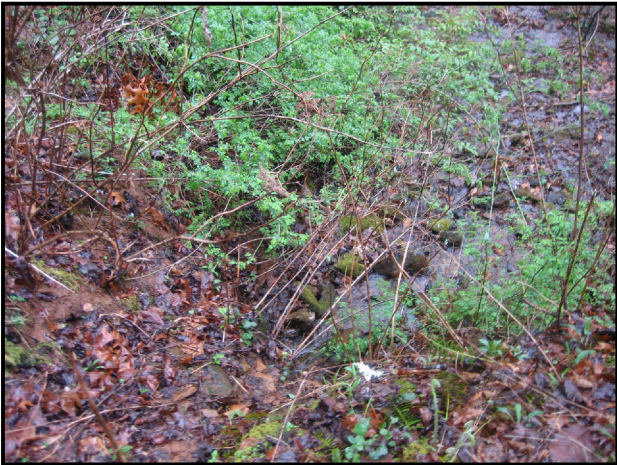
1. **Culvert (diameter/material/length):** 12”/ CPP
- | | |

| <input checked="" type="checkbox"/> clogged | <input type="checkbox"/> aquatic organism passage/ perched |
| <input type="checkbox"/> crushed | <input checked="" type="checkbox"/> erosion (upstream/ downstream) |
| <input type="checkbox"/> lack of natural bed | <input checked="" type="checkbox"/> piping |

Comments
Stream banks eroded, especially upstream of culvert. Culvert appears to be clogged with baseflow piping through earth.

| <input type="checkbox"/> relocate trail/close trail/road | <input checked="" type="checkbox"/> trail/road crossing improvement |
| <input type="checkbox"/> human/ animal exclusion | <input checked="" type="checkbox"/> culvert rehabilitation/ replacement |
