Area of Concern – Site: P10

Map Grid Location: D11 Site visit date/ team): 4/13/15/ BK, JZ Drainage Area (Sq. Mi.): < 0.1
Name & Location: Drainage across Burnt Mountain Trail

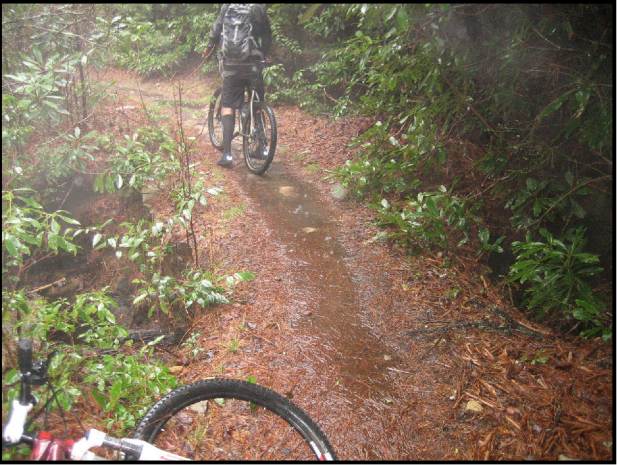
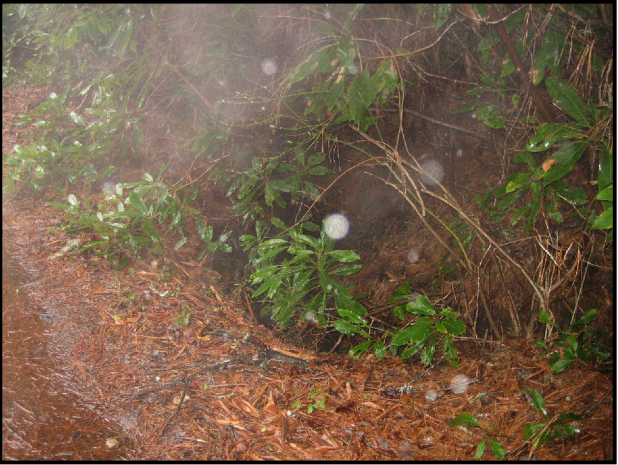
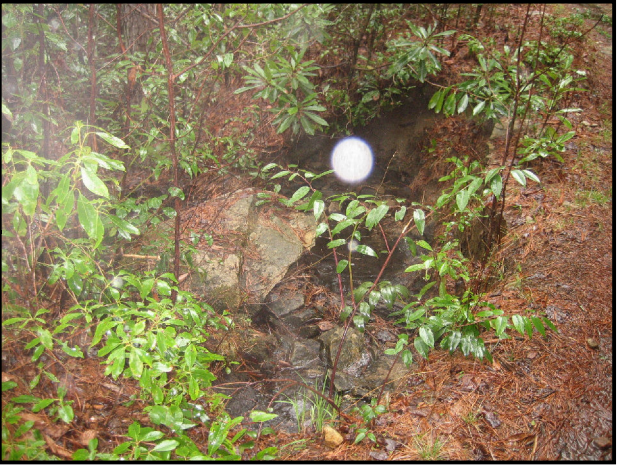
1. **Culvert (diameter/material/length):** 12”/ CPP
☐clogged ☐aquatic organism passage/ perched
☐crushed ☒erosion (upstream/ downstream)
☐lack of natural bed ☐piping
☐safety hazard ☐overtopping
2. **Trail/ Road Impact (trail/ road name):** _____
☐stormwater input ☐sediment input
☐bridge ☐utilities
☐unstable trail crossing ☐erosion
☐safety hazard ☐human impact (hiking/biking)
☐missing vegetation ☐equine/dog impacts
3. **Upland/ Stormwater**
☐nonpoint source pollution ☐upland erosion
☐pollutant point source ☐unvegetated upland area
4. **Lake/Pond/ Reservoir (reservoir name):** _____
☐erosion ☐lack of vegetation
☐equine impact ☐human impact (hiking/biking)
☐safety hazard ☐water quality (temperature, algae, geese, fecal)
5. **Other Problem Area(s)**(list contributing factors)

Comments
Stream banks eroded upstream/ downstream of culvert. Trail currently intact.

- Potential Solutions**
☐relocate trail/close trail/road ☒trail/road crossing improvement
☐vegetation/ shoreline planting ☐mechanical grading
☐stormwater treatment ☐animal watering
☐human/ animal exclusion ☒culvert rehabilitation/ replacement
☐signs ☐culvert daylighting
☐maintenance ☐bridge replacement/improvement
