## Area of Concern – Site: P11

Map Grid Location: E10 Site visit date/ team): 4/13/15/ BK, JZ Drainage Area (Sq. Mi.): 16.7  
 Name & Location: Corn Mill Shoals Trail at Little River Crossing

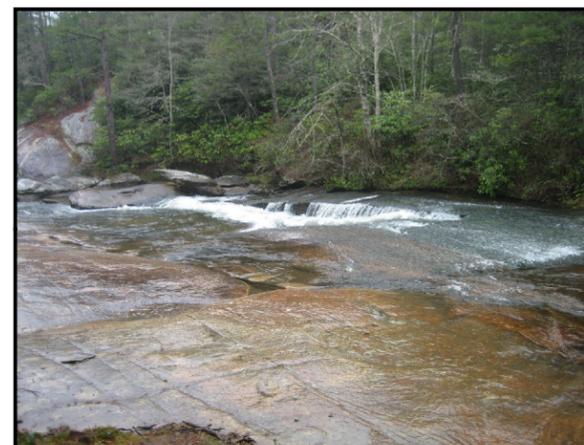
<input type="checkbox"/> stormwater input	<input type="checkbox"/> sediment input
<input type="checkbox"/> bridge	<input type="checkbox"/> utilities
<input type="checkbox"/> unstable trail crossing	<input type="checkbox"/> erosion
<input checked="" type="checkbox"/> safety hazard	<input checked="" type="checkbox"/> human impact (hiking/biking)
<input checked="" type="checkbox"/> missing vegetation	<input checked="" type="checkbox"/> equine/ dog impacts

Trail over widened and missing vegetation in vicinity of crossing. Actual crossing stable due to bedrock in riverbed.

| <input checked="" type="checkbox"/> relocate trail/close trail/road | <input checked="" type="checkbox"/> trail/road crossing improvement |
| <input checked="" type="checkbox"/> vegetation/ shoreline planting | <input type="checkbox"/> mechanical grading |
| <input checked="" type="checkbox"/> human/ animal exclusion | <input type="checkbox"/> culvert rehabilitation/ replacement |
