Area of Concern – Site: P12

Map Grid Location: E10 Site visit date/ team): 4/13/15/ BK, JZ Drainage Area (Sq. Mi.): < 0.1
 Name & Location: Tributary at Corn Mill Shoals Trail

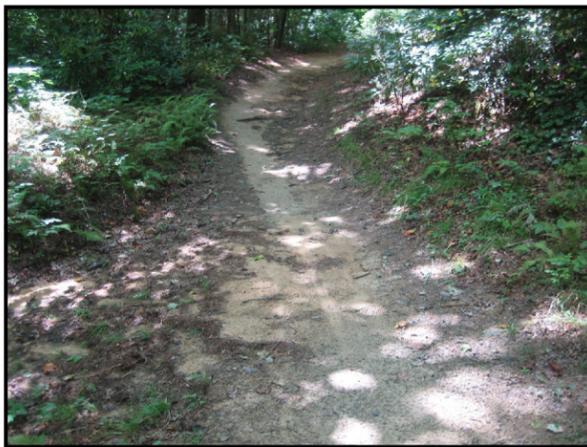
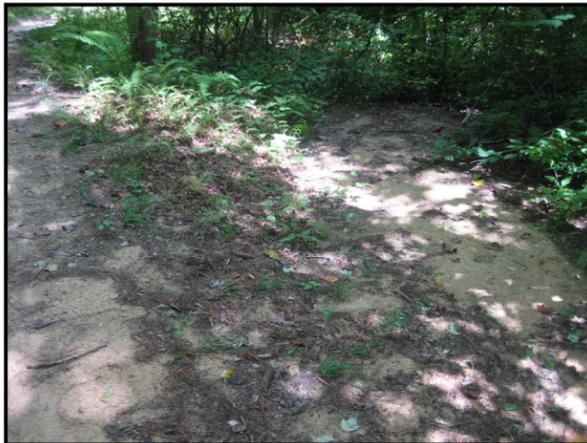
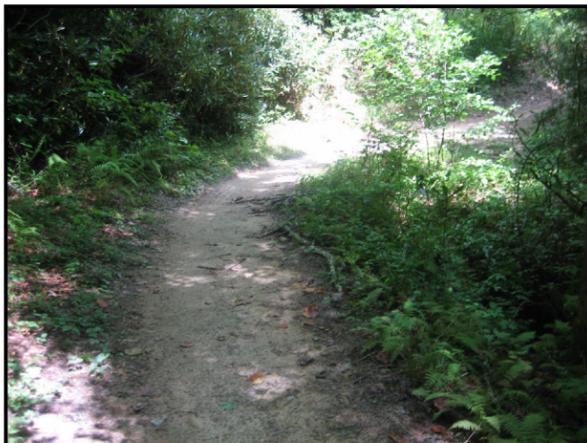
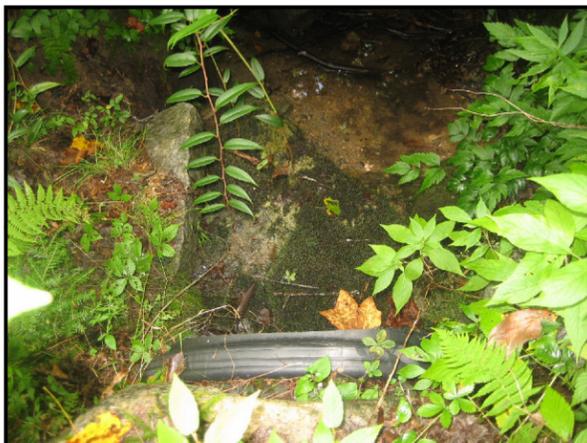
Culvert appears to be in good condition, though perched at downstream end. Trail serves as sediment source to stream, with sediment traps full.

| <input checked="" type="checkbox"/> relocate trail/close trail/road | <input checked="" type="checkbox"/> trail/road crossing improvement |
| <input checked="" type="checkbox"/> maintenance | <input type="checkbox"/> bridge replacement/improvement |
