Area of Concern – Site: P14

Map Grid Location: F9 Site visit date/ team): 8/31/15/ JZ Drainage Area (Sq. Mi.): 0.1
 Name & Location: Tributary at Shelter Rock Trail

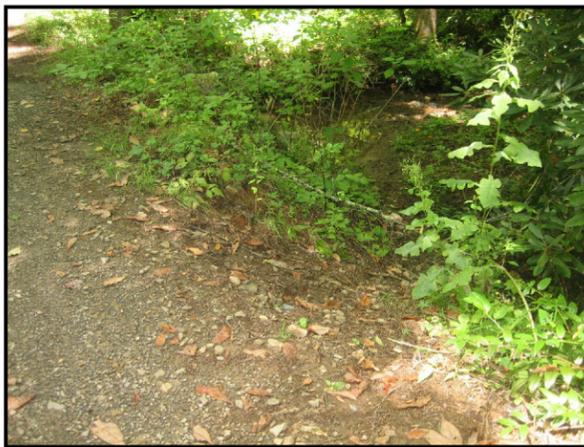
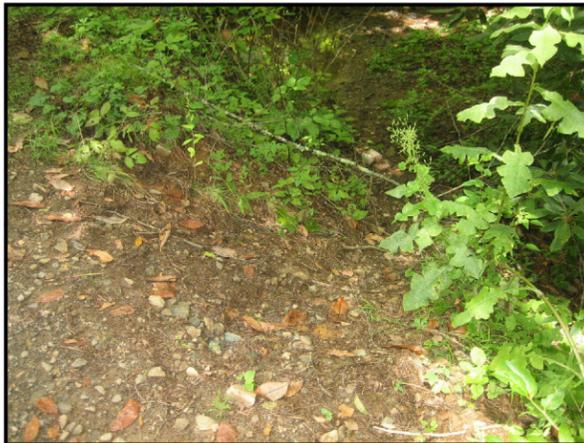
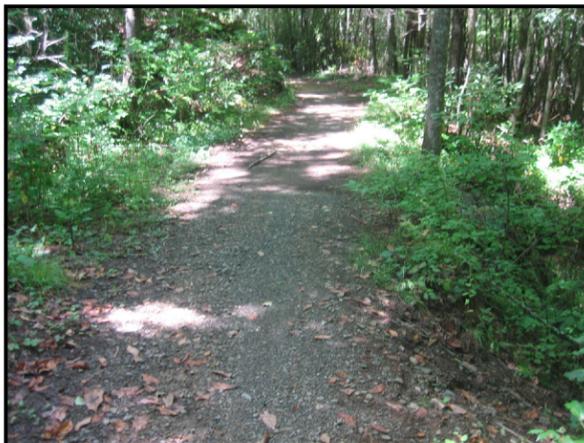
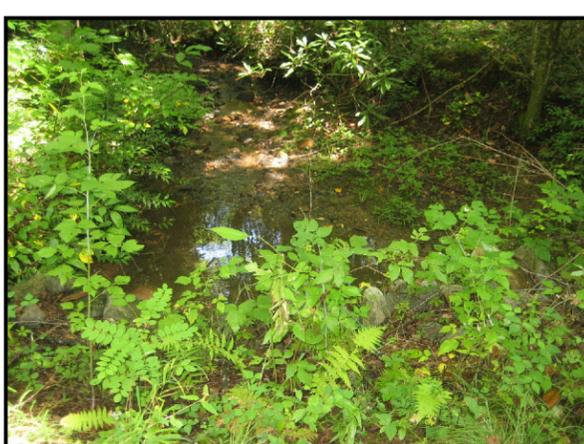
Comments
 Culvert exists and appears to be in good condition. Bare area between trail and stream caused/ exacerbated by human access and stormwater.

| <input checked="" type="checkbox"/> vegetation/ shoreline planting | <input type="checkbox"/> mechanical grading |
| <input checked="" type="checkbox"/> human/ animal exclusion | <input type="checkbox"/> culvert rehabilitation/ replacement |
