## Area of Concern – Site: P15

Map Grid Location: F9 Site visit date/ team): 8/31/15/ JZ Drainage Area (Sq. Mi.): 0.07  
 Name & Location: Tributary at Shelter Rock Trail

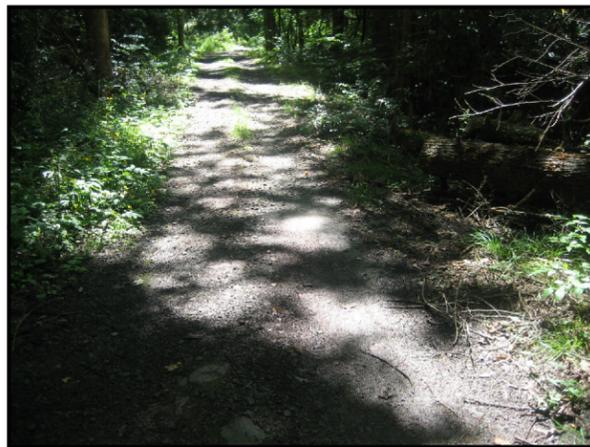
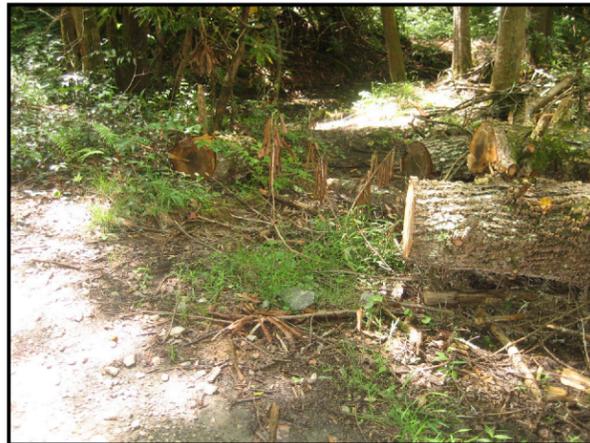
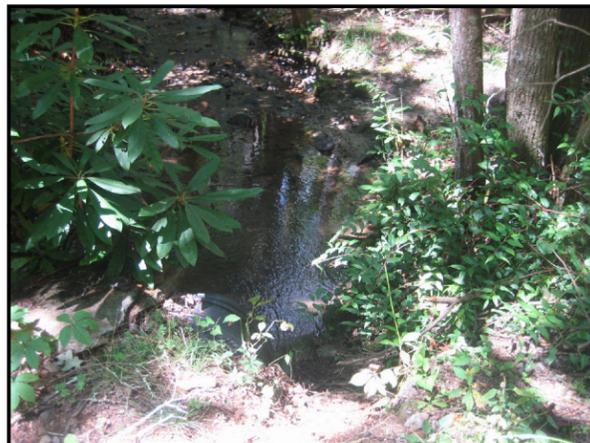
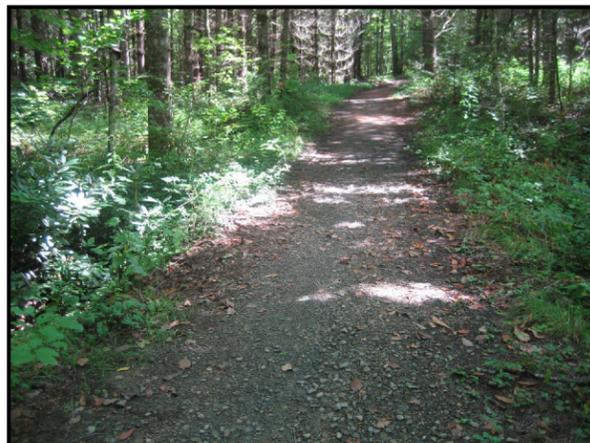
2. **Trail/ Road Impact (trail/ road name):** Shelter Rock Trail

<input checked="" type="checkbox"/> stormwater input	<input type="checkbox"/> sediment input
<input type="checkbox"/> bridge	<input type="checkbox"/> utilities
<input type="checkbox"/> unstable trail crossing	<input type="checkbox"/> erosion
<input type="checkbox"/> safety hazard	<input checked="" type="checkbox"/> human impact (hiking/biking)
<input checked="" type="checkbox"/> missing vegetation	<input type="checkbox"/> equine/dog impacts

**Comments**  
 Culvert exists and appears to be in good condition. Bare area between trail and stream caused/ exacerbated by human access and stormwater.

| <input checked="" type="checkbox"/> vegetation/ shoreline planting | <input type="checkbox"/> mechanical grading |
| <input checked="" type="checkbox"/> human/ animal exclusion | <input type="checkbox"/> culvert rehabilitation/ replacement |
