Area of Concern – Site: P19

Map Grid Location: G11 Site visit date/ team): 8/17/15/ JZ Drainage Area (Sq. Mi.): 2.58
 Name & Location: Reasonover Creek at Reasonover Creek Trail

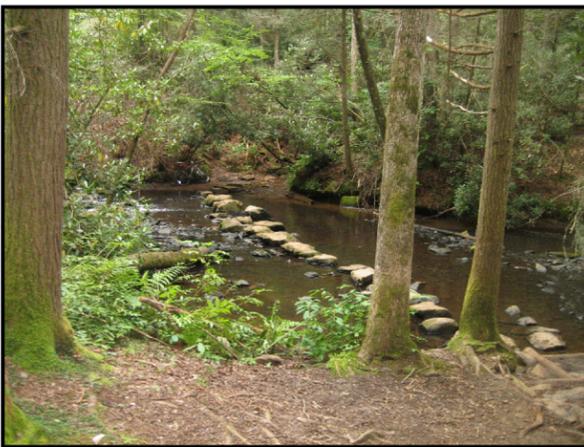
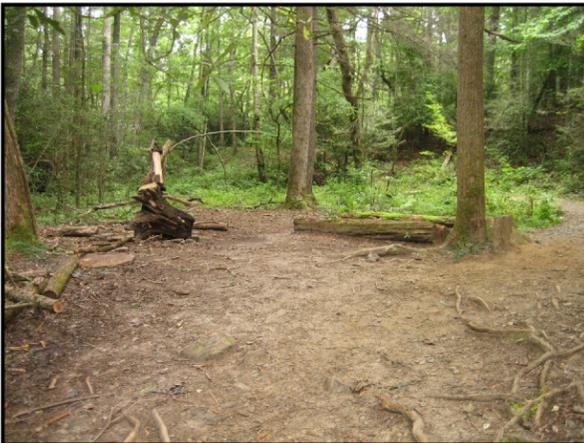
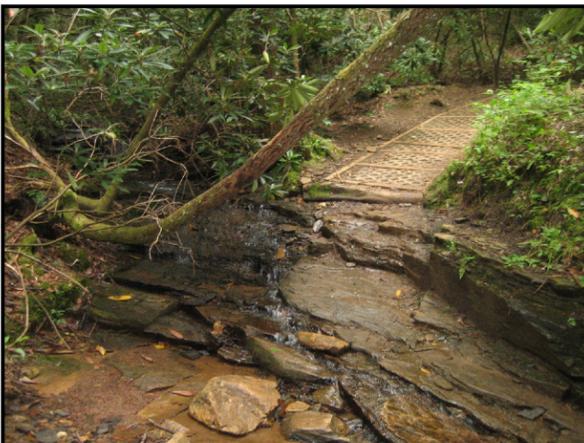
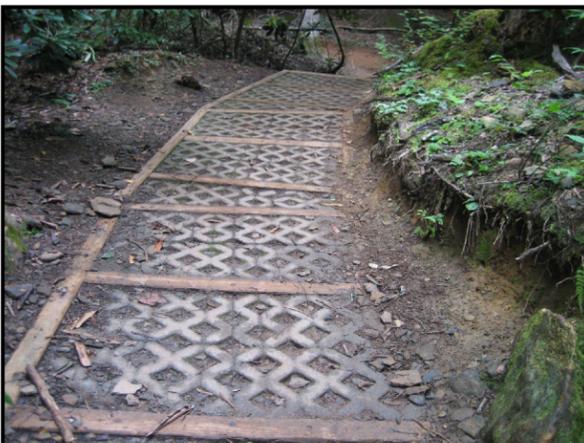
Trail crosses at confluence with tributary; hardened trail each side of Reasonover Creek. Left bank: very minor bank erosion and erosion along trail. Right bank: unvegetated area.

| <input type="checkbox"/> relocate trail/close trail/road | <input checked="" type="checkbox"/> trail/road crossing improvement |
| <input checked="" type="checkbox"/> vegetation/ shoreline planting | <input type="checkbox"/> mechanical grading |
