Area of Concern – Site: P23

Map Grid Location: F10 Site visit date/ team): 8/19/15/ JZ Drainage Area (Sq. Mi.): < 0.1  
Name & Location: Tributary at Reasonover Creek Trail

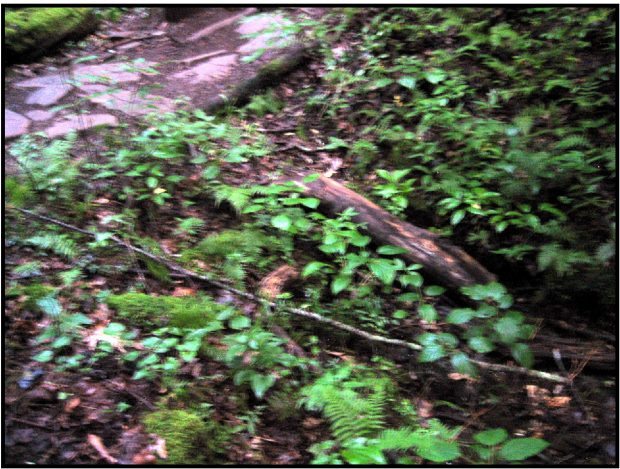
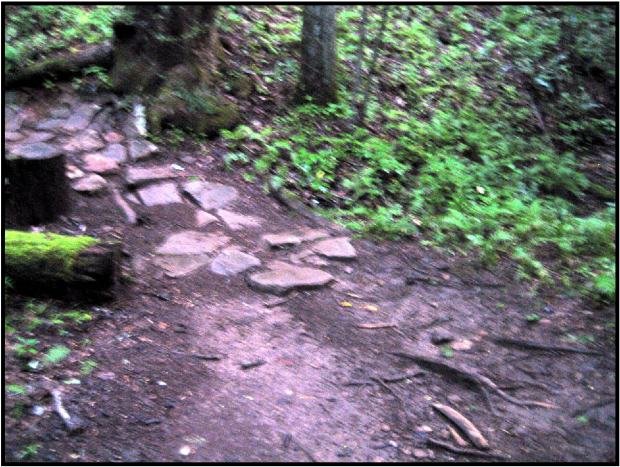
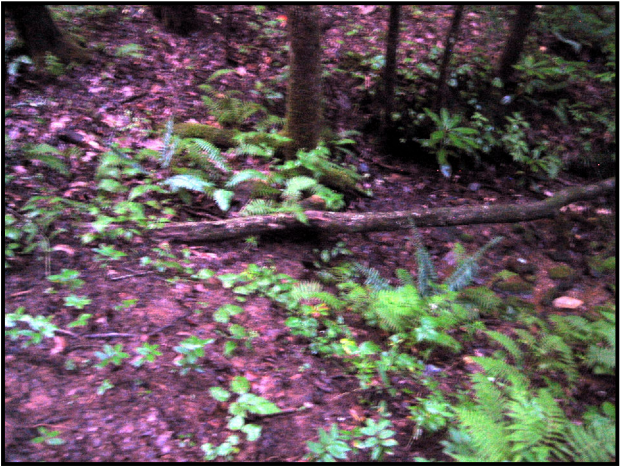
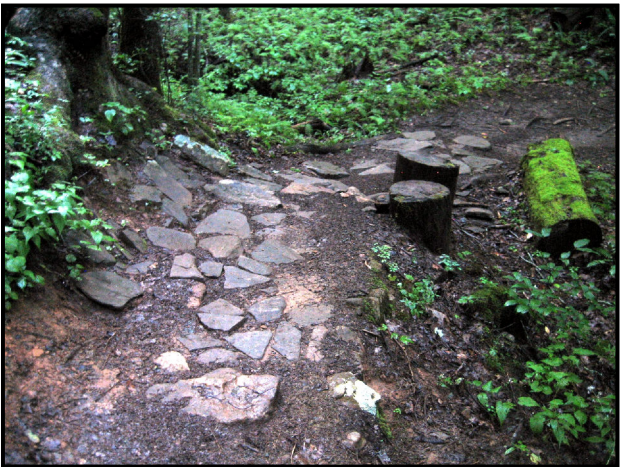
1. Culvert (diameter/material/length): 12”/ CPP  
☒clogged ☐aquatic organism passage/ perched  
☐crushed ☐erosion (upstream/ downstream)  
☐lack of natural bed ☐piping  
☐safety hazard ☐overtopping
2. Trail/ Road Impact (trail/ road name): \_\_\_\_\_  
☐stormwater input ☐sediment input  
☐bridge ☐utilities  
☐unstable trail crossing ☐erosion  
☐safety hazard ☐human impact (hiking/biking)  
☐missing vegetation ☐equine/dog impacts
3. Upland/ Stormwater \_\_\_\_\_  
☐nonpoint source pollution ☐upland erosion  
☐pollutant point source ☐unvegetated upland area
4. Lake/Pond/ Reservoir (reservoir name): \_\_\_\_\_  
☐erosion ☐lack of vegetation  
☐equine impact ☐human impact (hiking/biking)  
☐safety hazard ☐water quality (temperature, algae, geese, fecal)
5. Other Problem Area(s)list contributing factors)

Comments  
Culvert appears to be clogged. Trail currently stable, but potential exists for overtopping.

| <input type="checkbox"/> human/ animal exclusion | <input checked="" type="checkbox"/> culvert rehabilitation/ replacement |
| <input checked="" type="checkbox"/> maintenance | <input type="checkbox"/> bridge replacement/improvement |
