Area of Concern – Site: P43

Map Grid Location: I 3 Site visit date/ team): 8/20/15/ JZ Drainage Area (Sq. Mi.): < 0.1
 Name & Location: Tributary at Switchback Trail

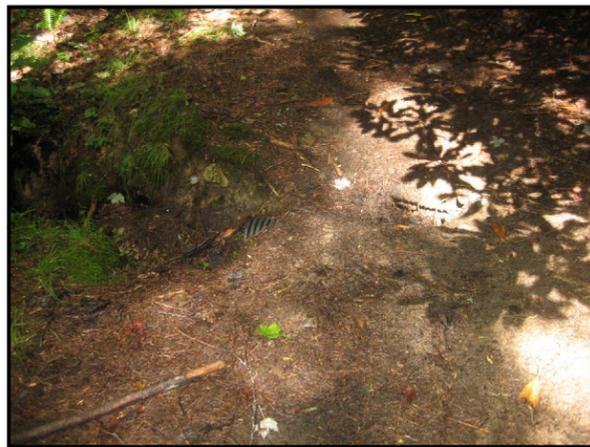
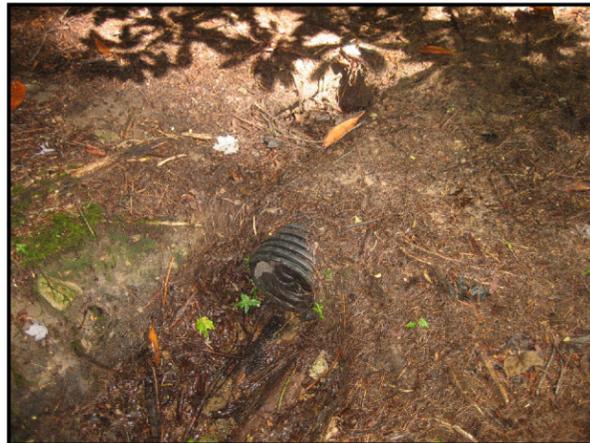
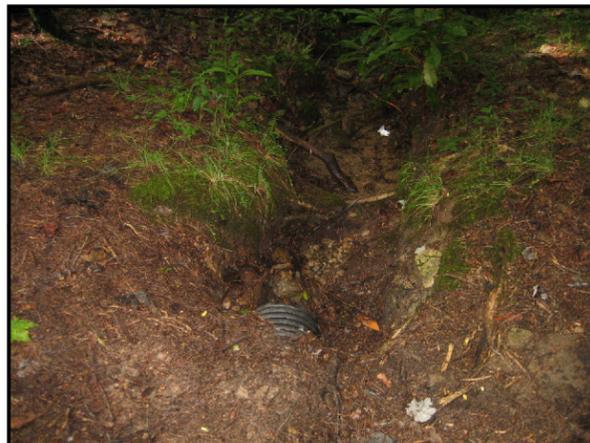
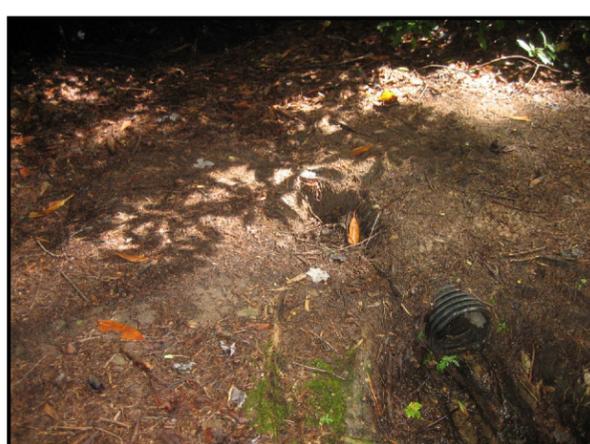
1. **Culvert (diameter/material/length):** 8"/ CPP

| <input type="checkbox"/> crushed | <input checked="" type="checkbox"/> erosion (upstream/ downstream) |
| <input type="checkbox"/> lack of natural bed | <input checked="" type="checkbox"/> piping |
| <input checked="" type="checkbox"/> safety hazard | <input type="checkbox"/> overtopping |

Comments
 Culvert failure by piping, leading to trail and downstream channel erosion.

| <input checked="" type="checkbox"/> relocate trail/close trail/road | <input checked="" type="checkbox"/> trail/road crossing improvement |
| <input type="checkbox"/> human/ animal exclusion | <input checked="" type="checkbox"/> culvert rehabilitation/ replacement |
| <input type="checkbox"/> signs | <input checked="" type="checkbox"/> culvert daylighting |
