Area of Concern – Site: P47

Map Grid Location: <u>J4</u> Site visit date/ team): <u>8/20/15/ JZ</u> Drainage Area (Sq. Mi.): < 0.1 Name & Location: <u>Tributary at Plantation Trail</u>	
Culvert (diameter/material/ □ clogged □ crushed □ lack of natural bed □ safety hazard	'length): 18" / CPP □ aquatic organism passage / perched ⊠ erosion (upstream / downstream) □ piping □ overtopping

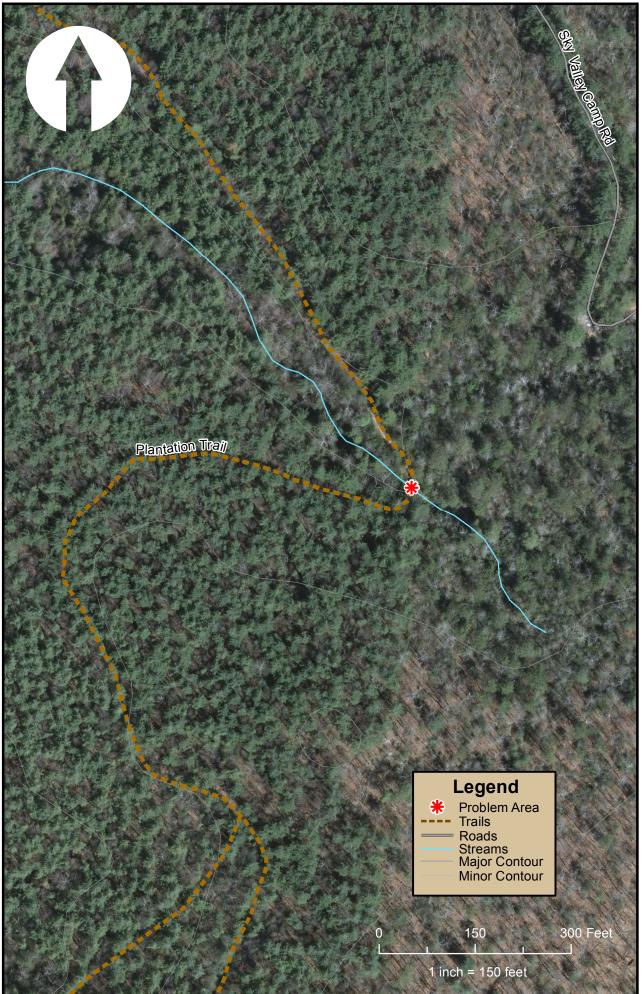
2. Trail/ Road Impact (trail/ re □ stormwater input □ bridge □ unstable trail crossing □ safety hazard ☑ missing vegetation	oad name): Plantation Trail sediment input utilities erosion human impact (hiking/biking) equine/dog impacts

3. Upland/ Stormwater ☐ nonpoint source pollution ☐ pollutant point source	☐ upland erosion ☐ unvegetated upland area
 4. Lake/Pond/ Reservoir (reservoir) □ erosion □ equine impact □ safety hazard 5. Other Problem Area(s) (list of the content o	□ lack of vegetation □ human impact (hiking/biking) □ water quality (temperature, algae, geese, fecal)
Potential Solutions □ relocate trail/close trail/road ☑ vegetation/ shoreline planting □ stormwater treatment □ human/ animal exclusion □ signs □ maintenance	☐ trail/road crossing improvement ☐ mechanical grading ☐ animal watering ☐ culvert rehabilitation/ replacement ☐ culvert daylighting ☐ bridge replacement/improvement
Comments No problems with culvert. However,	trail in vicinity is over widened and lacking vegetation.
