### Area of Concern – Site: P48

Map Grid Location: F11 Site visit date/ team): 8/17/15/ JZ Drainage Area (Sq. Mi.): \_\_\_\_\_  
 Name & Location: Fawn Lake

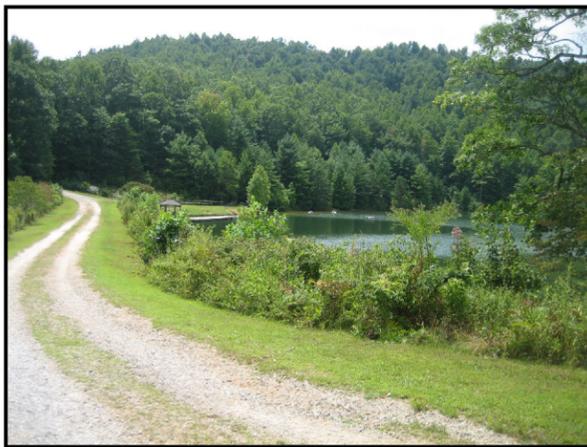
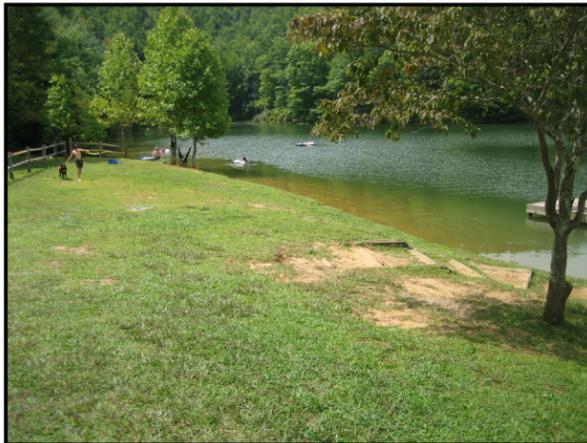
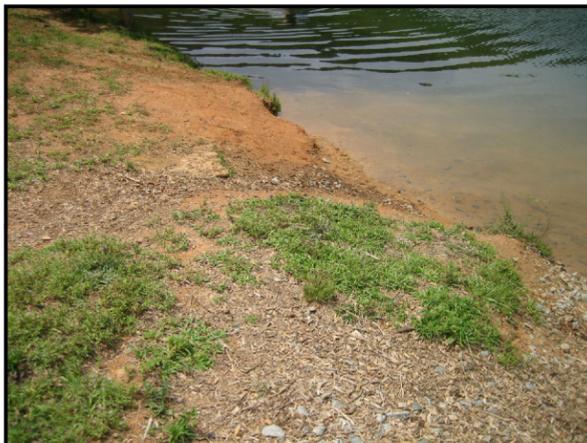
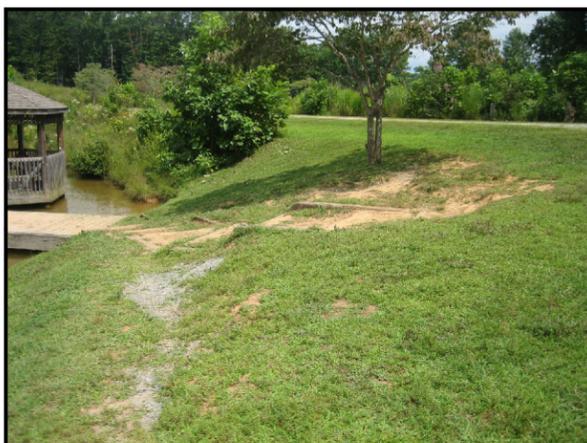
**Comments**  
 Shoreline of lake unvegetated and partially eroding at human access area; vegetation could be improved between lake and Fawn Lake Road.
