Area of Concern – Site: P49

Map Grid Location: G11 Site visit date/ team): 8/19/15/ JZ Drainage Area (Sq. Mi.):
 Name & Location: Power lines at Fawn Lake Road

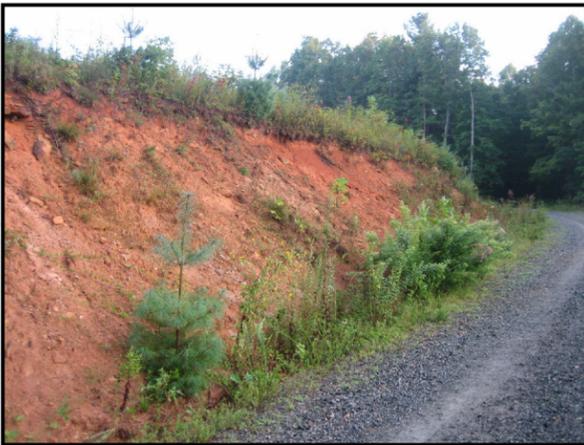
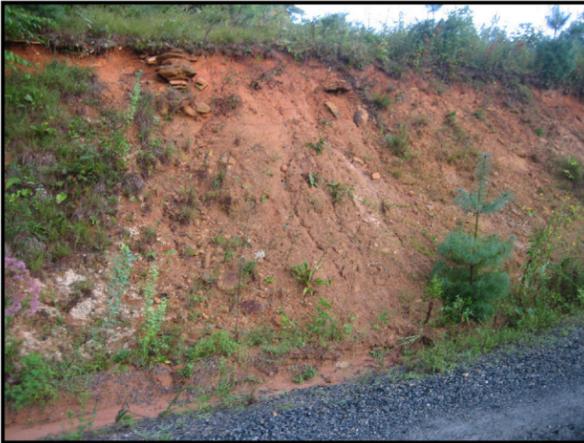
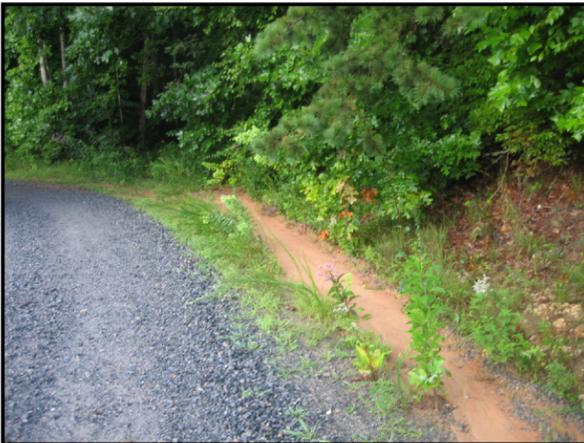
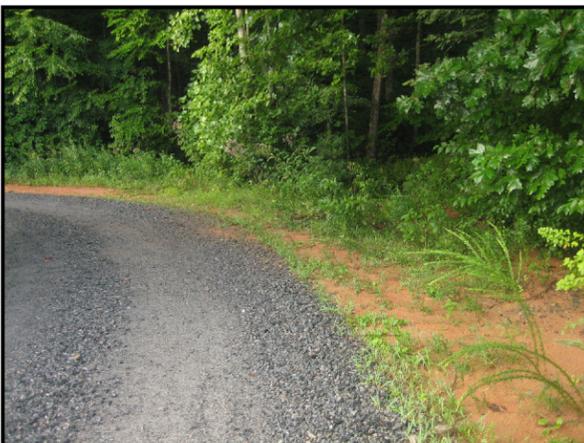
2. **Trail/ Road Impact (trail/ road name):** Fawn Lake Road
 stormwater input sediment input
 bridge utilities
 unstable trail crossing erosion
 safety hazard human impact (hiking/biking)
 missing vegetation equine/ dog impacts

Comments
 Steep eroding slope along Fawn Lake Road contributing fine sediment directly to adjacent drainage.

| <input checked="" type="checkbox"/> vegetation/ shoreline planting | <input checked="" type="checkbox"/> mechanical grading |
