Stream Condition – Site: S02

Map Grid Location: E9 Site visit date/ team): 4/13/15 / BK, JZ Drainage Area (Sq. Mi.): 18.3

Stream name & Location: Little River above Bridal Veil Falls

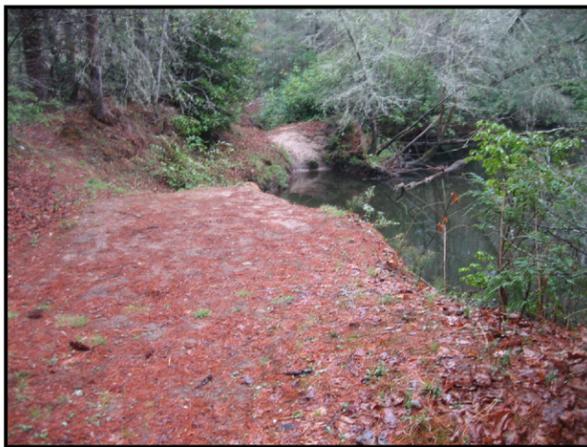
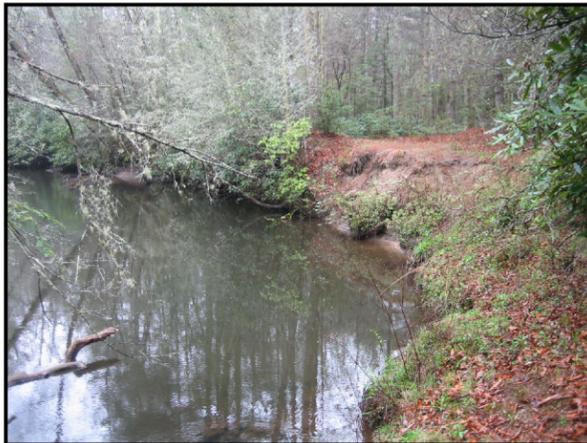
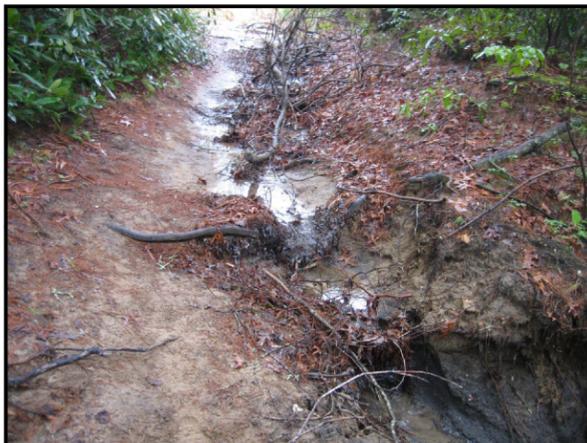
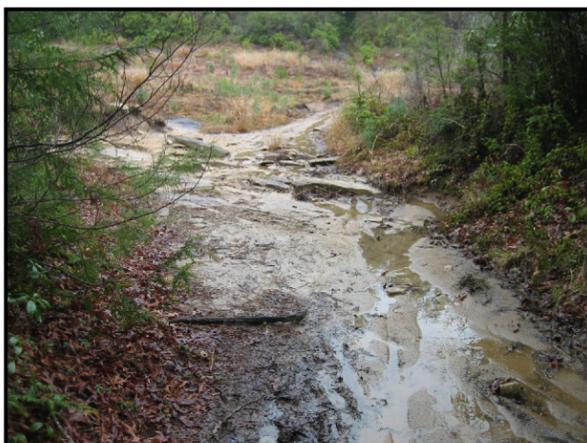
Trail (both open and closed – though still used) in buffer. Trails provide sediment source and restrict buffer vegetation. Lengthy powerline crossing affects buffer.
