Stream Condition – Site: S05

Map Grid Location: F10 Site visit date/ team): 8/17/15 / JZ Drainage Area (Sq. Mi.): 0.06
Stream name & Location: Tributary at Conservation Road
Streambed Substrate: silt Length (ft): +/- 515 Bankfull Width (ft): +/- 10

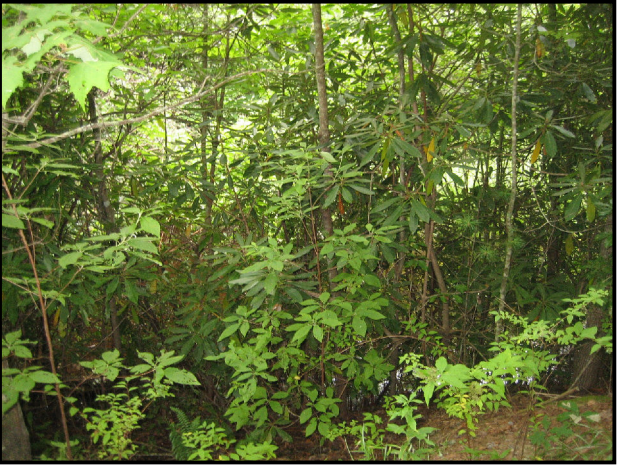
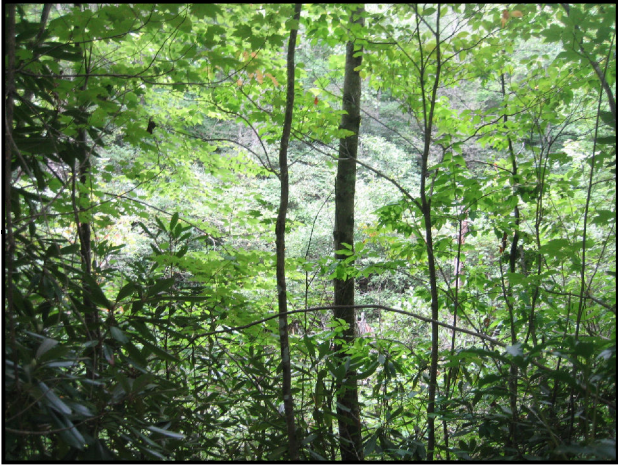
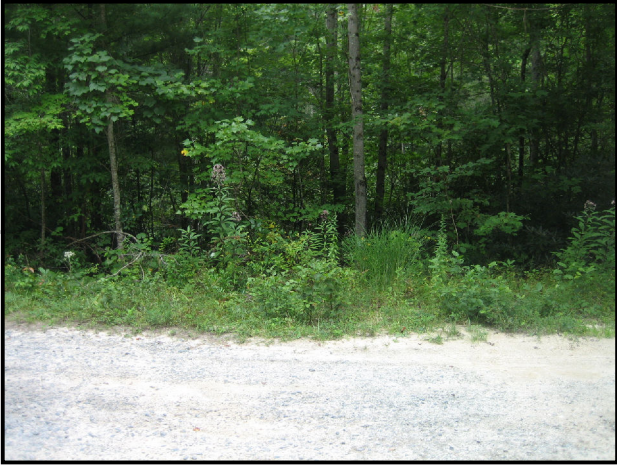
2. Channel Morphology and Condition	1
<input checked="" type="checkbox"/> overwide	<input type="checkbox"/> incised
<input type="checkbox"/> straightened	<input type="checkbox"/> eroding banks
<input type="checkbox"/> head-cutting	<input checked="" type="checkbox"/> lack of bedform diversity
<input type="checkbox"/> high bed scour	<input type="checkbox"/> excessive sediment deposition

5. Habitat	2
<input type="checkbox"/> lack of woody debris	<input type="checkbox"/> poor water quality (turbid, algae, temperature)
<input checked="" type="checkbox"/> lack of diverse bedform/ flow	<input checked="" type="checkbox"/> lack of fine roots, leaf packs, coarse substrate
Score (of 20) and Rating(Poor 0-7; Fair 8-12; Good 13-17; Excellent 18-20)	12

Culvert clogged upstream of Conservation Road, creating large area of backwater in channel; woody vegetation has died as a result.

<input type="checkbox"/> relocate/close trail	<input type="checkbox"/> trail crossing improvement
<input checked="" type="checkbox"/> vegetation planting	<input type="checkbox"/> mechanical grading
<input type="checkbox"/> in-stream structures	<input type="checkbox"/> watershed improvements
<input type="checkbox"/> preservation/ exclusion	<input checked="" type="checkbox"/> culvert rehabilitation/ replacement
<input checked="" type="checkbox"/> maintenance	<input type="checkbox"/> signs
