Stream Condition – Site: S06

Map Grid Location: G11 Site visit date/ team): 8/17/15 / JZ Drainage Area (Sq. Mi.): 0.06  
Stream name & Location: Tributary to Reasonover Creek  
Streambed Substrate: Clay, fine gravel, bedrock Length (ft): +/- 200 Bankfull Width (ft): +/- 10

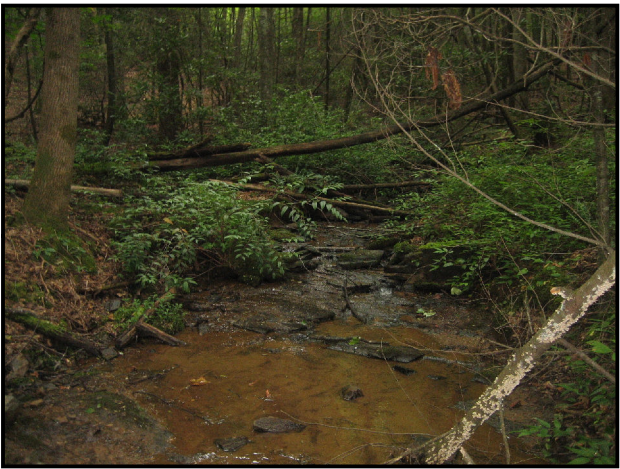
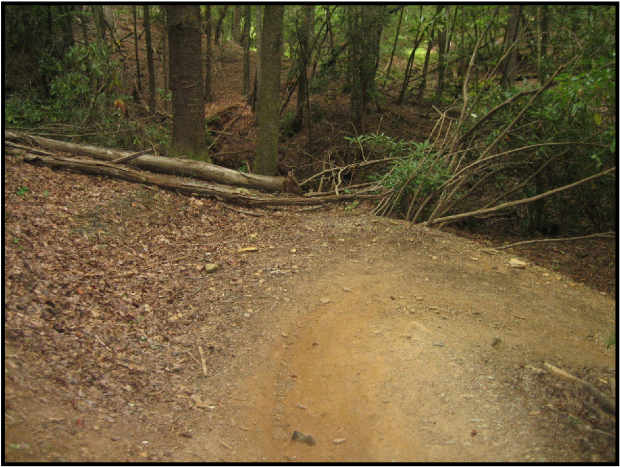
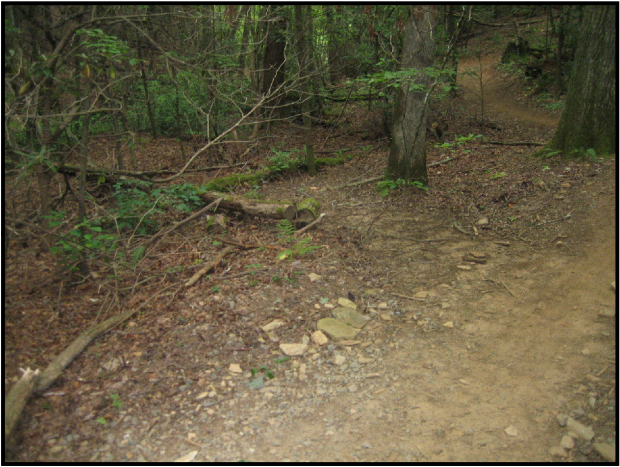
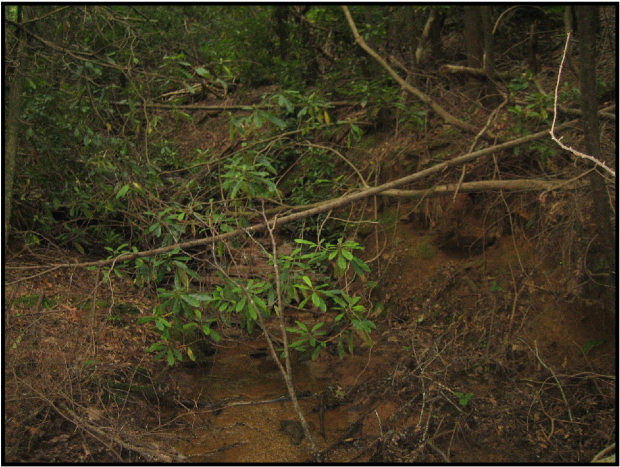
<b>1. Site and Watershed Conditions</b>	<b>2</b>
<input type="checkbox"/> stormwater input	<input checked="" type="checkbox"/> sediment input
<input type="checkbox"/> trampled banks	<input type="checkbox"/> equine/dog impacts
<input checked="" type="checkbox"/> trail crossing	<input checked="" type="checkbox"/> trail in buffer
<input type="checkbox"/> bridge/culvert/armoring	<input type="checkbox"/> utilities
<b>2. Channel Morphology and Condition</b>	<b>2</b>
<input type="checkbox"/> overwide	<input checked="" type="checkbox"/> incised
<input type="checkbox"/> straightened	<input checked="" type="checkbox"/> eroding banks
<input type="checkbox"/> head-cutting	<input checked="" type="checkbox"/> lack of bedform diversity
<input type="checkbox"/> high bed scour	<input checked="" type="checkbox"/> excessive sediment deposition
<b>3. Floodplain Morphology</b>	<b>3</b>
<input checked="" type="checkbox"/> incised channel	<input checked="" type="checkbox"/> entrenched channel

Eroding left bank just downstream of bedrock grade control, fine sediment deposition in channel; trail near channel serves as sediment source.

<input checked="" type="checkbox"/> relocate/close trail	<input type="checkbox"/> trail crossing improvement
<input checked="" type="checkbox"/> vegetation planting	<input type="checkbox"/> mechanical grading
<input checked="" type="checkbox"/> in-stream structures	<input type="checkbox"/> watershed improvements
<input type="checkbox"/> preservation/ exclusion	<input type="checkbox"/> culvert rehabilitation/ replacement
<input type="checkbox"/> maintenance	<input type="checkbox"/> signs
