Stream Condition – Site: S09

Map Grid Location: H6 Site visit date/ team): 8/26/15 / JZ Drainage Area (Sq. Mi.): 4.11
Stream name & Location: Grassy Creek along Sandy Trail
Streambed Substrate: Silt, sand, cobble Length (ft): +/- 150 Bankfull Width (ft): +/- 25

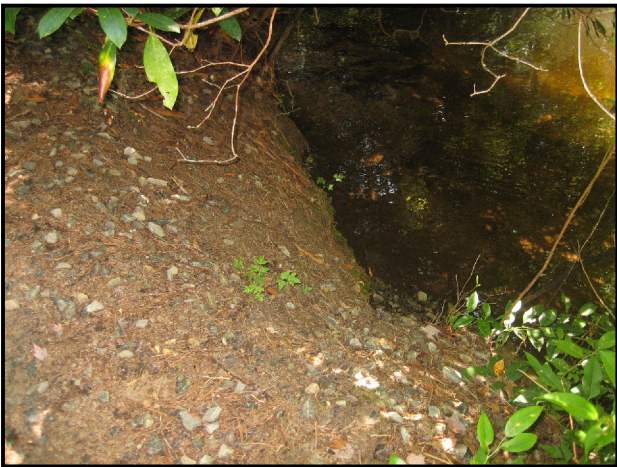
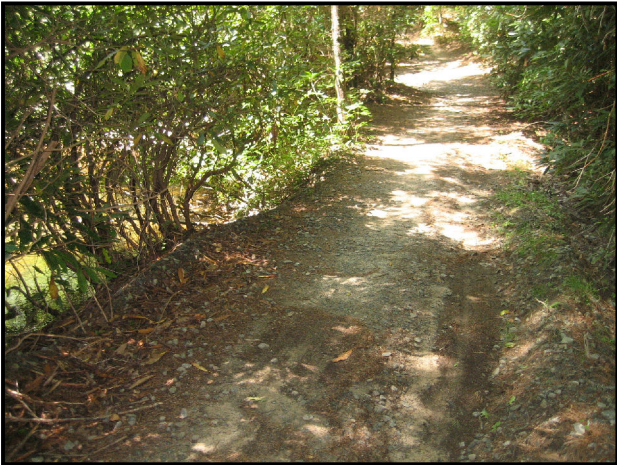
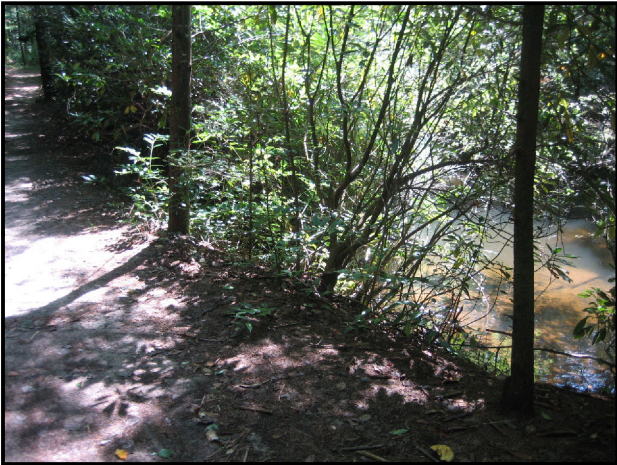
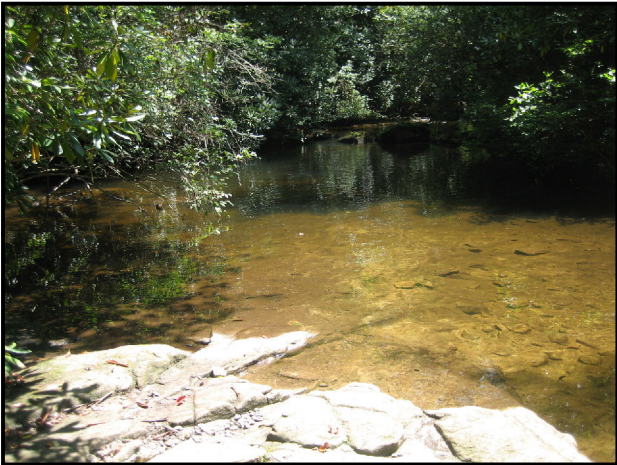
2. Channel Morphology and Condition	2
<input checked="" type="checkbox"/> overwide	<input type="checkbox"/> incised
<input type="checkbox"/> straightened	<input checked="" type="checkbox"/> eroding banks
<input type="checkbox"/> head-cutting	<input checked="" type="checkbox"/> lack of bedform diversity
<input type="checkbox"/> high bed scour	<input checked="" type="checkbox"/> excessive sediment deposition

4. Vegetation	2
<input checked="" type="checkbox"/> narrow buffer width	<input type="checkbox"/> invasive plants (banks/floodplain)
<input checked="" type="checkbox"/> poor overstory/tree cover	<input checked="" type="checkbox"/> bare areas/mineral soil (banks/floodplain)

5. Habitat	2
<input checked="" type="checkbox"/> lack of woody debris	<input type="checkbox"/> poor water quality (turbid, algae, temperature)
<input checked="" type="checkbox"/> lack of diverse bedform/ flow	<input type="checkbox"/> lack of fine roots, leaf packs, coarse substrate

Comments
Trail crossing stable. However, trail in buffer with minor stream bank crosion.

Potential Solutions	
<input checked="" type="checkbox"/> relocate/close trail	<input type="checkbox"/> trail crossing improvement
<input checked="" type="checkbox"/> vegetation planting	<input type="checkbox"/> mechanical grading
<input checked="" type="checkbox"/> in-stream structures	<input type="checkbox"/> watershed improvements
<input type="checkbox"/> preservation/ exclusion	<input type="checkbox"/> culvert rehabilitation/ replacement
<input type="checkbox"/> maintenance	<input type="checkbox"/> signs
