Stream Condition – Site: S11

Map Grid Location: F8 Site visit date/ team): 8/31/15 / JZ Drainage Area (Sq. Mi.): 6.70
Stream name & Location: Reasonover Creek below Lake Julia
Streambed Substrate: bedrock Length (ft): +/- 630 Bankfull Width (ft): +/- 50

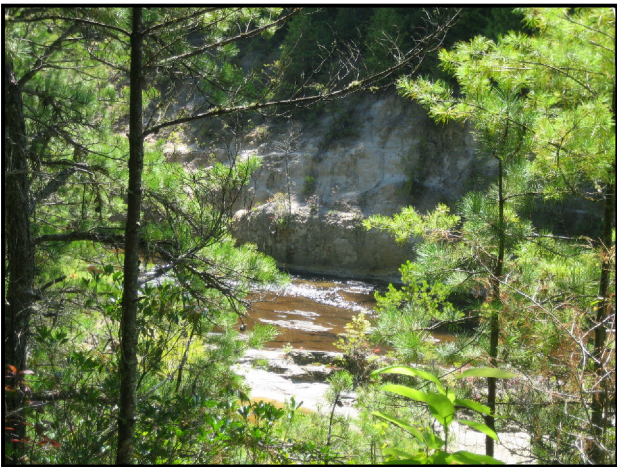
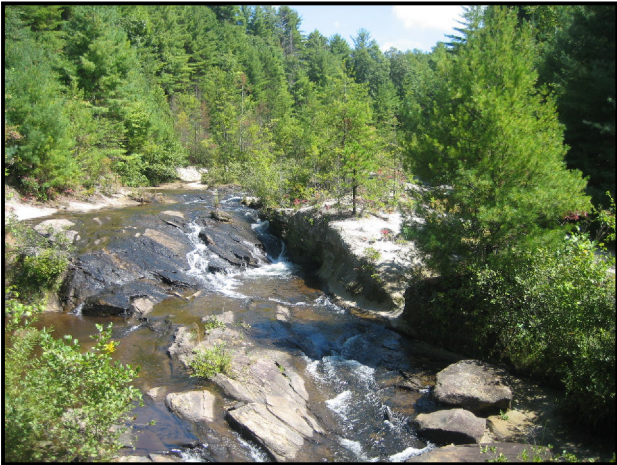
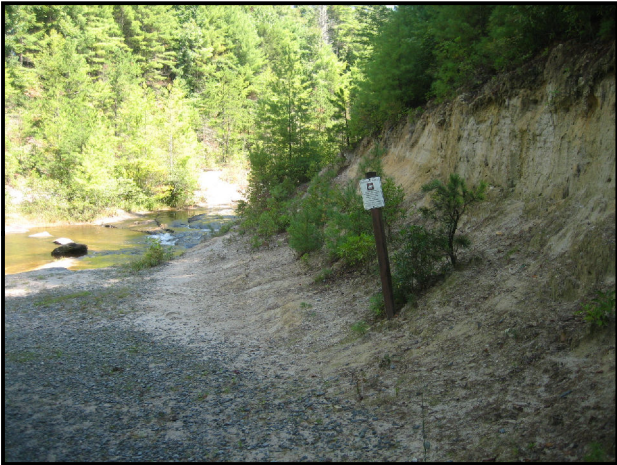
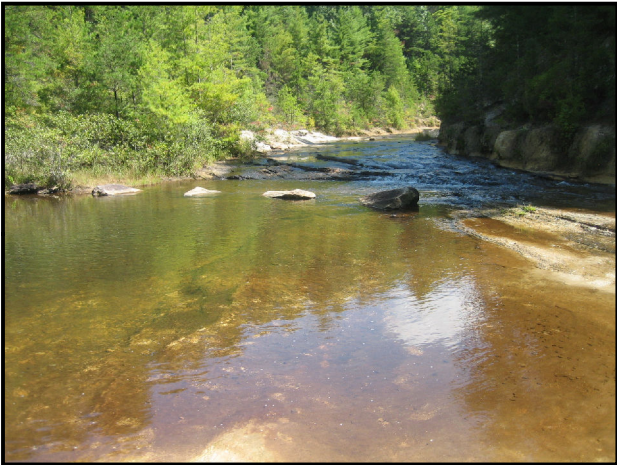
1. Site and Watershed Conditions	1
<input type="checkbox"/> stormwater input	<input checked="" type="checkbox"/> sediment input
<input checked="" type="checkbox"/> trampled banks	<input checked="" type="checkbox"/> equine/dog impacts
<input type="checkbox"/> trail crossing	<input checked="" type="checkbox"/> trail in buffer
<input checked="" type="checkbox"/> bridge/culvert/armoring	<input type="checkbox"/> utilities

2. Channel Morphology and Condition	1
<input checked="" type="checkbox"/> overwide	<input type="checkbox"/> incised
<input type="checkbox"/> straightened	<input checked="" type="checkbox"/> eroding banks
<input type="checkbox"/> head-cutting	<input checked="" type="checkbox"/> lack of bedform diversity
<input type="checkbox"/> high bed scour	<input type="checkbox"/> excessive sediment deposition

3. Floodplain Morphology	2
<input type="checkbox"/> incised channel	<input checked="" type="checkbox"/> entrenched channel
<input type="checkbox"/> floodplain fill/ levees	<input type="checkbox"/> irregular/ obstructed floodplain

4. Vegetation	1
<input type="checkbox"/> narrow buffer width	<input type="checkbox"/> invasive plants (banks/floodplain)
<input checked="" type="checkbox"/> poor overstory/tree cover	<input checked="" type="checkbox"/> bare areas/mineral soil (banks/floodplain)

5. Habitat	0
<input checked="" type="checkbox"/> lack of woody debris	<input checked="" type="checkbox"/> poor water quality (turbid, algae, temperature)
<input checked="" type="checkbox"/> lack of diverse bedform/ flow	<input checked="" type="checkbox"/> lack of fine roots, leaf packs, coarse substrate

Score (of 20) and Rating(Poor 0-7; Fair 8-12; Good 13-17; Excellent 18-20) **5**

Comments
Stream over widened on bedrock with steep, unvegetated banks. Restoration challenging due to bedrock bed and lack of soil. Consider retrofit to Lake Julia outlet to lower water temperature.

Potential Solutions	
<input type="checkbox"/> relocate/close trail	<input type="checkbox"/> trail crossing improvement
<input checked="" type="checkbox"/> vegetation planting	<input checked="" type="checkbox"/> mechanical grading
<input checked="" type="checkbox"/> in-stream structures	<input type="checkbox"/> watershed improvements
<input type="checkbox"/> preservation/ exclusion	<input type="checkbox"/> culvert rehabilitation/ replacement
<input type="checkbox"/> maintenance	<input type="checkbox"/> signs
