Stream Condition – Site: S15

Map Grid Location: H3 Site visit date/ team): 8/26/15 / JZ Drainage Area (Sq. Mi.): 0.14

Stream name & Location: Shoal Creek

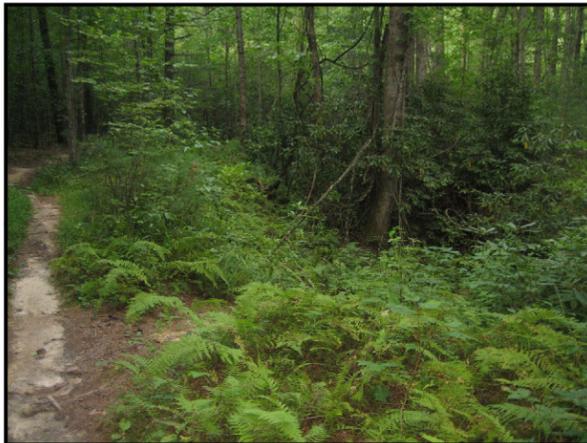
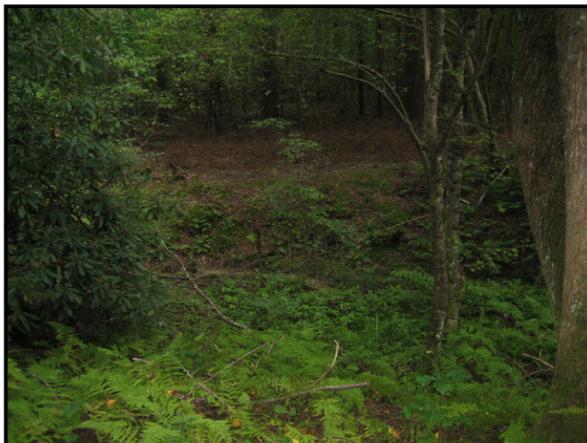
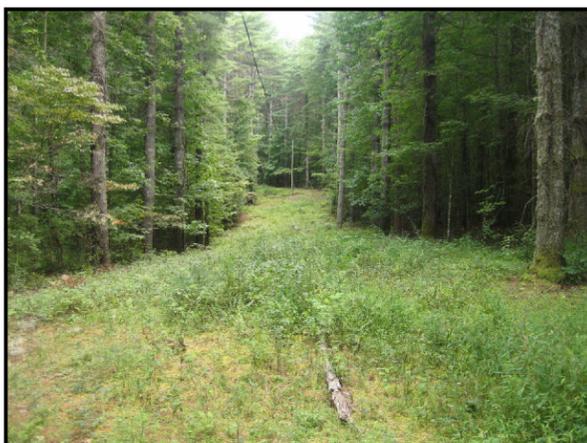
1. Site and Watershed Conditions	1
<input type="checkbox"/> stormwater input <input type="checkbox"/> trampled banks <input type="checkbox"/> trail crossing <input type="checkbox"/> bridge/culvert/armoring	<input type="checkbox"/> sediment input <input type="checkbox"/> equine/dog impacts <input checked="" type="checkbox"/> trail in buffer <input checked="" type="checkbox"/> utilities

2. Channel Morphology and Condition	1
<input type="checkbox"/> overwide <input type="checkbox"/> straightened <input checked="" type="checkbox"/> head-cutting <input type="checkbox"/> high bed scour	<input type="checkbox"/> incised <input checked="" type="checkbox"/> eroding banks <input type="checkbox"/> lack of bedform diversity <input checked="" type="checkbox"/> excessive sediment deposition

3. Floodplain Morphology	1
<input checked="" type="checkbox"/> incised channel <input checked="" type="checkbox"/> floodplain fill/ levees	<input checked="" type="checkbox"/> entrenched channel <input type="checkbox"/> irregular/ obstructed floodplain

4. Vegetation	2
<input checked="" type="checkbox"/> narrow buffer width <input checked="" type="checkbox"/> poor overstory/tree cover	<input type="checkbox"/> invasive plants (banks/floodplain) <input checked="" type="checkbox"/> bare areas/mineral soil (banks/floodplain)

5. Habitat	2
<input type="checkbox"/> lack of woody debris <input checked="" type="checkbox"/> lack of diverse bedform/ flow	<input type="checkbox"/> poor water quality (turbid, algae, temperature) <input checked="" type="checkbox"/> lack of fine roots, leaf packs, coarse substrate
Score (of 20) and Rating (Poor 0-7; Fair 8-12; Good 13-17; Excellent 18-20)	7

Power line through watershed, trail and old road/ trail in buffer. Head-cut at top of reach, some bank erosion throughout reach.

| <input checked="" type="checkbox"/> relocate/close trail | <input type="checkbox"/> trail crossing improvement |
| <input checked="" type="checkbox"/> vegetation planting | <input type="checkbox"/> mechanical grading |
| <input checked="" type="checkbox"/> in-stream structures | <input type="checkbox"/> watershed improvements |
| <input checked="" type="checkbox"/> preservation/ exclusion | <input type="checkbox"/> culvert rehabilitation/ replacement |
