Stream Condition – Site: S17

Map Grid Location: E5 Site visit date/ team): 8/19/15 / JZ Drainage Area (Sq. Mi): 35.6
Stream name & Location: Little River at Hooker Falls Road
Streambed Substrate: Boulder, bedrock Length (ft): +/- 810 Bankfull Width (ft): +/- 50

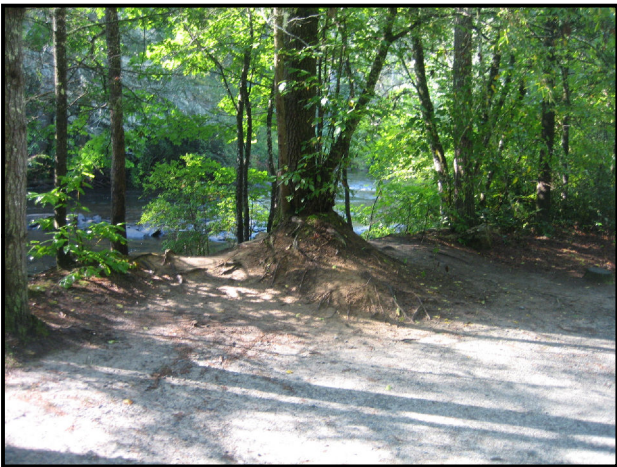
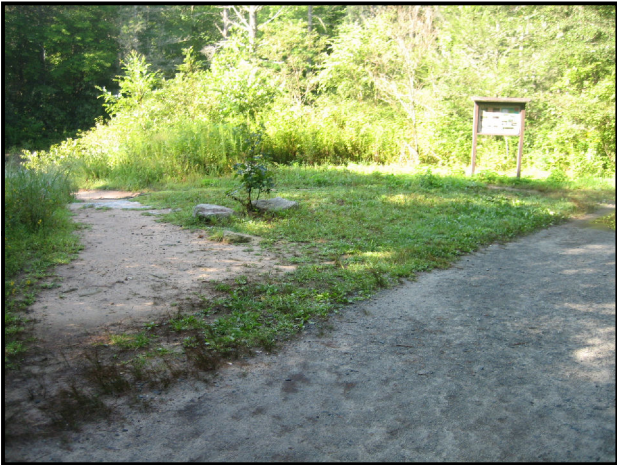
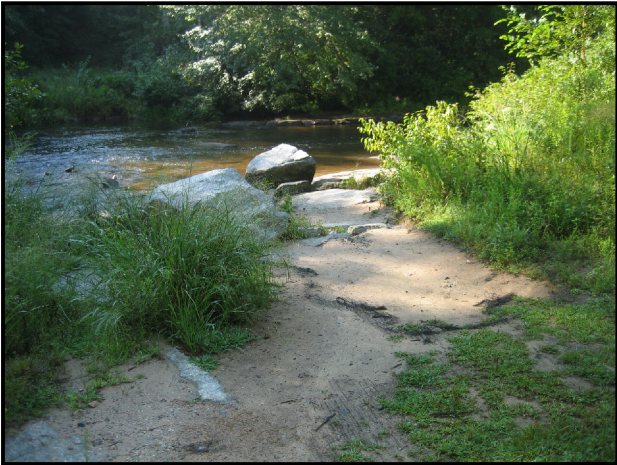
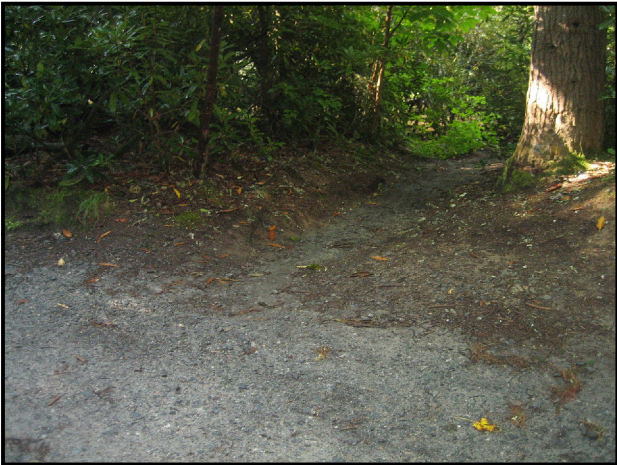
1. Site and Watershed Conditions	1
<input type="checkbox"/> stormwater input	<input checked="" type="checkbox"/> sediment input
<input checked="" type="checkbox"/> trampled banks	<input checked="" type="checkbox"/> equine/dog impacts
<input type="checkbox"/> trail crossing	<input checked="" type="checkbox"/> trail in buffer
<input type="checkbox"/> bridge/culvert/armoring	<input checked="" type="checkbox"/> utilities

2. Channel Morphology and Condition	2
<input type="checkbox"/> overwide	<input type="checkbox"/> incised
<input type="checkbox"/> straightened	<input checked="" type="checkbox"/> eroding banks
<input type="checkbox"/> head-cutting	<input type="checkbox"/> lack of bedform diversity
<input type="checkbox"/> high bed scour	<input checked="" type="checkbox"/> excessive sediment deposition

4. Vegetation	2
<input checked="" type="checkbox"/> narrow buffer width	<input type="checkbox"/> invasive plants (banks/floodplain)
<input checked="" type="checkbox"/> poor overstory/tree cover	<input checked="" type="checkbox"/> bare areas/mineral soil (banks/floodplain)

Human access along Hooker Falls Road has led to excessive bare areas and sediment input. Potential solutions include relocating trail away from river and revegetating.

<input checked="" type="checkbox"/> relocate/close trail	<input type="checkbox"/> trail crossing improvement
<input checked="" type="checkbox"/> vegetation planting	<input type="checkbox"/> mechanical grading
<input type="checkbox"/> in-stream structures	<input type="checkbox"/> watershed improvements
<input checked="" type="checkbox"/> preservation/ exclusion	<input type="checkbox"/> culvert rehabilitation/ replacement
<input type="checkbox"/> maintenance	<input checked="" type="checkbox"/> signs
