# **FINAL REPORT**

## **Dupont State Forest Lake Julia Outfall Stream Restoration**

**December 12, 2011**

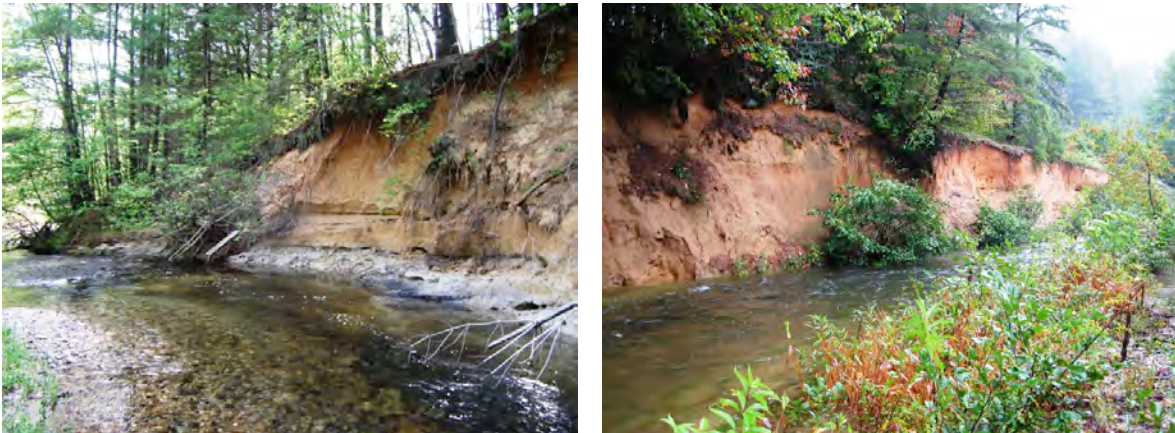
Natural stream functions in many areas of North Carolina are threatened by historical and ongoing alterations in watershed hydrology and land use, resulting in unstable streams with poor habitat and water quality. Causes of degradation include channelization, sediment inundation, stormwater runoff, road crossings, and loss of riparian vegetation. These degraded functions are made worse from the results of severe floods that have occurred in western North Carolina over the previous decade. Prior to becoming part of Dupont State Forest, the Little River watershed, including Reasonover Creek, experienced impacts from floods, logging, agriculture, impoundments, and road construction. Reasonover Creek immediately downstream of Lake Julia was unstable with severe bank erosion and excessive in-stream sediment, resulting in poor habitat for fish and aquatic invertebrates (Figure 1). Based on a field evaluation of bank erodibility, it was estimated that the streambanks in this area are contributing 600 to 1000 tons of sediment per year directly to the stream.

Figure 1. Reasonover Creek prior to restoration.

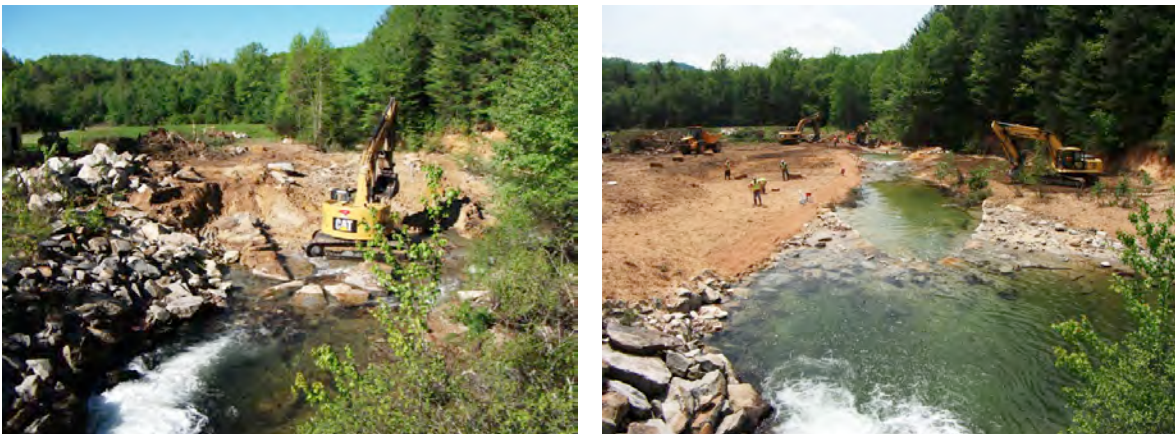
Figure 2. Relocated stream channel.

Approximately 300 feet of channel was relocated away from an eroding hillslope. A new channel was constructed in the dry, gravel and cobble bed material was transferred from the old channel, then flow was turned into the new channel (Figure 2).

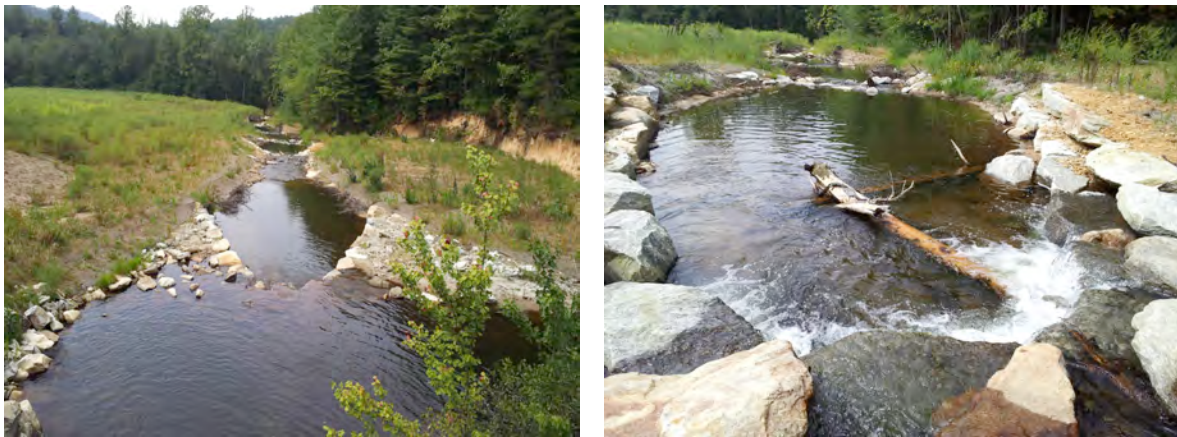
Figure 3. Boulder cross-vanes.

Two boulder cross vanes were constructed in the channel to provide grade control, direct flow into the new channel alignment, and enhance habitat (Figure 3).

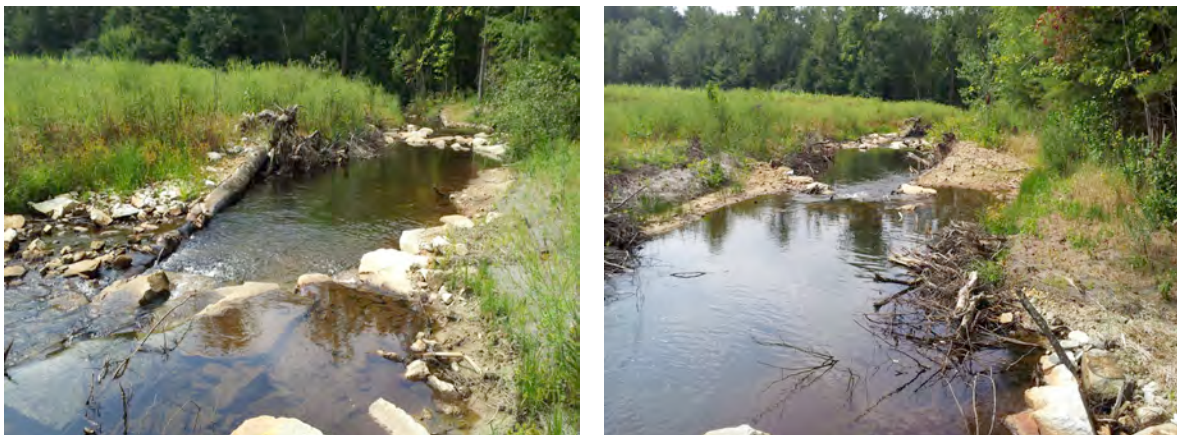
Figure 4. Log j-hook vanes.

Three log j-hook vanes were installed in the stream channel. These vanes help to turn flow while providing grade control and maintaining scour pools (Figure 4).

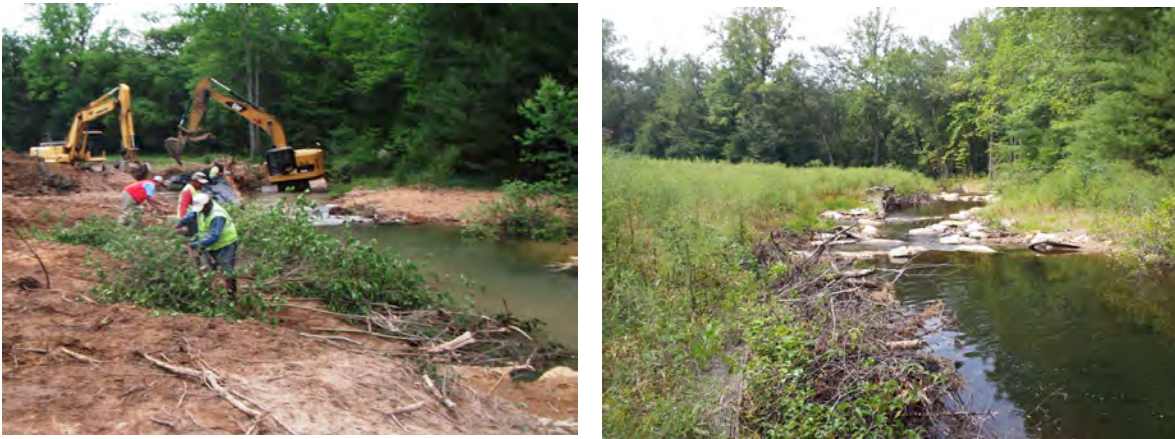
Figure 5. Brush toes.

Brush toes were installed in the streambank at several locations, particularly at scour pools downstream of boulder and log structures (Figure 5). These involved layers of logs and brush under the water surface and live cuttings above the water surface. The top of the brush toe was seeded, matted, and covered with transplants.
