# **Linville River Restoration Master Plan**

## **Gill State Forest Avery County, North Carolina**

**March 19, 2014**

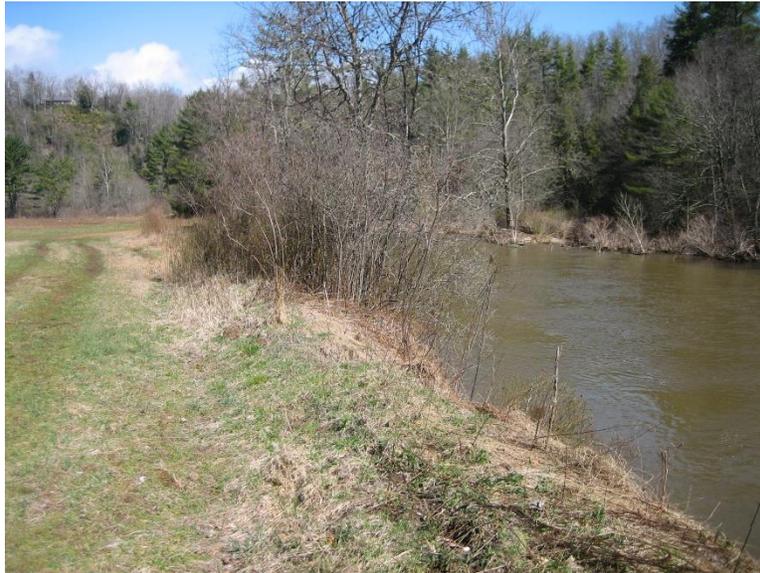
Photo 1: Reach 1, downstream view from adjacent field

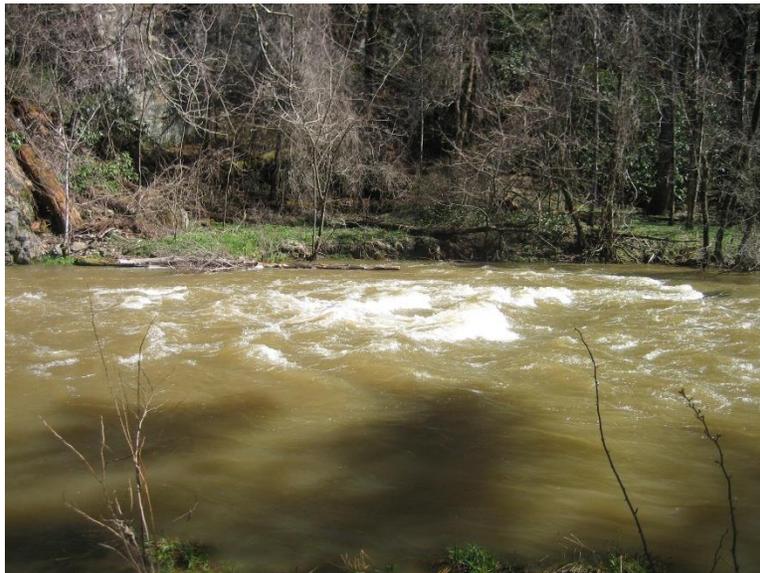
Most of Reach 1 flows through well-vegetated areas, and is laterally and vertically stable. An exception to this is 600 feet of the left bank which is steep, highly erodible, and adjacent to a field with minimal buffer (Photo 1). Additionally, minor bank erosion exists on the right bank at the outside of the large meander bend (Photo 2).

Photo 2: Reach 1, right bank erosion

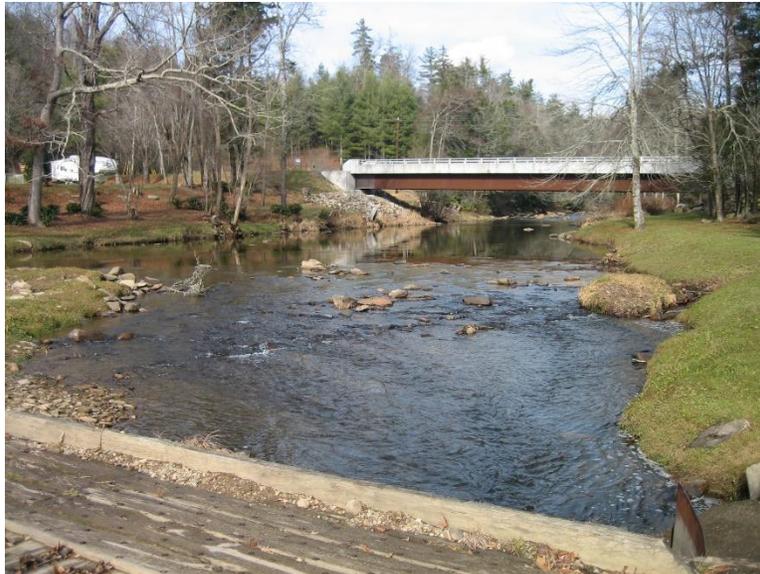
Reach 2 contains two bridges: one recently constructed and one several decades old. At the upstream bridge, riprap exists on the streambanks, though the bridge piers remain susceptible to scour at high flows. The downstream bridge was designed for use during times of low flow, and is currently not used at all, due to damage to the bridge deck. A nursery-related irrigation line is affixed to this low water bridge. Between the two bridges, streambanks are covered with mowed grass, and lack deep-rooted vegetation (Photo 3).

Photo 3: Reach 2, upstream view from low-water bridge

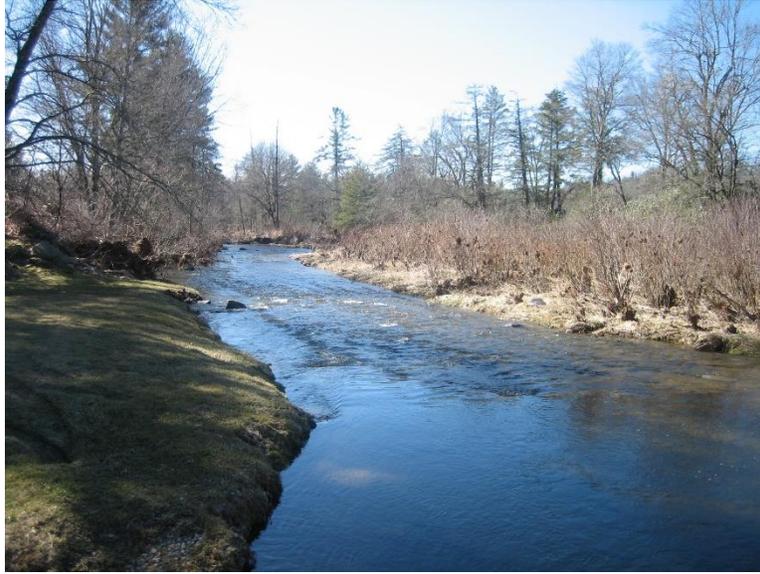
A large mid-channel bar (approximately 440 feet long and 28,000 square feet in area) exists downstream of the low-water bridge (Photo 4). The bar is primarily vegetated with tag alder (*Alnus serrulata*), with some areas covered by willow (*Salix* sp.) and sedges (*Carex* sp.).

Photo 4: Reach 2, downstream view from low-water bridge, mid-channel bar on right

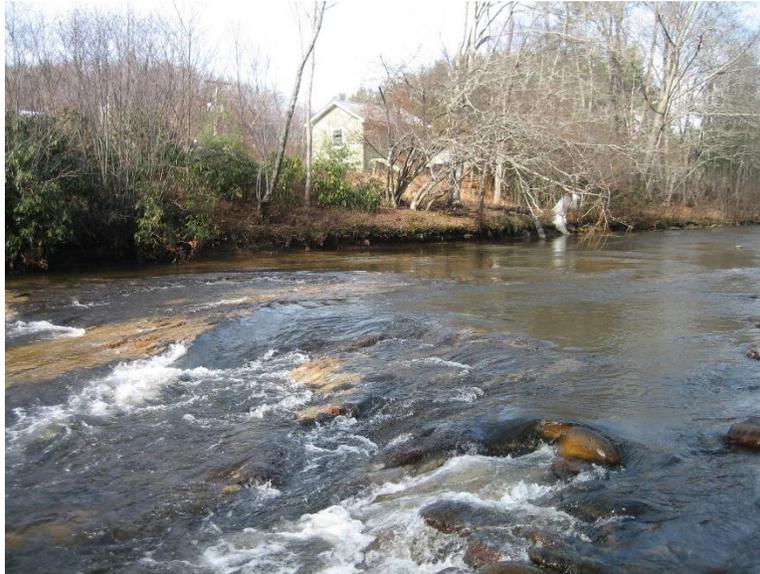
of the new bridge, and one downstream of a prominent bedrock ledge (Photo 5). This bedrock provides a vertical drop of 1.4 feet in the water surface, followed by 500 feet of flat water. A water intake for irrigation is located on the right bank upstream of the bedrock.

Photo 5: Reach 2, bedrock step with water intake just upstream

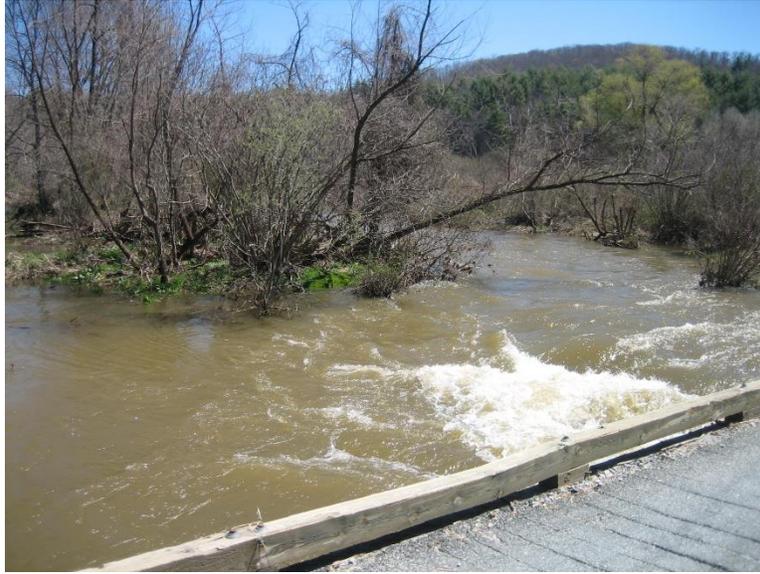
Most of Reach 3 is a multi-thread channel, with flow split around two large mid-channel bars. The upstream mid-channel bar begins near the upstream extent of Reach 3, with the lower bar ending at the Greene Road bridge, at the bottom of Reach 3 (Photo 6). Vegetation on the upstream bar is dominated by tag alder (*Alnus serrulata*), with the lower bar containing mixed hardwood trees.

Photo 6: Reach 3, upstream view of mid-channel bar from Greene Road bridge
