Oct-Nov-Dec 2016 Issue No. BMP.4.16

North Carolina Forest Service

BMP Newsletter Best Management Practices for Water Quality & Soil Conservation

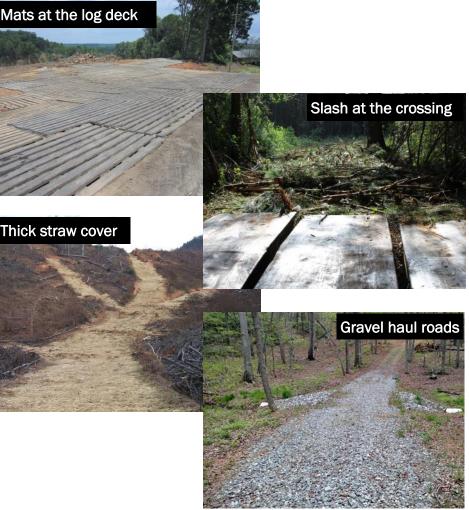
Winter can be a challenging time to stabilize and cover exposed soil, however, it is important that it gets done. Grass seed doesn't grow well in the cold weather, but here are some other alternatives to grass cover this winter:

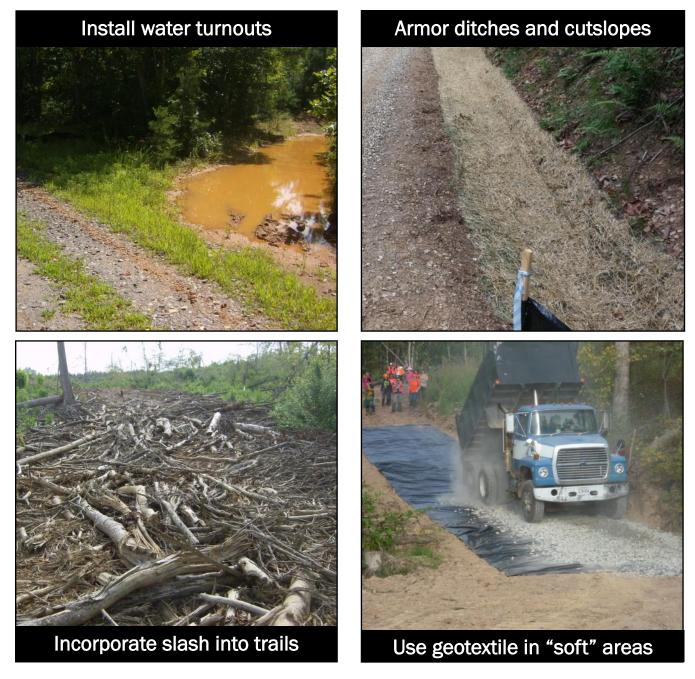
Particular attention should be paid to water control structures and covering areas of bare soils, especially at stream crossings. For example:

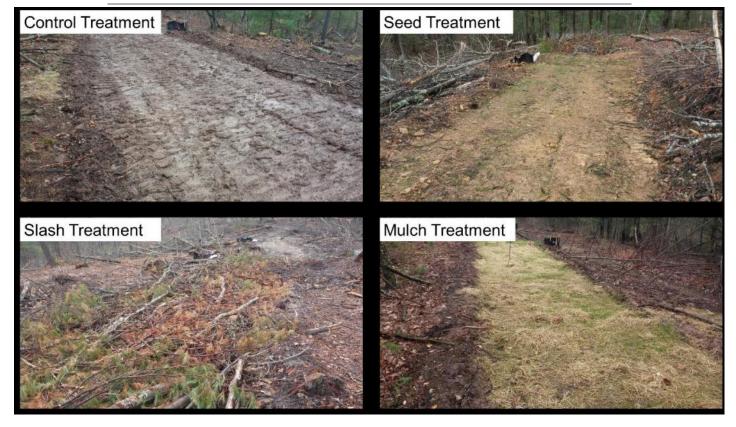
The take-home message from this study was that **all cover BMP treatments reduced soil erosion rates** over the bare soil, waterbar only (control) treatment. However, Slash and Mulch treatments performed better at reducing erosion rates than the seed only treatments. The table and photos below are from the study conducted by Andrew Vinson, a Master's student in Forest Operations at Virginia Tech.

Treatment	Avg. Erosion Rate (tons/ac/yr)	Minimum Erosion Rate (tons/ac/yr)	Maximum Erosion Rate (tons/ac/yr)
Control	6.8	2.5	15.3
Seed	2.6	0.3	6.4
Mulch	0.5	0.01	1.1
Slash	0.4	0.01	0.6

A study conducted by Virginia Tech in the western Ridge and Valley region of Virginia examined the differences in erosion rates from bladed skid trails with different soil cover treatments. The term "bladed" in this case means that the trails were cut into the earth by a bulldozer. These types of trails are often seen in areas with steep or off-camber slopes.

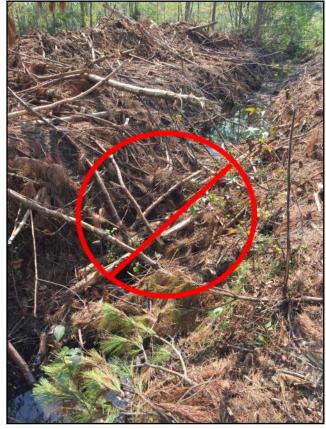
After timber harvests, it is important to ensure that the ditch networks are free of debris. During harvesting operations, skidding across ditches without implementing BMPs can lead to blockages and/or sediment issues. If not corrected, blockages can alter the depth to the water table. In North Carolina, two state laws prohibit waterway obstructions. Blockages such as the one to the left must be corrected and often cost the logger time and money to come back and fix.

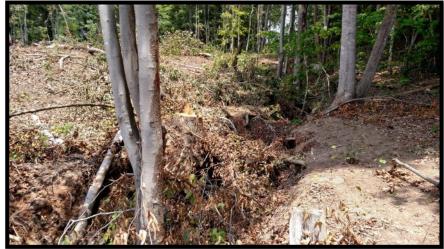
What's Wrong With This Picture?

Streamside management zones were not marked in this harvest. Several streambank trees that help maintain bank stability were cut and the tops were left within the channel.

Debris in the stream can alter or block the natural flow within the channel. This may cause the stream to cut out a new pathway and contribute additional sediment into the stream system. This particular situation was a violation of FPG .0202.
