Estimates of Soil Erosion and BMP Effectiveness at Forestry Stream Crossings

Fire Rehabilitation: Gator Fire

North Carolina Forest Service

WATER RESOURCES BRANCH
 1616 Mail Service Center. Raleigh, NC. 27699-1600

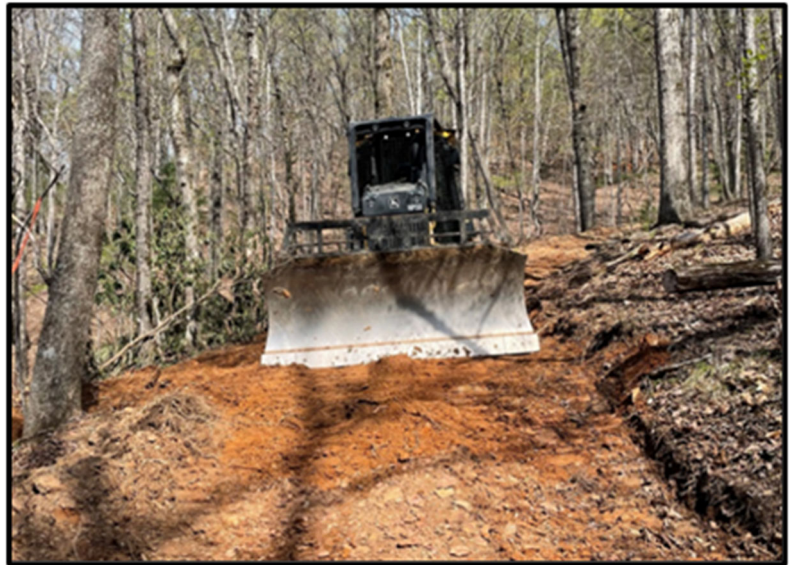
Dozer operator Chris installing water diversions on steep sections of a low standard forest access road that was used as a firebreak.

The plan consisted of removing debris and vegetative material from the stream where flow was partially obstructed, installing several water bars and/or broad-based dips to divert flow off the trail thereby segmenting long sections into shorter ones, and reinforcing the new culvert crossing. To stabilize the crossing, additional soil was added first to ensure that the corrugated plastic pipe would not be crushed by vehicle traffic. Next, riprap was used in conjunction with geotextile fabric to reinforce the crossing side slopes and road/trail surface.

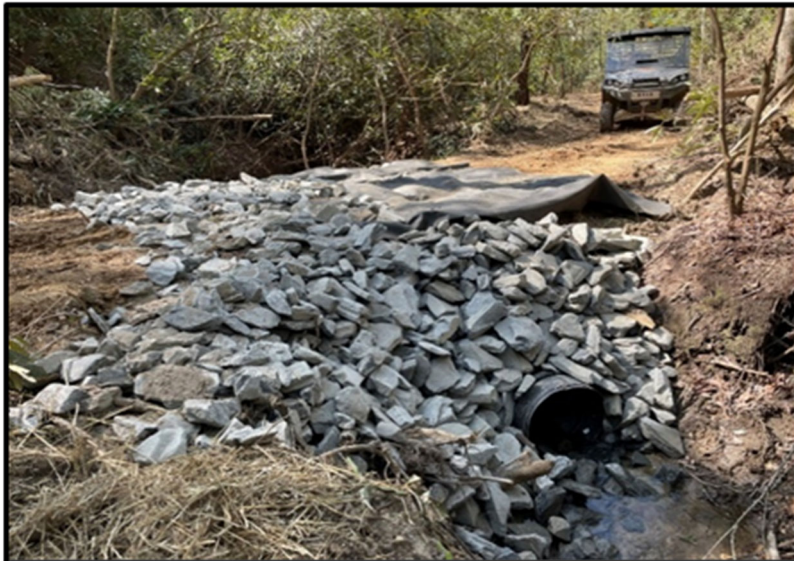
Culvert crossing repair in progress. Headwall has been armored with riprap while additional stone is still needed for the roadway on top of the geotextile fabric.

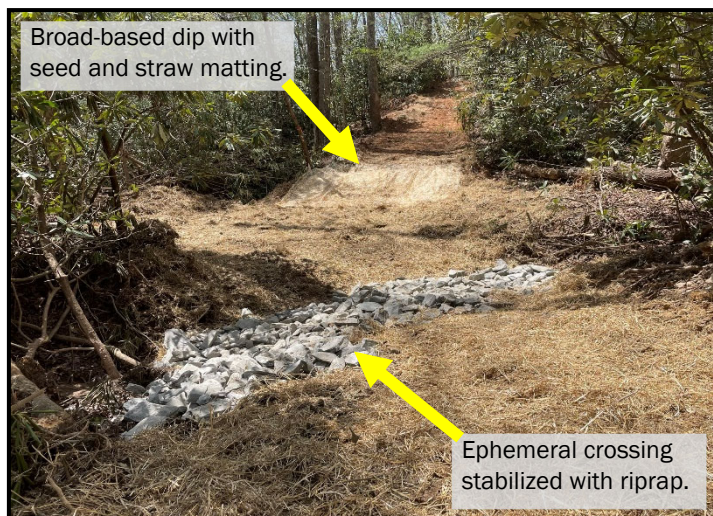
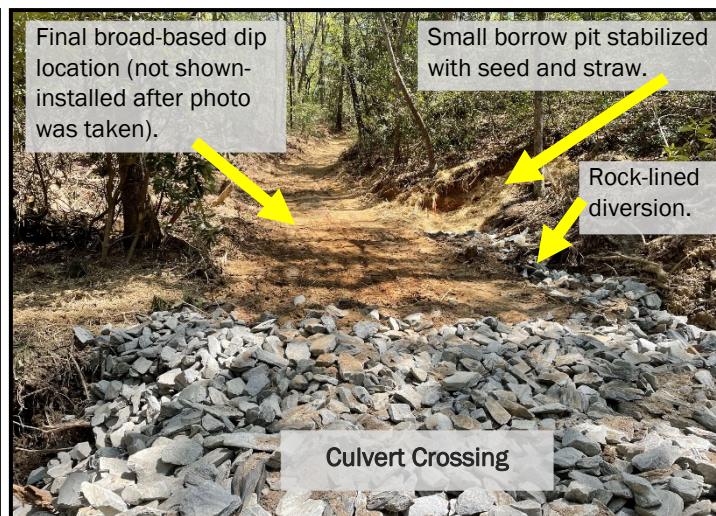
Lastly, a small diversion was installed along the approach way to direct water to the downstream side of the crossing and prevent rills from forming on the road surface itself.

In addition to these main efforts, seed and straw (straw matting in high risk locations) was used to encourage vegetative stabilization, and an ephemeral channel which crossed the trail was reinforced using riprap as well. Thanks to the thorough planning, cooperative and helpful landowner and hardworking staff, this project was completed successfully.
