Bridgemats for Forestry in North Carolina: 2002 to 2008 Project Status Report

Report Compiled by Tom Gerow Jr., RF
BMP Staff Forester, Forestry Nonpoint Source Branch
North Carolina Division of Forest Resources
April 2009

April 2009. Publication #WQ-01-09. This publication is a print-as-needed document available to view and download from the N.C. Division of Forest Resources Web site www.dfr.nc.gov.

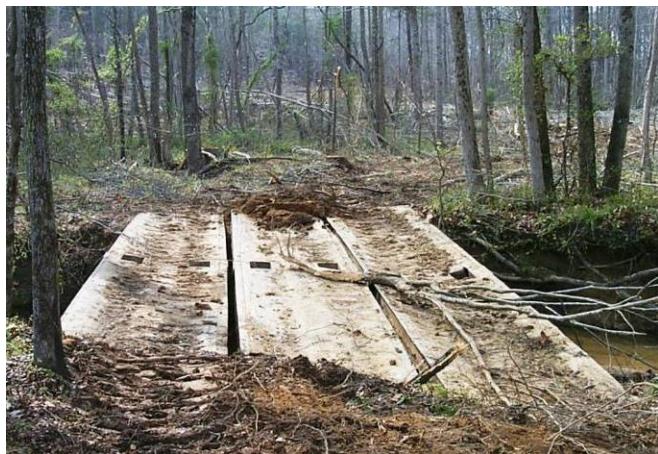
Figure 1: A set of three bridgemats installed for a skid trail crossing of a stream in central North Carolina.

Typically, two to four individual bridgemat panels are positioned into place for each temporary crossing. By using multiple panels, the logging equipment is provided a wide pathway for crossing the water channel. Additionally, by installing multiple panels tightly against each other, gaps between the panels are kept to a minimum. This prevents loose soil, tree limbs and other logging debris from falling into the water channel during the skidding or equipment travel.

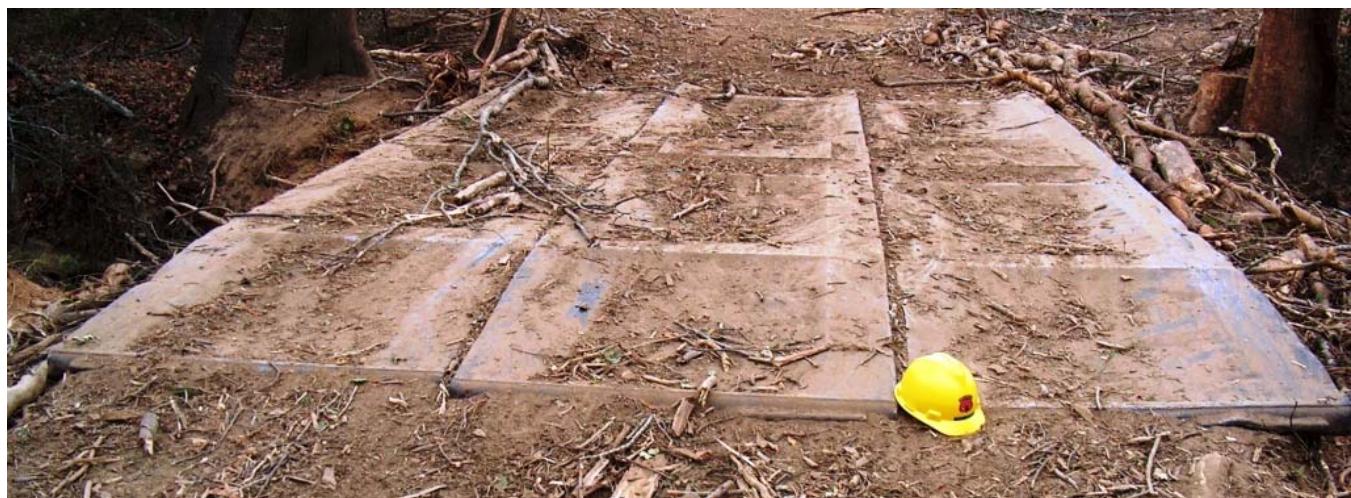
Figure 2: Gaston County, 2007. A set of NCDFR bridgemats purchased in 2003, exhibiting cupping of the 3/16-inch thick top sheeting. These bridgemats also have had steel plates welded over the center handling access holes (read below).

On the original 2003 order for steel bridgemats, the NCDFR specified a top-sheeting steel thickness that proved to be too thin (3/16-inch gauge). The top sheeting was not sufficient to support the heavy loads of the skidders and log trucks. As a result, the top sheets cupped and became deformed (Figure 2), which contributed to the breakage of the weld bonds along the edges of the top sheets affixing them to the underlying I-beams (Figure 17). On subsequent orders of steel bridgemats, the minimum top sheeting gauge was specified at 1/4-inch. No deformation or cupping of the top sheeting has been observed on those newer bridgemats that have a 1/4-inch thick top sheet.

On the original 2003 order for steel bridgemats, the NCDFR specified that two square holes be fabricated into each bridgemat panel, in the center of the bridgemat. The intent was to provide a location for a knuckleboom log-loader to pick-up the bridgemat when loading and unloading. However, soon after delivery and use by loggers, many complained and questioned why the bridgemats had holes in them. The holes were pointed out as potential tripping-hazards when walking. Several individuals pointed out that by having these holes in the bridgemats, they defeated the purpose of keeping soil and debris from falling into the stream when skidding across them. As a result, several of our District Offices welded heavy-gauge steel plates over the holes to alleviate further concerns. Subsequent purchases of steel bridgemats by the NCDFR have not had any access holes incorporated into their design or construction.

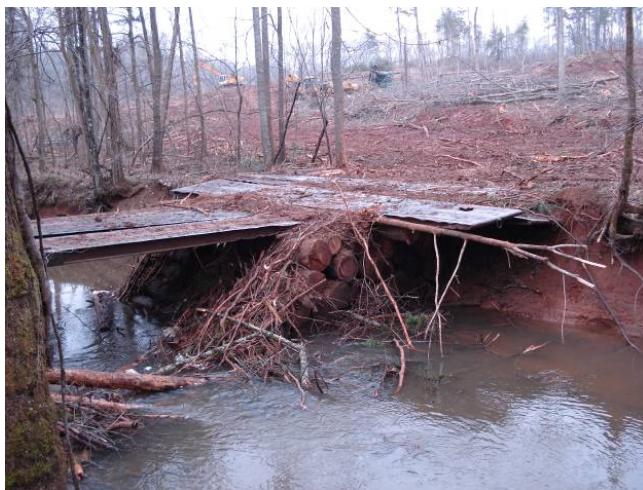
Figure 3: The logger used NCDFR bridgemats for the center span on this crossing and used his own bridgemats on the approachway.

In January 2007, a logger approached the NCDFR Hillsborough District Water Quality Forester seeking a solution to a skidder crossing of a major stream on a tract of timber he was harvesting. After the logger consulted with the forester and the US Army Corps of Engineers, he managed to construct an extra-wide crossing using a set of NCDFR bridgemats and a set of bridgemats he owned. Without using bridgemats, this wide crossing could not have otherwise been accomplished with such minimal environmental impact. There was no other viable logging road or skid trail access on the opposite side of this stream.

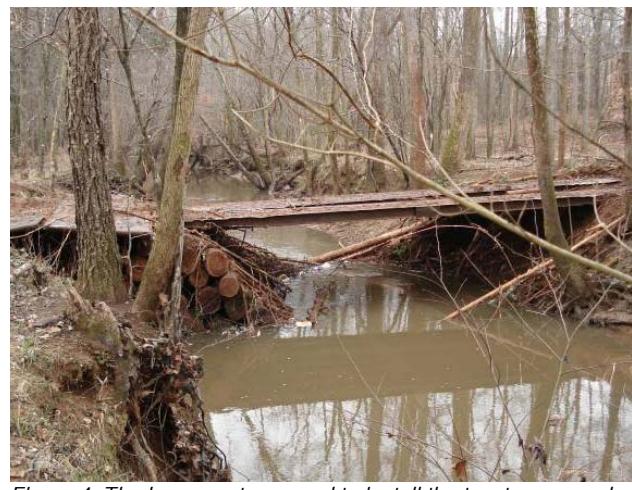
Figure 4: The logger got approval to install the two temporary log abutments in the creek channel to support the bridgemats.

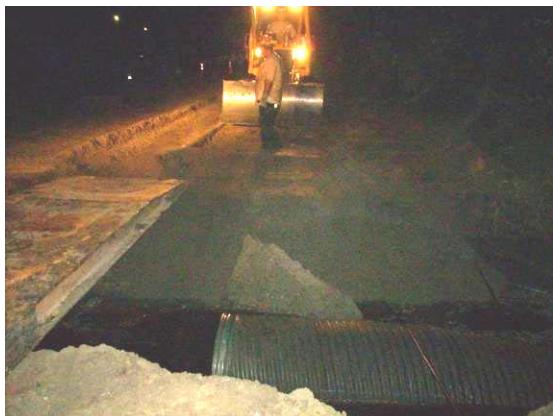
Figure 5: NCDFR personnel installing bridgemats on the same night that the road was severed from a failed culvert crossing.

In September 2008, torrential rains from the remnants of Tropical Storm Hanna soaked a large area of central North Carolina. In the small community of Riverbend, located near the town of Vass in Moore County, the only access road for approximately 80 residents was washed away from flood waters. The road's existing twin-culvert crossing of a perennial stream failed, severing the road. During the late-night hours after the storm had passed, personnel from nearby NCDFR offices retrieved a set of bridgemats assigned to the Rockingham District Office, transported them to the site and installed the bridgemat across the severed road section. This quick action provided temporary vehicle access for the community. After approximately one week of use, the bridgemats were replaced with a more substantial temporary portable bridge from another NCDFR office. The work completed by the NCDFR and the usage of the bridgemats was well-publicized in print and television news media.

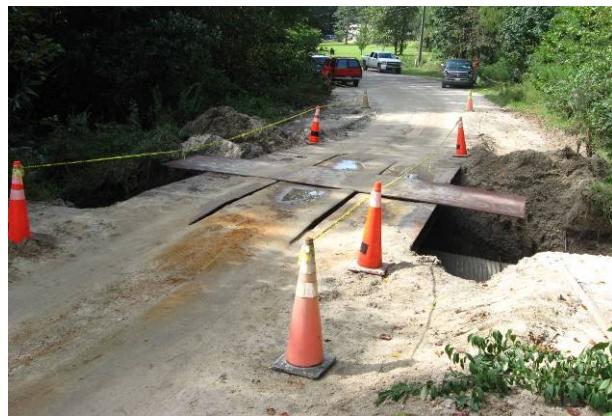
Figure 6: NCDFR bridgemats installed as temporary vehicle access for Riverbend in Moore County, NC

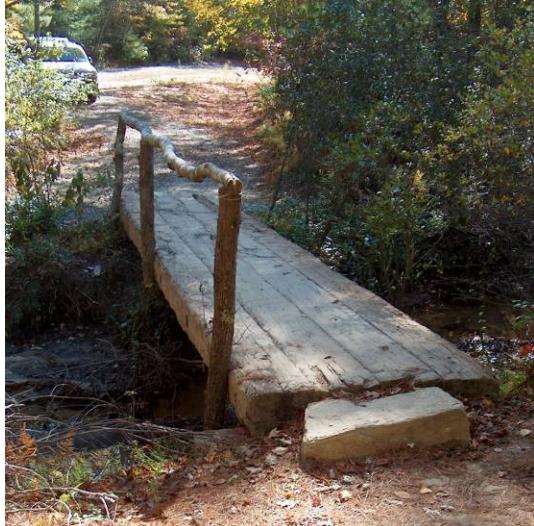
Figure 7: Retired bridgemat used on a hiking trail.

An alternative use for a retired bridgemat panel exists at DuPont State Forest, in which a single panel is now used for a hiking trail stream crossing. Figure 7, at right, illustrates the panel installed for this purpose.

Even though the bridgemat panel is no longer considered viable for use during logging, it remains rugged enough and suitable to accommodate occasional pedestrian use and horseback riders. In addition to this hiking trail application, old sets of bridgemats are available and being considered for use as a permanent display exhibit at the State Forest.

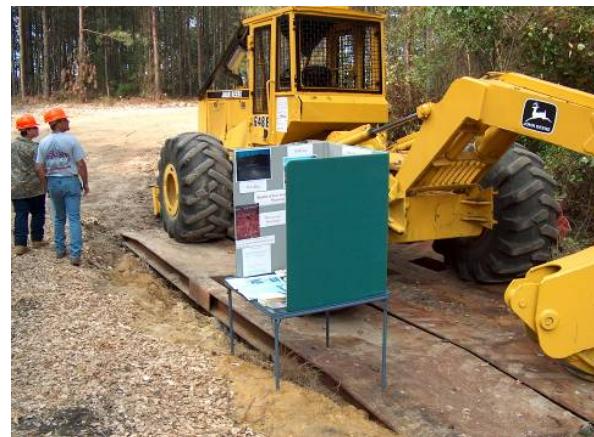
Figure 8: NCDFR bridgemats at the 2005 Carolina Log'n Demo.

During the 2005 Carolina Log'n Demo, hosted by the North Carolina Forestry Association, a set of NCDFR bridgemats were set up as a stationary exhibit near the entryway to this biennial logging equipment show. An estimated 1,500 people, mostly loggers, attended. While the bridgemats were not actually installed across a stream channel, their presence at the show clearly indicated that bridgemats should be viewed as another standard piece of equipment for loggers.

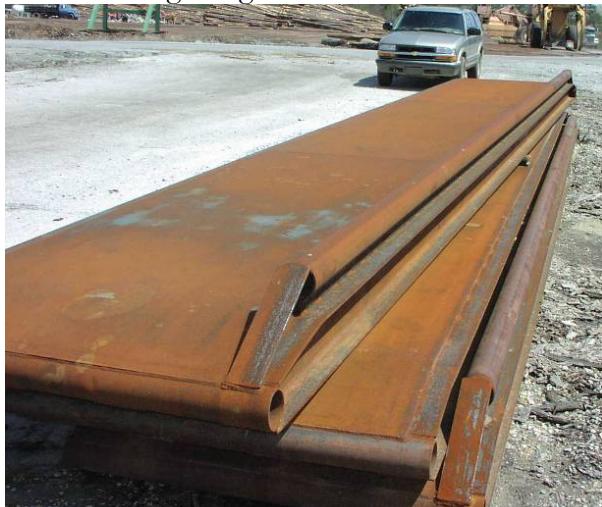
Figure 9: Wayne County, 2003. Note the side-rail incorporated into the bridgemat. Installing a side-rail guard will limit where or how each panel can be positioned over the crossing, since there is now a definite "inside" and "outside" of each bridgemat.

A word about side-rail guards: As seen in both photos above, the purchaser of those bridgemats decided to incorporate a side-rail guard along one edge of the bridgemat. The benefits of having a side-rail guard are not clear, since the large mass of a skidder tire, or even a log truck tire, could easily surmount and drive over such a minimal side-rail. If the side-rail were to break and produce a piece of steel sticking up, it could puncture a tire. One supporting theory in favor of a side-rail guard is to keep skidders or log trucks from sliding off the bridgemats when used in wet, slick, icy or snowy conditions. However, there has been no documented evidence or examples shared with this report's author of such a situation having occurred, although that is not to say that it has not happened. Ultimately, if a logger feels more comfortable using bridgemats that have a side-rail guard installed, then there should be no reason not to install one for his/her own peace of mind when buying or constructing bridgemats. However, as noted in Figure 9, by installing a side-rail guard, you are limiting how each bridgemat panel can be situated atop a crossing, and potentially increasing the installation time. The NCDFR has chosen to not have side-rail guards incorporated into its steel bridgemats. This decision is based primarily to allow greater ease for the logger in orienting the bridgemats for use, promote uniform wear of bridgemat panels, and because there is an absence of compelling evidence that the side-rail guards provide any substantial increase in operating safety.

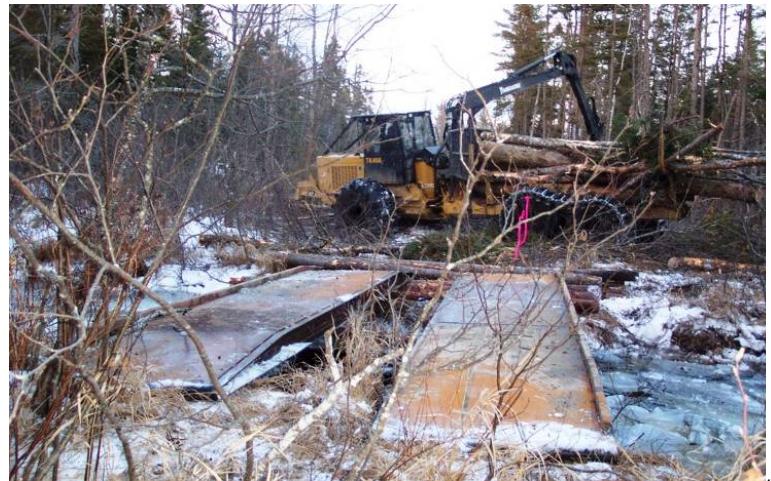
Figure 10: Maine 2007, photo provided by Maine Forest Service. Note that their bridgemat design also includes side-rail guards, but of a different configuration than those seen in the photo at left.

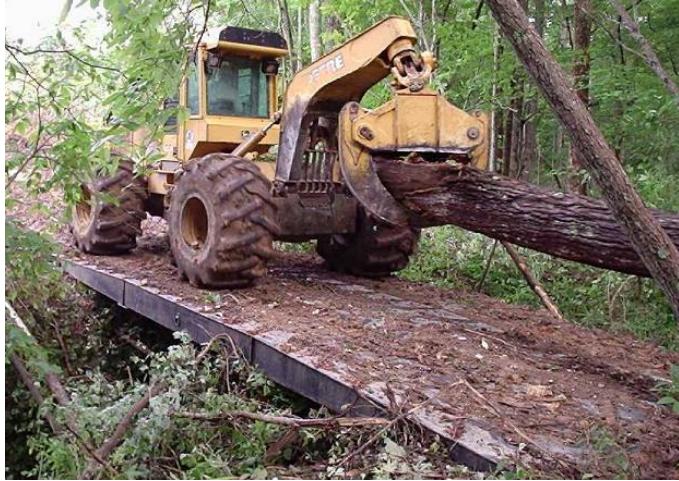
Figure 11: western North Carolina.

This bridgemat appears to consist of one single panel, with tapered ends. No other information is known, but it is yet another example of the variety of ways to cross a stream by using a portable bridge.

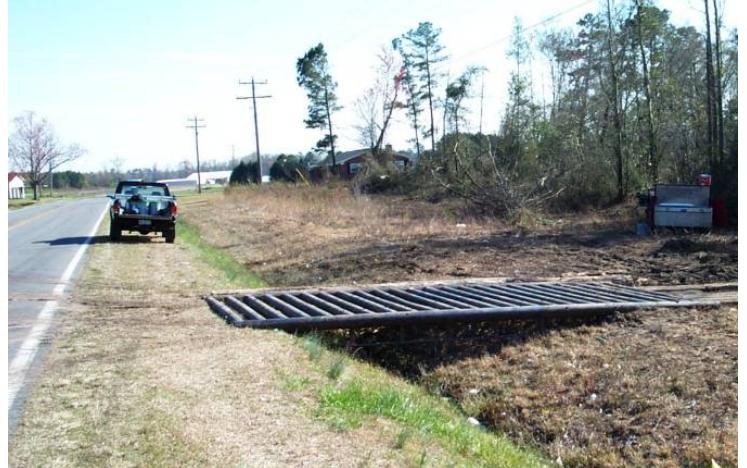
Figure 12: Duplin County, 2001. This open-grid bridgemat panel allows log trucks to cross a DOT roadside ditch. Not only does this bridgemat avoid the need of filling in the road ditch with a culvert or with logs, but the open-faced configuration helps to 'shake off' any caked-on mud from the truck's tires prior to entering the public roadway.

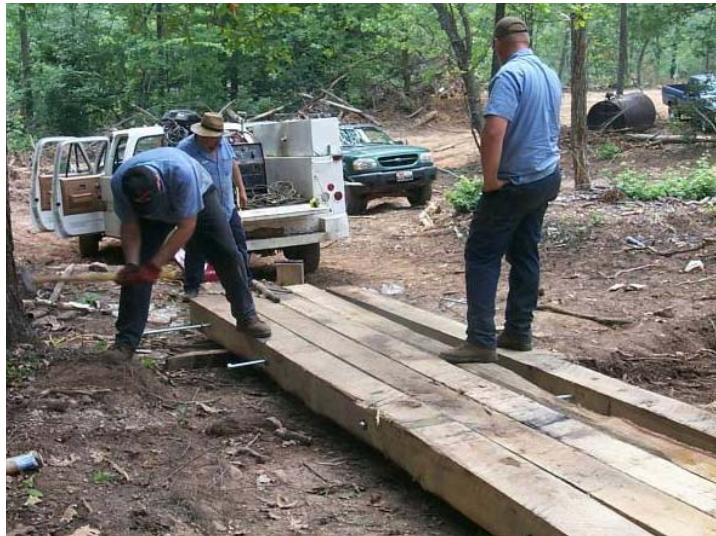
Figure 13: Alexander County, 2004.

A set of wood/timber beam bridgemats being constructed in the woods by a logging company for their use.

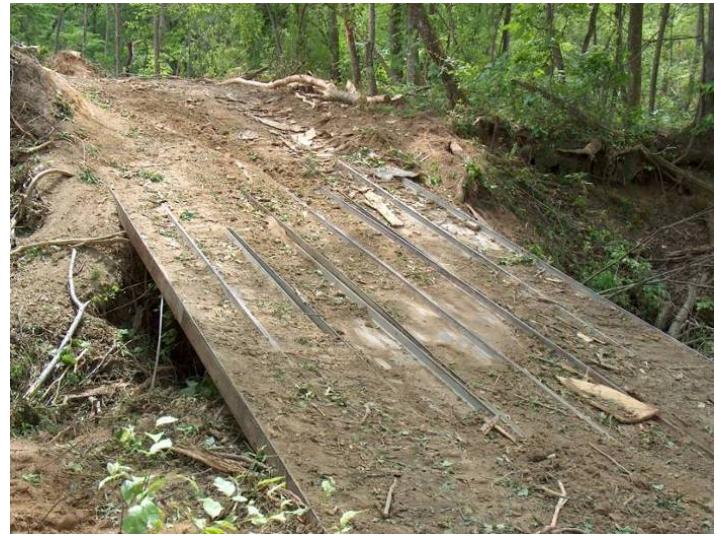
Figure 14: Iredell County, 2005. Steel I-beams are welded together to create this panel crossing. The equipment operator indicated that this panel works well for skidder crossings, but is not used at all for log trucks. Although this layout is an option, it would not appear to be a first-choice solution to constructing a bridgemat, due to potential structural and flexing issues, given the orientation of the I-beams.

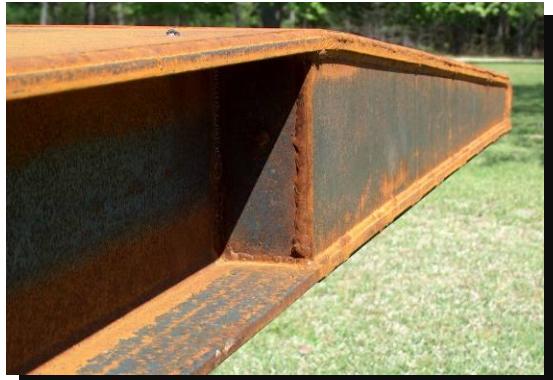
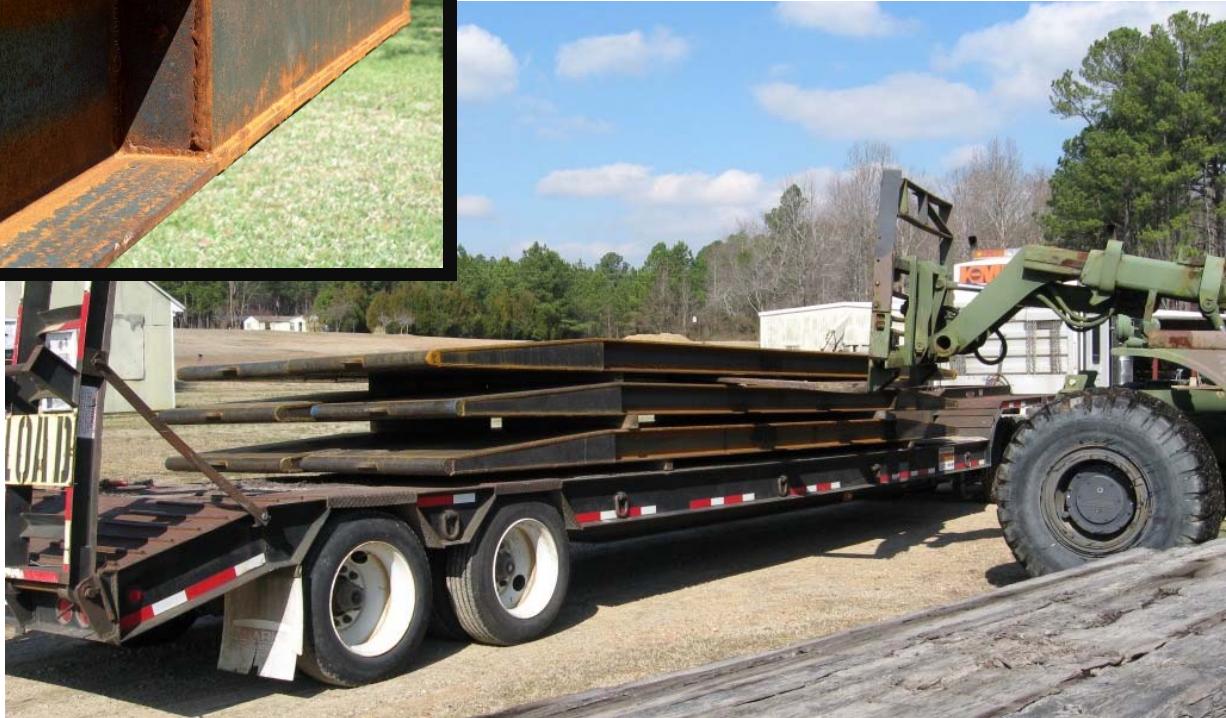
Figures 15 and 16: Johnston County, 2008. A shipment of new, 25-foot long steel bridgemats is received by the NCDFR and being unloaded for staging. On this bridgemat order, the addition of a steel plate along the sides of each end-ramp of the bridgemat was specified, effectively boxing-in this area within the I-beam flanges (see inset photo, above left). This is an attempt to strengthen the end-ramps and reduce the crimping damage we have observed when a grapple-skidder grabs the end for handling or moving the bridgemat. The addition of a boxed-in end-ramp may also increase the rigidity of the bridgemat.

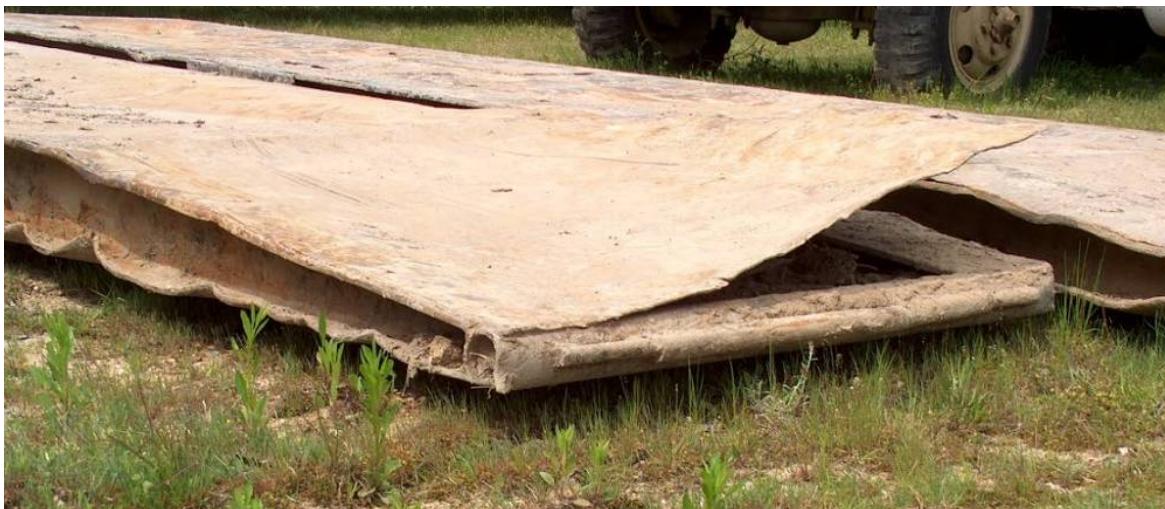
Figure 17: NCDFR Rocky Mount District Office, 2007. This bridgemat is part of the first order of steel bridgemats purchased by NCDFR in 2003. In this photo, the crimping damage on the I-beam flanges, along the end-ramp, is visible. Also, a number of bridgemats from this purchase order exhibited a breakage of the welds that bonded the top sheeting with the structural I-beams, as seen above. After welding to re-connect the top sheet, the bridgemats were placed back into service and remain in-service in 2009.

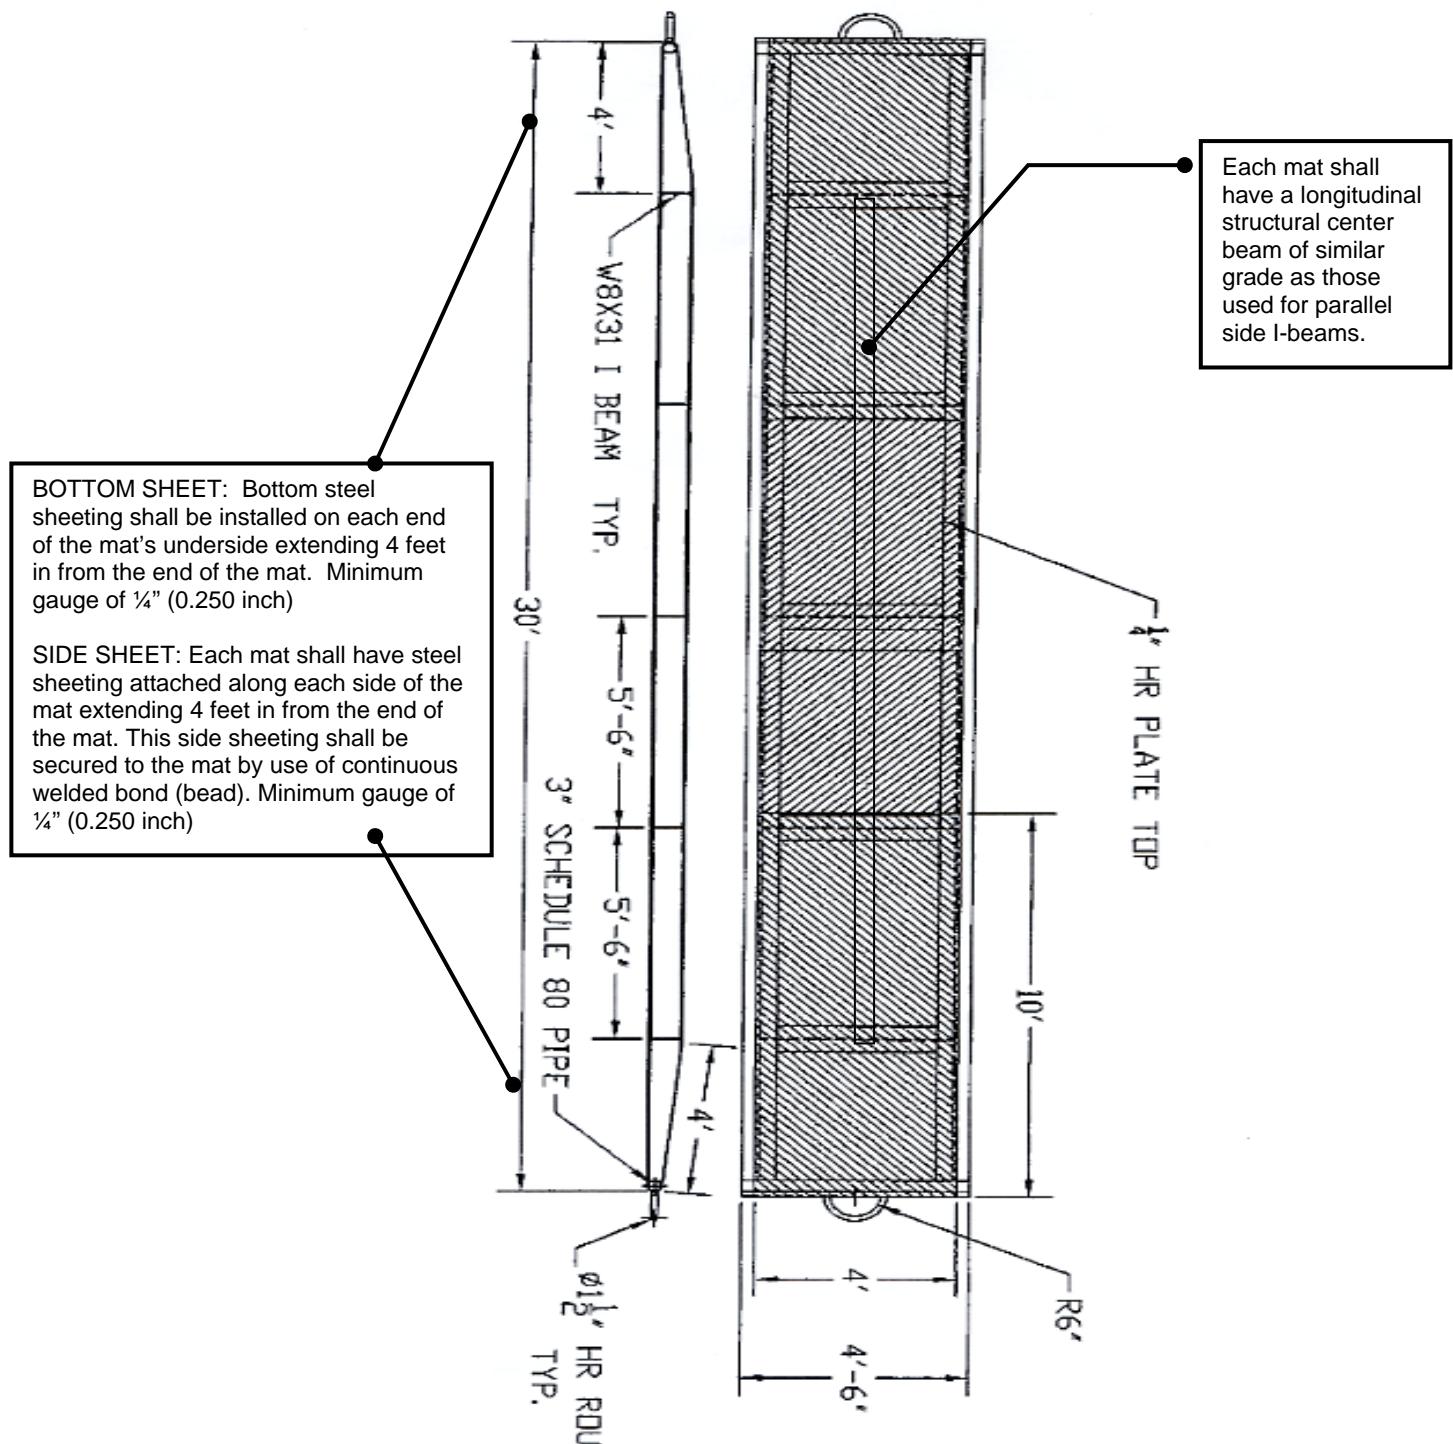
Appendix F: Sample Sketch Illustration of a 30-foot Steel Bridgemat

General design sketch of portable steel bridgemats used for specifying the 2008 purchase by the N.C. Division of Forest Resources. Plans modified June 2007 from original source.

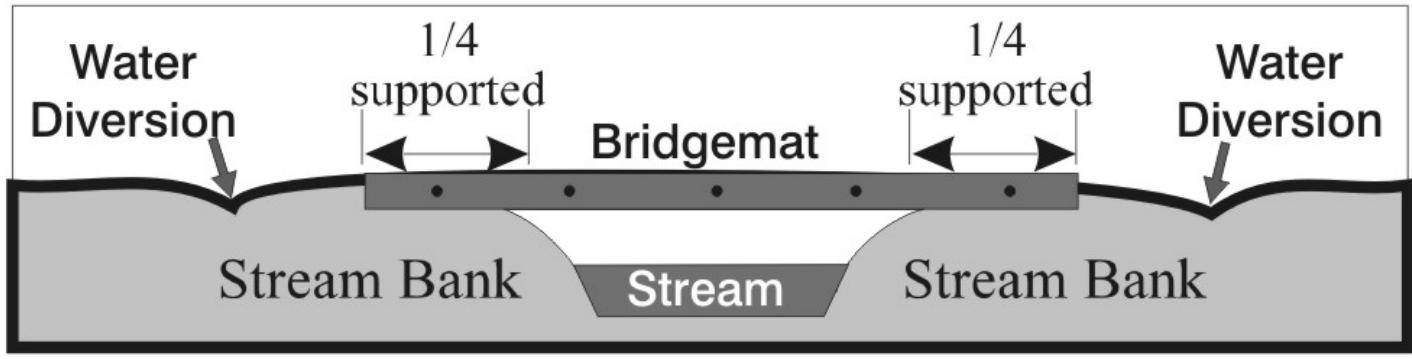
Appendix F: Illustration of a Bridgemat Stream Crossing

Bridgemat for Stream Crossing
