Area of Concern – Site: P44

Map Grid Location: J2 Site visit date/ team): 8/20/15/ JZ Drainage Area (Sq. Mi.): < 0.1
 Name & Location: Tributary at Switchback Trail

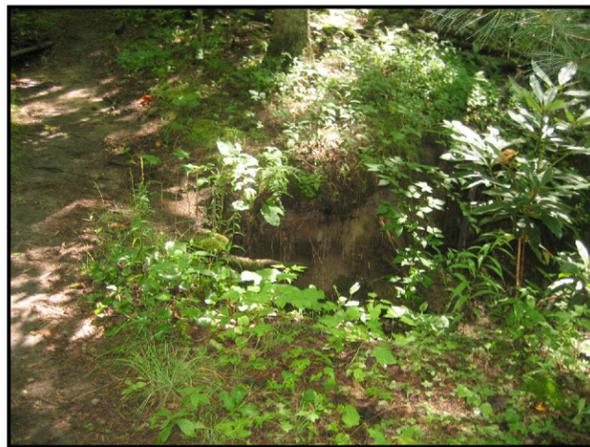
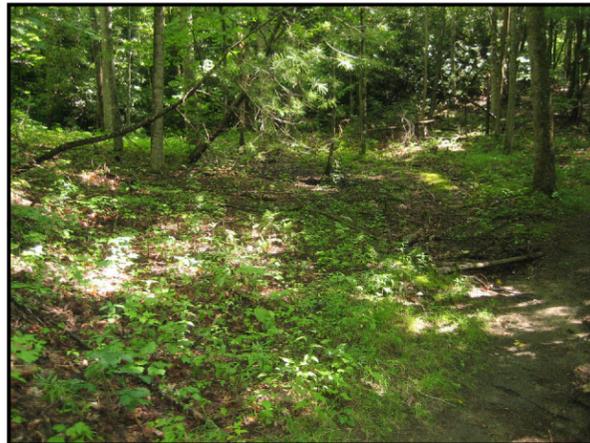
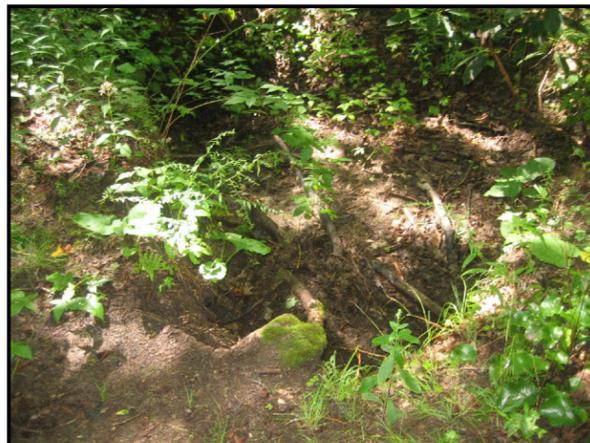
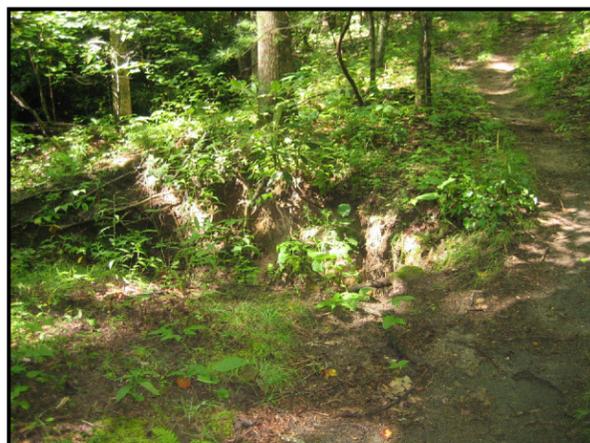
<input type="checkbox"/> stormwater input	<input type="checkbox"/> sediment input
<input type="checkbox"/> bridge	<input type="checkbox"/> utilities
<input checked="" type="checkbox"/> unstable trail crossing	<input checked="" type="checkbox"/> erosion
<input checked="" type="checkbox"/> safety hazard	<input type="checkbox"/> human impact (hiking/biking)
<input checked="" type="checkbox"/> missing vegetation	<input type="checkbox"/> equine/dog impacts

Comments
 Large eroded hole just downstream of culvert. Trail relocation suggested along with measures to stabilize hole (head-cut).

| <input checked="" type="checkbox"/> relocate trail/close trail/road | <input checked="" type="checkbox"/> trail/road crossing improvement |
| <input type="checkbox"/> vegetation/ shoreline planting | <input checked="" type="checkbox"/> mechanical grading |
| <input checked="" type="checkbox"/> human/ animal exclusion | <input type="checkbox"/> culvert rehabilitation/ replacement |
