## LINVILLE RIVER RESTORATION PROJECT UPDATE September 25, 2019

## In-channel work was completed September 18, 2019

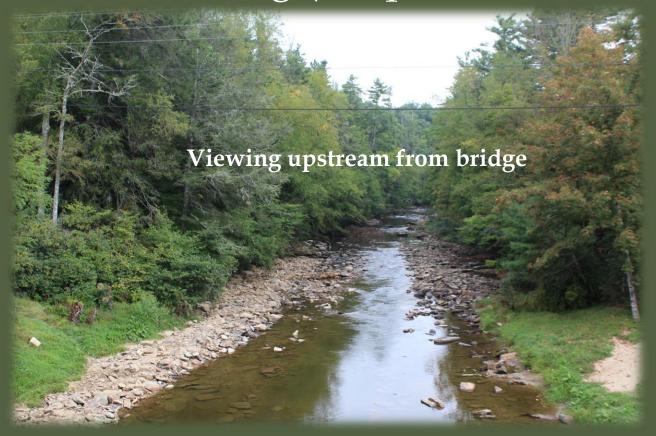
# In-channel structures include:Low-water thalweg (deeper center channel)

• Low-water thalweg (deeper center channel)

Viewing downstream from bridge

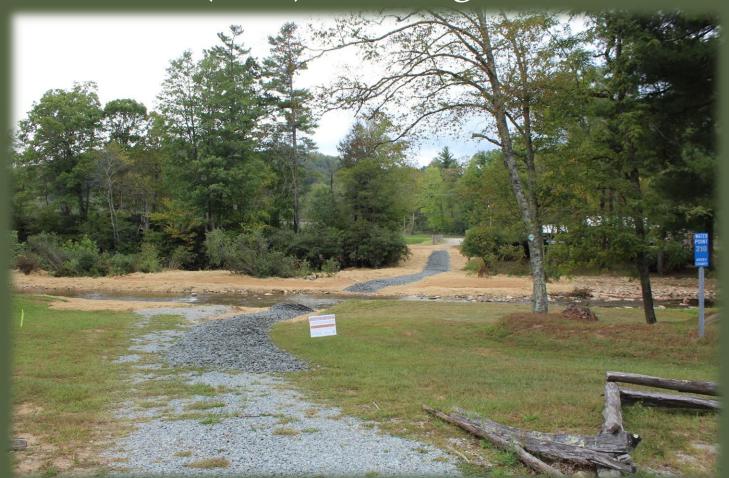
## • Low-water (ford) crossing

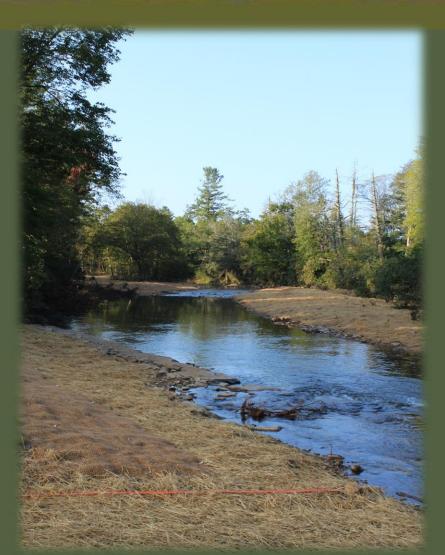
• Boulder J-hook to set grade and maintain low-water crossing

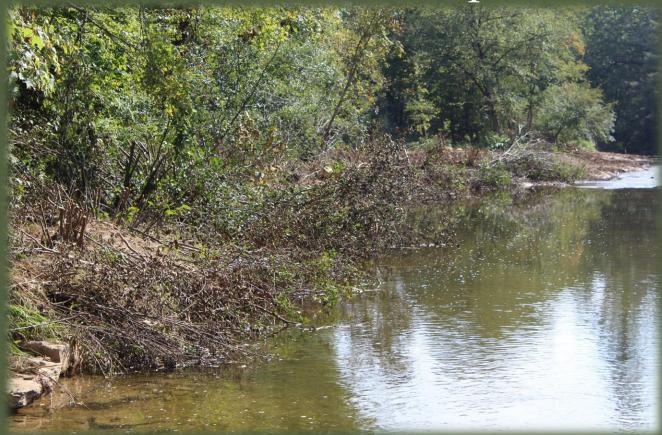
# Toewood (brush bank) that represents both a riverbank erosion buffer and aquatic habitat

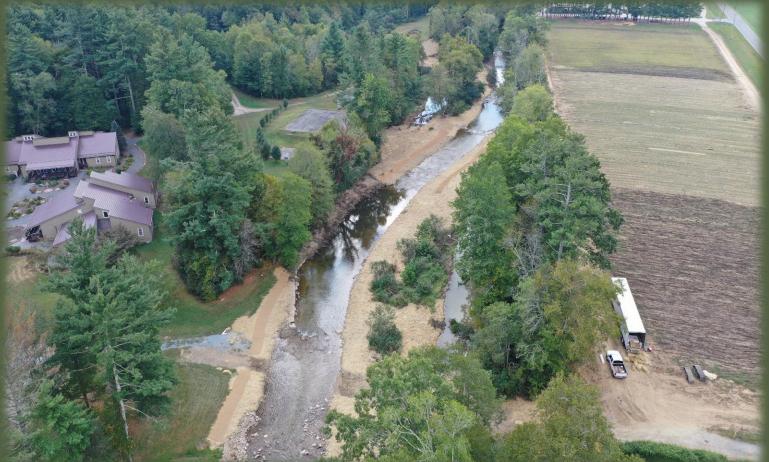
## A riffle-pool-glide sequence for habitat diversity

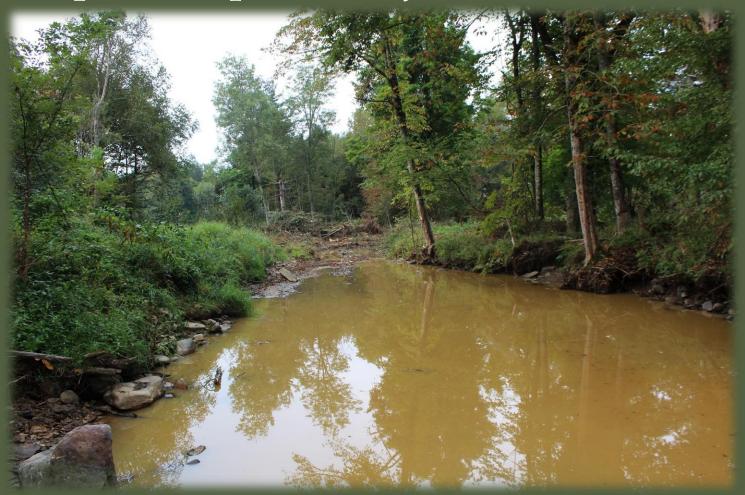
## Amphibian ponds adjacent to the river

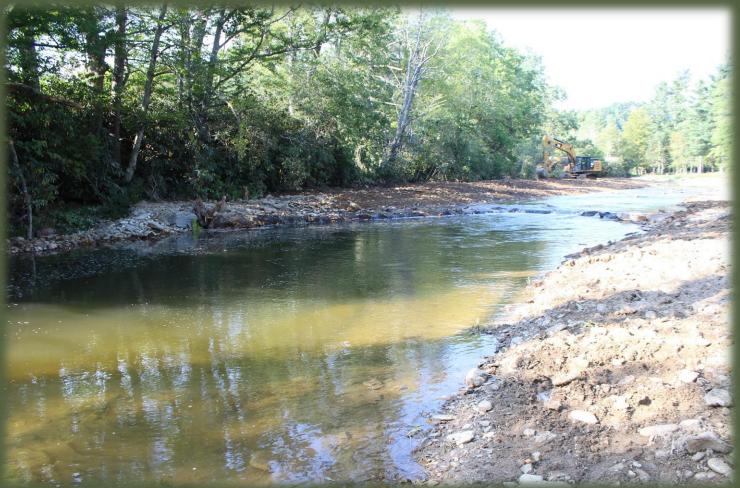
## Log and Rock J-Hook

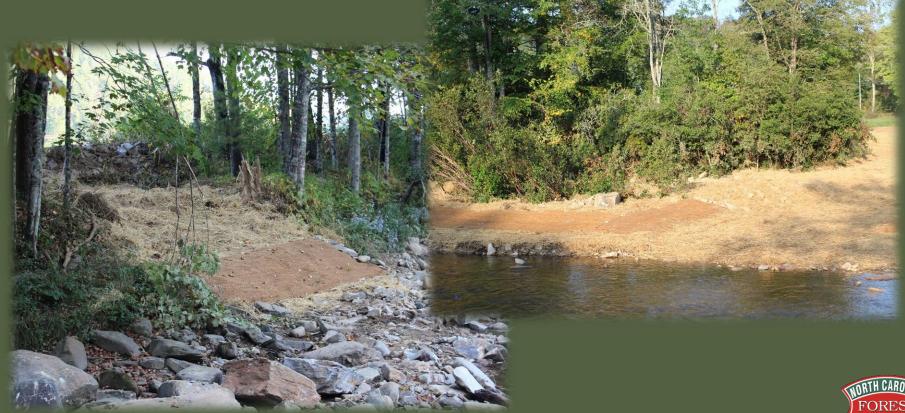
# Stabilization including the application of erosion matting, native grass seed and straw

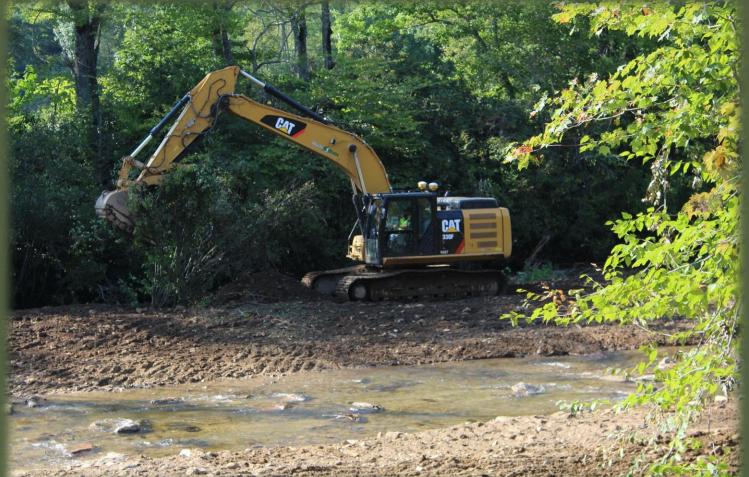
## Alder salvage plantings for river bank stability

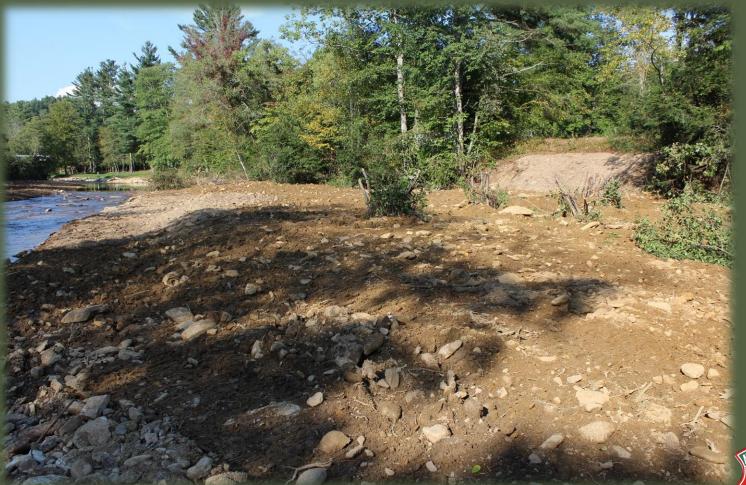
## Alder salvage plantings trimmed for regrowth
