North Carolina Forest Service Bridgemat Loan & Education Service Report 2009 - 2017

**Water Resources Branch
North Carolina Forest Service
August 2018**

North Carolina Forest Service Bridgemat Loan & Education Service Report: 2009 - 2017

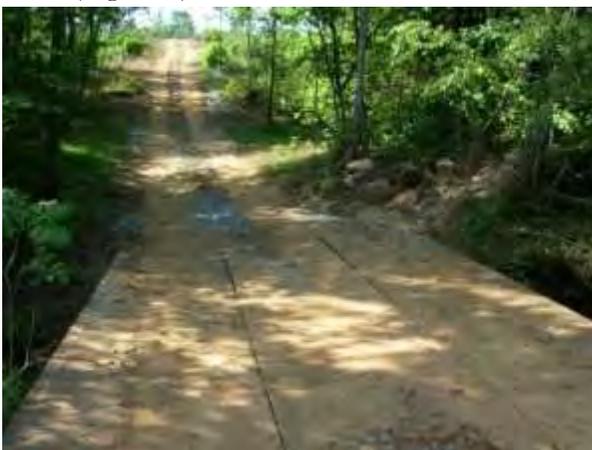
Figure 1a: A set of three bridgemats installed for a haul road crossing of a perennial stream in central North Carolina.

Typically, individual bridgemat panels (4-ft wide) are installed across a channel using a grapple skidder or by winching the panels into place with a skidder or crawler tractor. Bridgemat panels butted next to one another help prevent loose soil, tree limbs and other logging debris from dropping into the channel during equipment travel. These single span structures often provide temporary access for main skidding trails or haul roads (Figure 1a,b). Some forest operators choose to use two panels where machinery tires will travel and log stringers in the center to reduce costs associated with an additional panel (Figure 1b). Multiple panels are used compared to one large structure to provide easier staging and reduce transportation width. Installing three 4-ft panels tightly against each other provides a sufficient pathway for most forest machinery. However, several bridgemats are frequently used in the Coastal Plain region at log decks to span an adjacent road ditch or canal. These additional panels provide necessary space for turning semi-trailer log trucks (Figure 2).

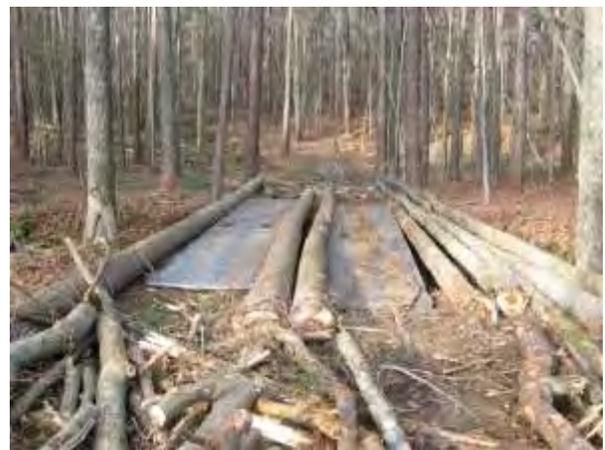
Figure 1b: A set of two bridgemats with log stringers installed for a skid trail crossing of a stream in central North Carolina.

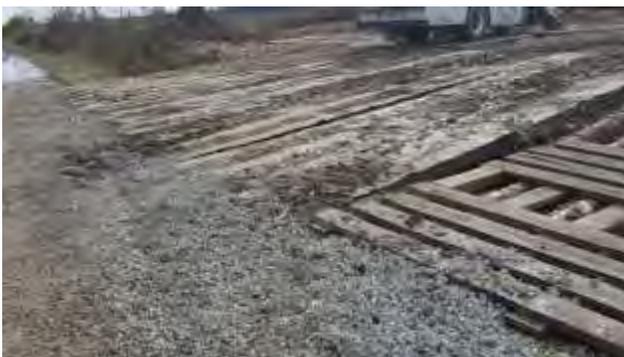
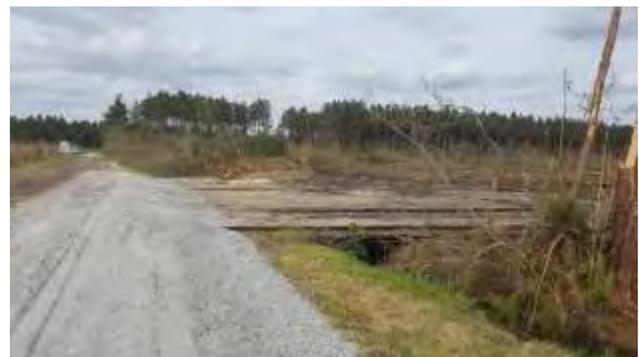
Figure 2: Two perspectives of several bridgemats spanning a road-side ditch in the Coastal Plain of North Carolina

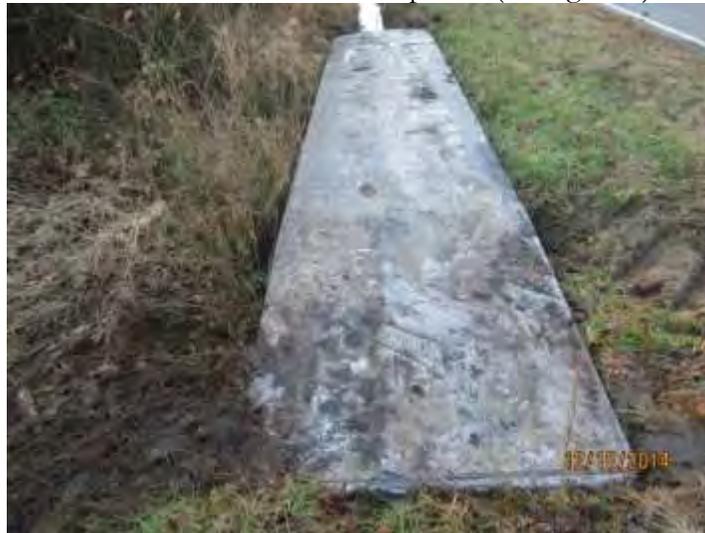
Figure 3. NCFS bridgemats used in Edgecombe County, 2014 to protect a ditch from sedimentation.

- Can be installed with common logging equipment (grapple skidder or bulldozer).
- Less time to install and remove with an experienced operator.
- Minimal direct contact with the stream channel during installation and use.
- Less soil disturbance at the stream crossing site.
- No backfill material needed to be placed into the stream channel.
- Do not need to alter the stream channel or flow.
- Reusable for multiple years, making them economically competitive to culvert and ford options.
- Reduced cost and time needed for stabilizing the stream crossing after logging is completed.
- Easy to fabricate, or can be purchased prefabricated.
- Removal following the operation restricts unwanted traffic.
- Can be used to protect ditches at haul road access points (see figure 3).

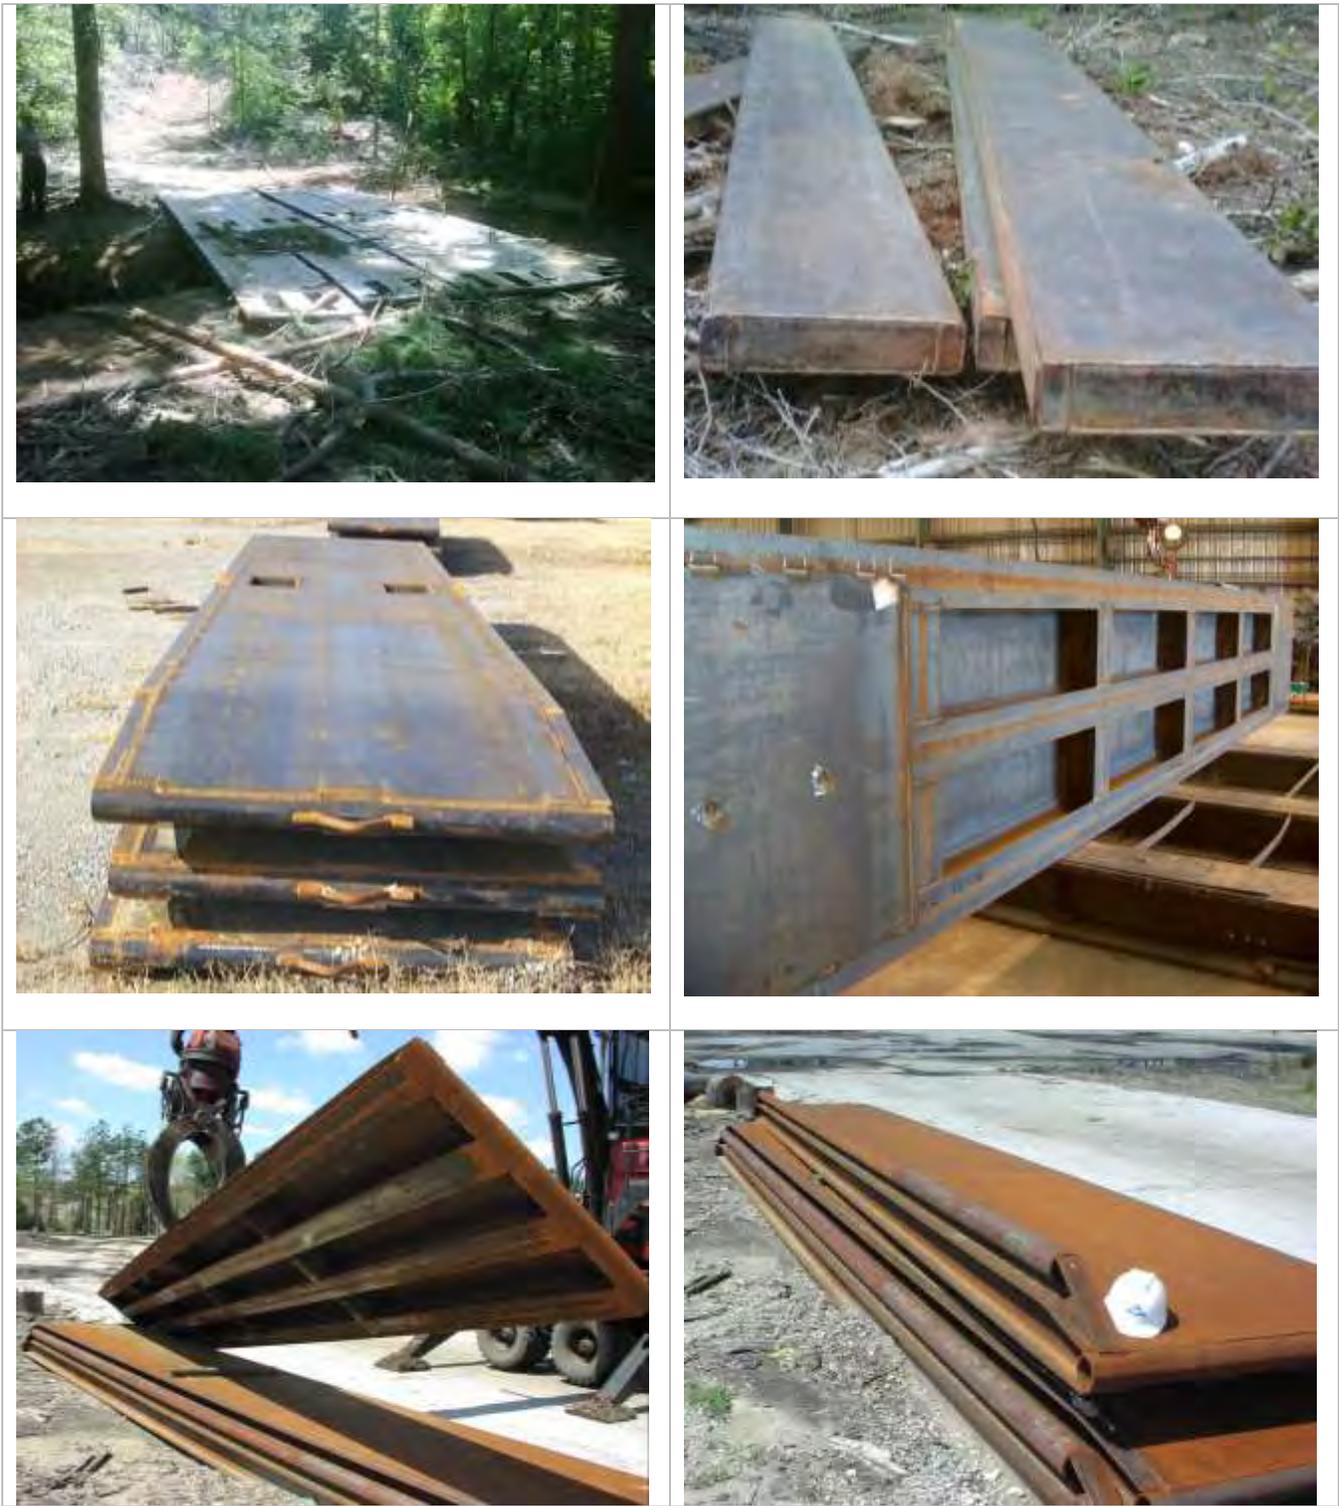
Figure 4: Six different steel bridgemat design configurations observed by NCFS staff.

Constructing your own set of bridgemats may be a cheaper alternative if you have the necessary equipment and an appropriate design. Below are some pictures of different bridgemat designs observed by NCFS staff (Figures 4 and 5).

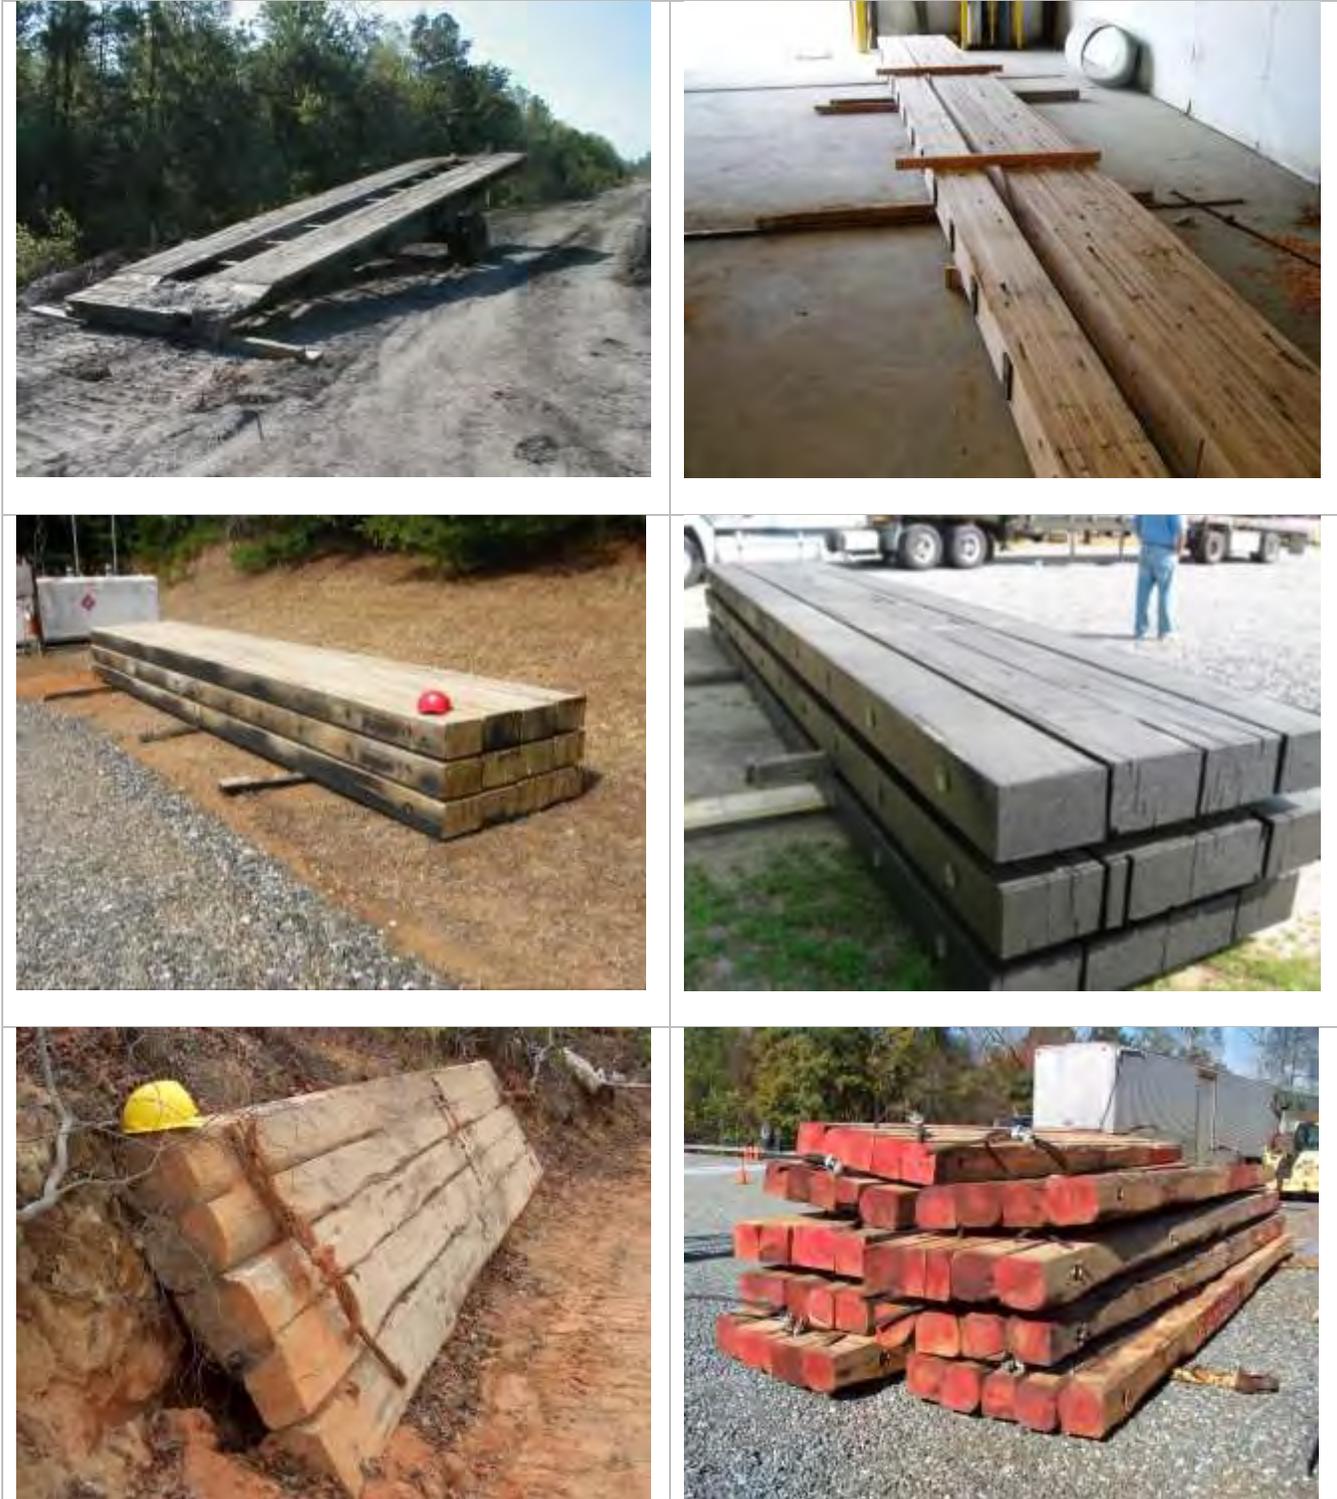
Figure 5: One steel trailer with wooden travel surface and five different wood bridemat designs/configurations.

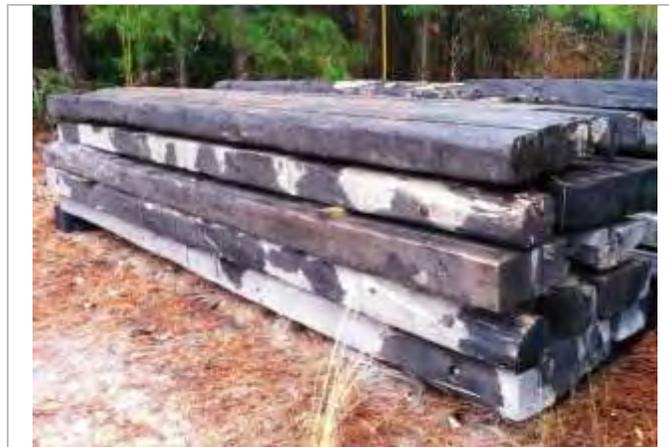
Figure 6: Old timber bridgemats donated by NCDOT, at the NCFS Fayetteville District Office. Photo taken January 2014.

Several dozen timber bridgemats were obtained from the N.C. Department of Transportation (NCDOT), after the mats were turned-in from a large highway construction project. Several sets of bridgemats were retrieved by NCFS Districts, to be loaned to loggers and for possible use as footbridges on State Forest lands (figure 6).

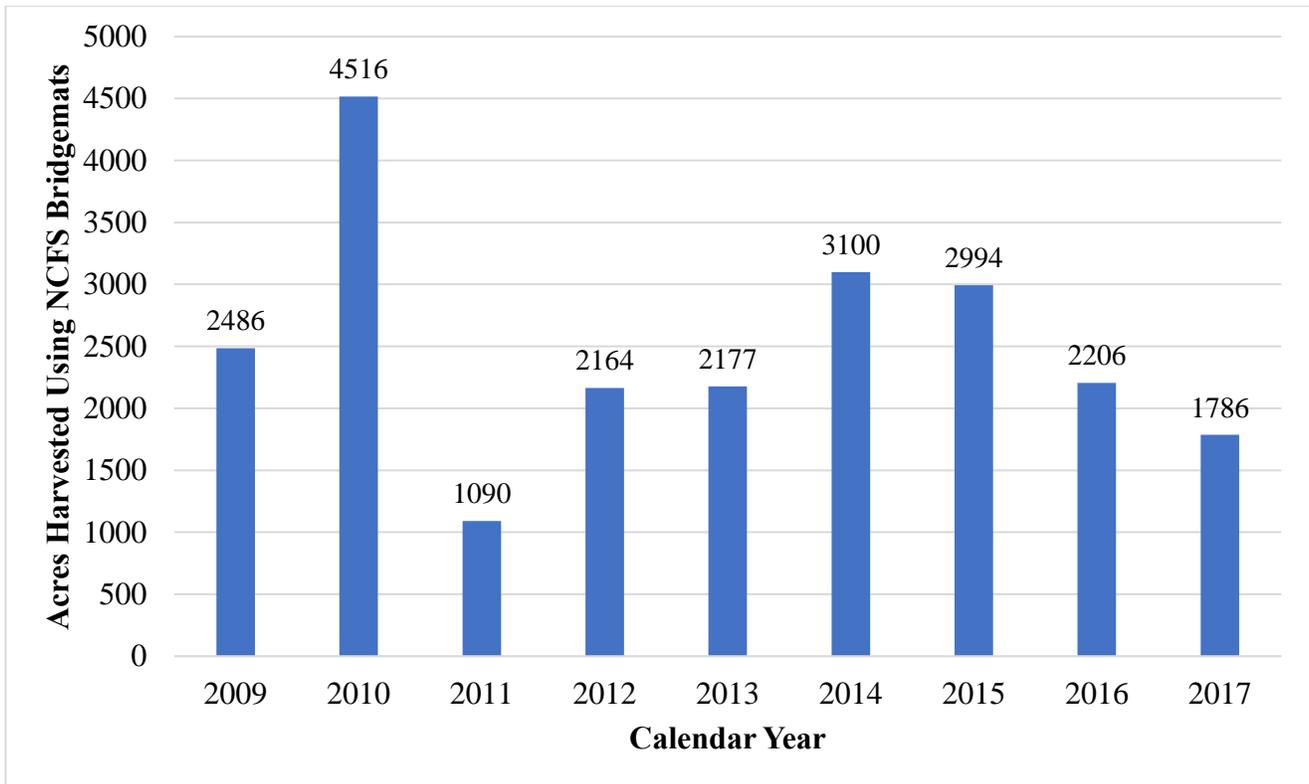
Figure 7: Number of acres harvested by using 16 sets of NCFS bridgemats summarized by year

Between 2009 and 2017, documented loans of NCFS owned bridgemats were used on 452 logging jobs to establish 542 stream or ditch crossings and provided access to over 22,500 acres of timberland. The total estimated harvest acreage of those tracts in which NCFS bridgemats were used exceeds 31,600 acres. Therefore, the bridgemats were used, on average, to access about 71 percent of the harvested acres. A summary of these bridgemat loan metrics is depicted by year in Figures 7, 8, and 9.

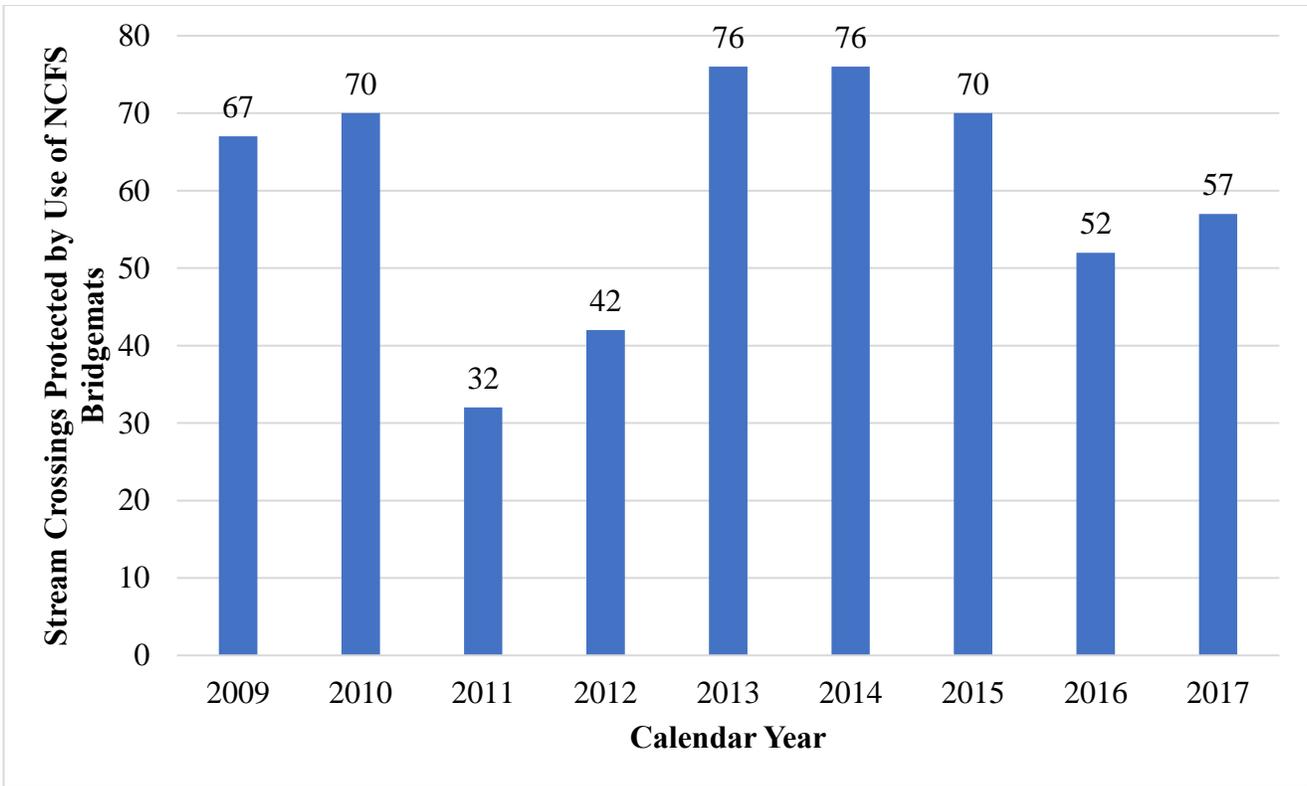
Figure 8: Number of stream crossings protected through use of 16 sets of NCFS bridgemats summarized by year.

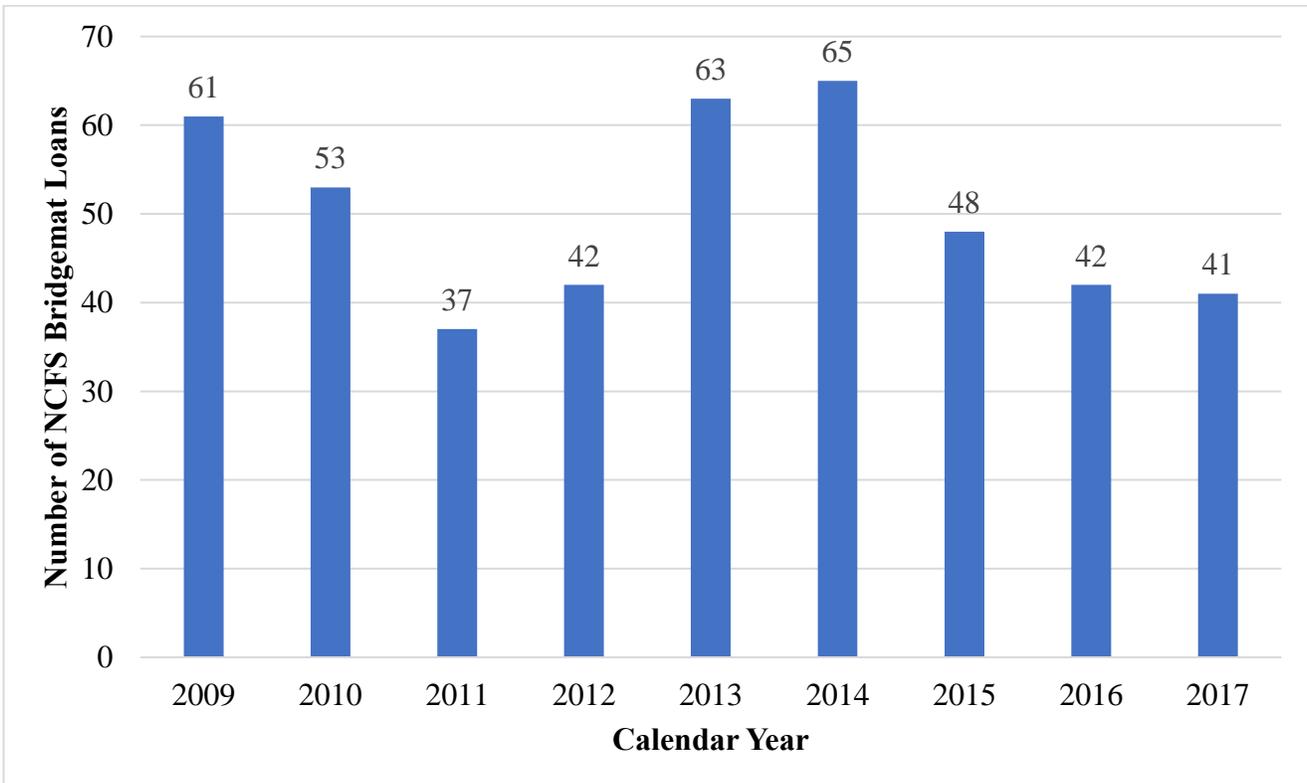
Figure 9: Number of recorded loaning events for all 16 sets of NCFS bridgemats summarized by year.

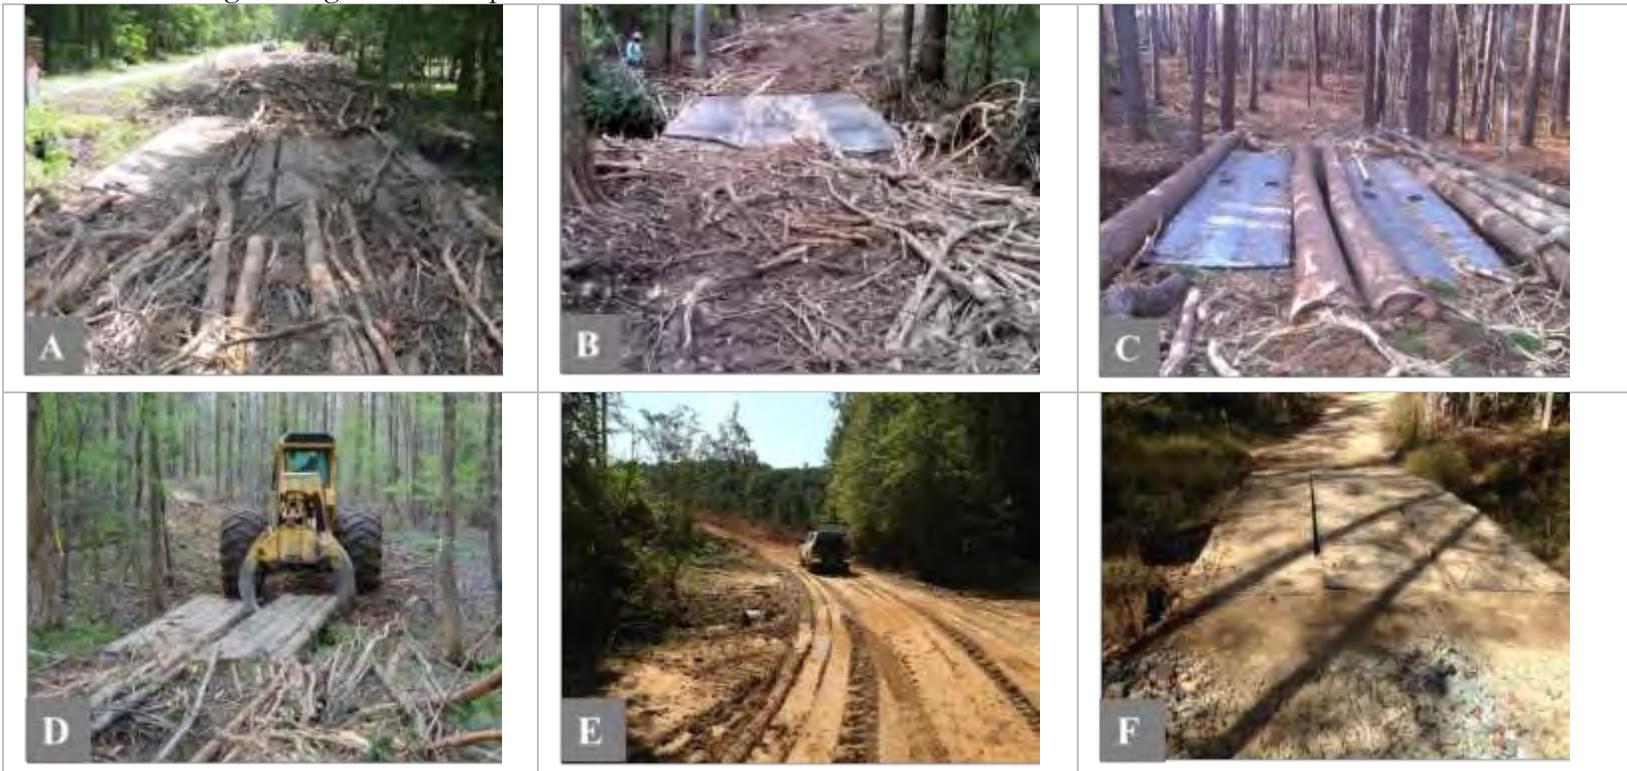
Figure 10. Stream crossing sites during forest operations as published in Boggs and others (2017). A) Wood bridgemats on temporary skid trail, B) Steel bridgemats on a temporary skid trail, C) Steel bridgemats on a temporary skid trail, D) Wood bridgemats on temporary skid trail, E) 30-inch diameter culvert on a permanent haul road, and F) Steel bridgemats on a permanent haul road.

Two goals outlined in the previous (2009) bridgemat program status report have been accomplished. The first goal of measuring effectiveness was accomplished through completion of research with the USDA-Forest Service Southern Research Station. Published in 2017, Boggs and others sampled total suspended sediment (TSS) above and below five bridgemat and one culvert stream crossings preharvest, during-harvest and post-harvest. Each stream crossing had different site characteristics (i.e., differing approaches, soil types, land use history, watershed sizes, road class and closure BMPs). Slash was incorporated into the four temporary crossings, while all approaches were installed with customized water control structures (i.e., waterbars, turnouts, and/or broad-based dips). Post-harvest, all areas of bare soil near the stream received grass seed, lime fertilizer and straw. Comparisons between upstream and downstream TSS measures revealed that none of crossings had significantly increased TSS levels for any of the monitoring periods. Researchers concluded that customization of BMPs according to site conditions prevented increased risks for water quality impairment. Figure 10 depicts each of the stream crossings during the forest operations.

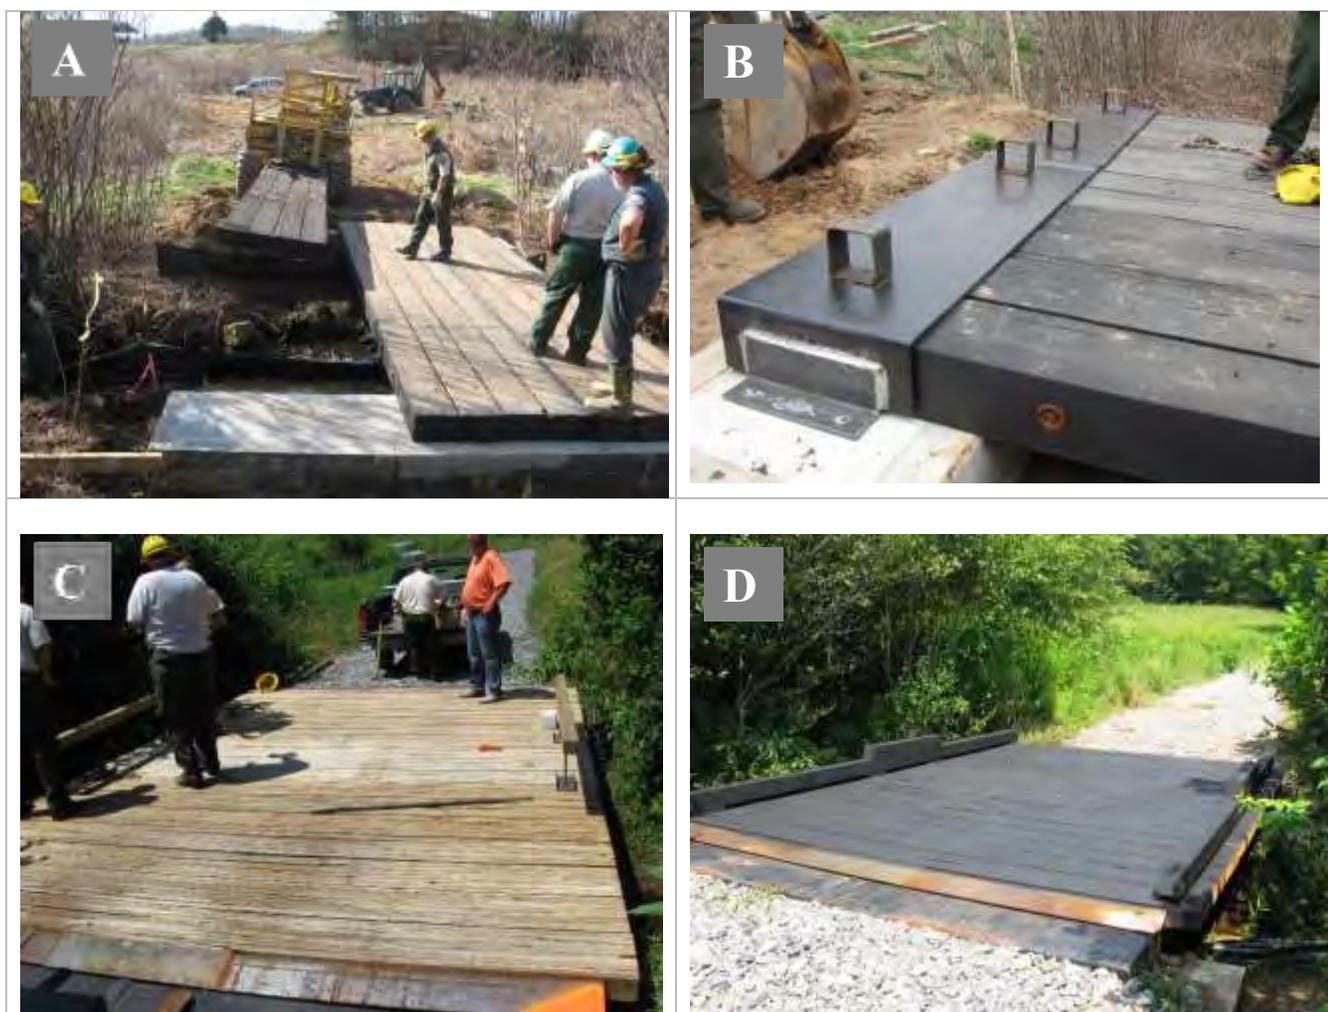
Figure 11. A) Installation of treated **Emtek™** wooden bridgemat panels over Purlear Creek, B) Metal end-cap securing wooden panels to the concrete abutment, C) Cross decking installed atop the initial bridgemat paneling. D) Completed installation of the demonstration bridge.

The second goal outlined in the 2009 report was installing demonstration areas that showcase bridgemat stream crossings. In 2011, a set of three engineered-lumber Emtek™ bridgemats were installed over Purlear Creek at Rendezvous Mountain Educational State Forest in Wilkes County. The 3,500-pound bridgemats were fabricated of pressure-treated, and stress tested laminated lumber, then covered with a water-resistant coating to prolong their use. These bridgemats were then secured onto concrete abutments using steel end caps. Cross decking was then installed over the existing bridge to further strengthen and reinforce the structure. Another treatment of water-resistant coating and an additional metal ramp was applied. This stream crossings provides an example of a permanent bridgemat crossing that can be used for haul truck access. Figure 11 showcases pictures of the bridge installation process. The crossing provides the agency with vehicle access to an area of the State Forest that was previously isolated, due to the limitations of crossing the previously-restored reach of Purlear Creek. The use of 319-Grant funding to purchase and install this crossing demonstration complements the extensive capital investment of state funds that went into the overall restoration and protection of the Purlear Creek watershed on the State Forest.

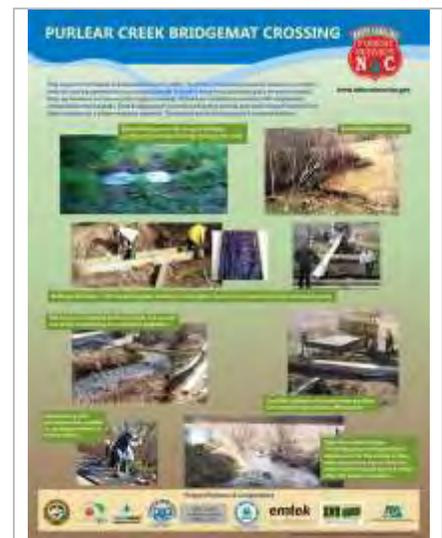
Figure 12. Project information depicting the construction stages of the Purlear creek bridgemat crossing at Rendezvous Mountain Educational State Forest.

Educational information was developed and produced for the Purlear Creek bridgemat crossing at Rendezvous Mountain Educational State Forest. The exhibit shows the before, during, and after photos of the crossing (figure 12).

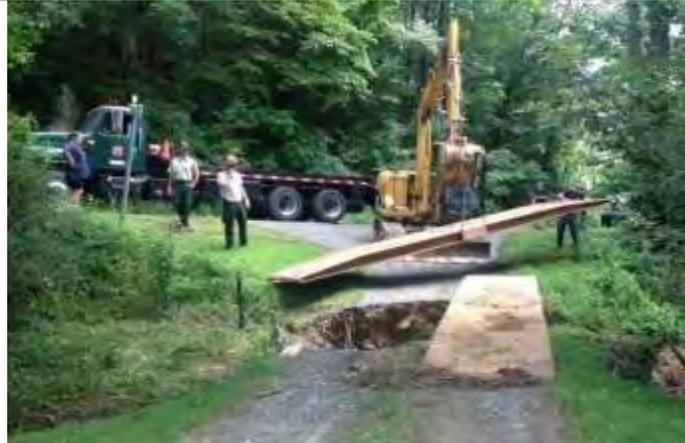
Figure 15: July 2013, NCFS Asheville District's bridgemats being installed for public road access after flooding in Madison County, NC. The bridgemats provided homeowners access to their homes until the crossing could be repaired.

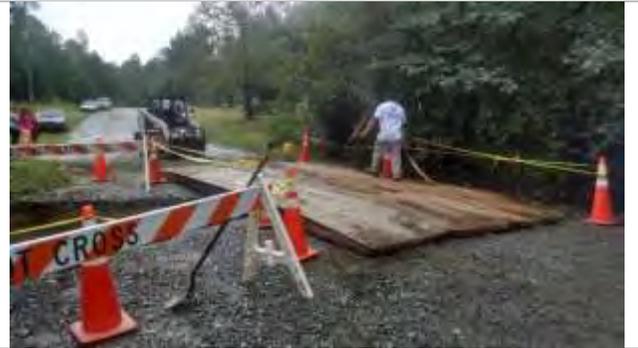
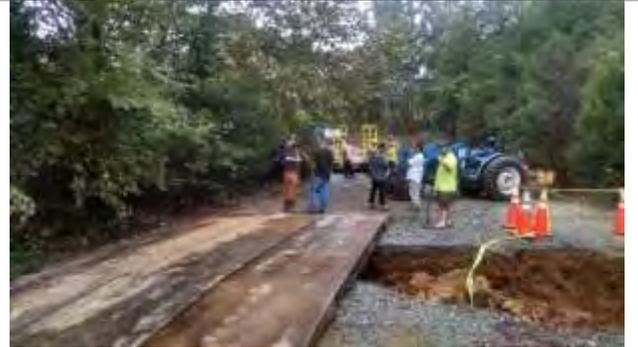
Figure 16 (above two pictures): September 2016, NCFS Hillsborough District's bridgemats installed for public road access following Hurricane Matthew in Alamance County, NC. This temporary fix provided access to dozens of homes and was highlighted by local television media.

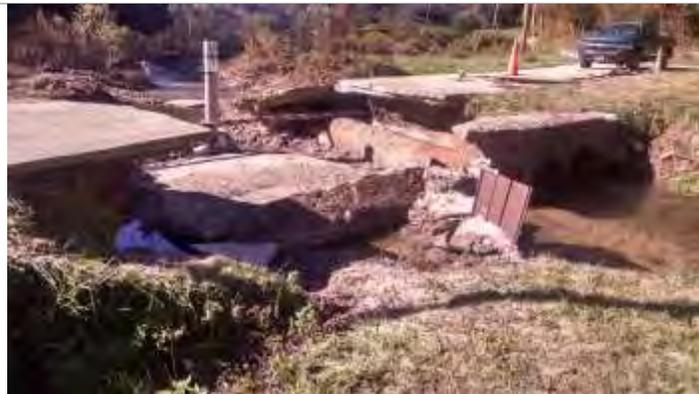
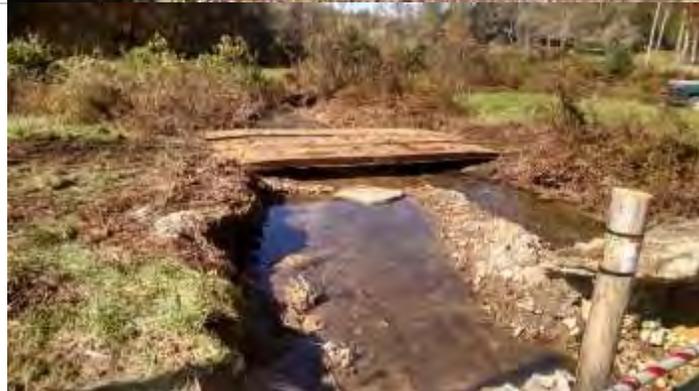
Figure 17 (left two pictures): November 2017, NCFS Asheville District's bridgemats were installed following severe storms caused damage to a low-water crossing in Buncombe County, NC. NCFS Bridgemats were placed about 30-ft upstream and served as the primary access to several homes until the crossing was repaired.

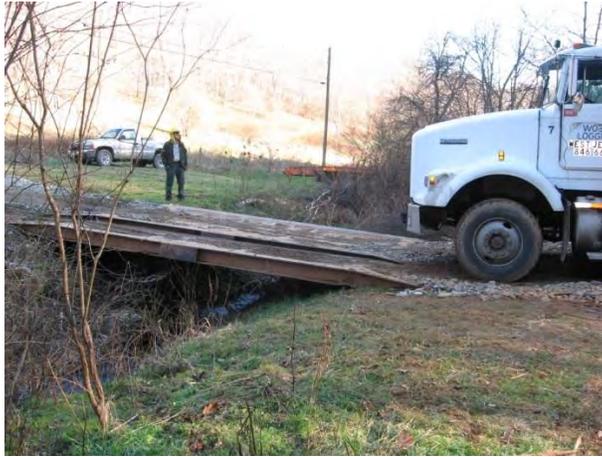
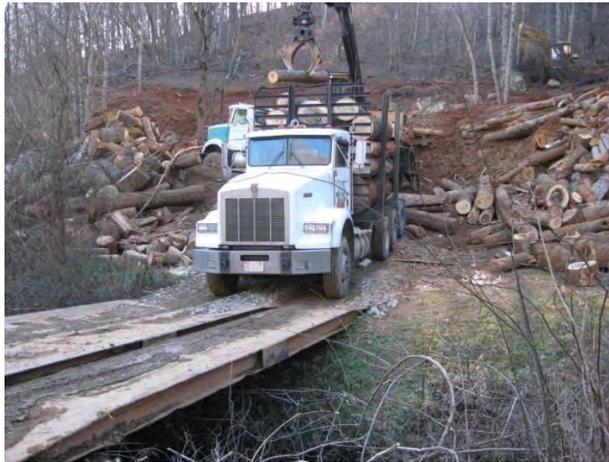
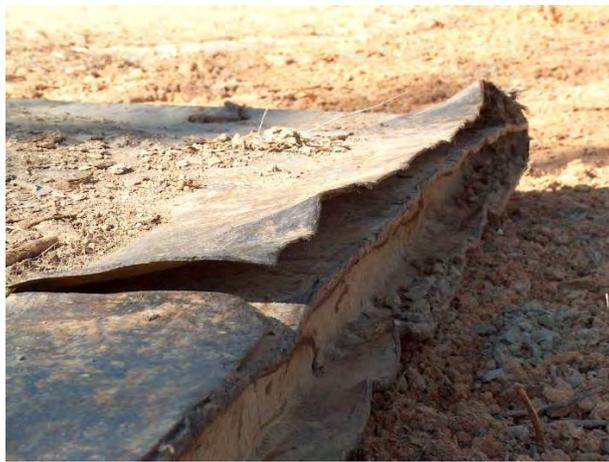
Insert Applicable Bridge Mat Photos Depicting Customer Use or Showing Damage as Illustrated Below
