High Gradient Stream Restoration Applying restoration techniques to a steeply sloped stream

Michael B. Shaffer, NCSU BAE, Tom Gerow, NC Div. Forest Resources NPS Unit

Purlear Creek Stream Restoration Phase 1: UT of Purlear - Aug. 2006

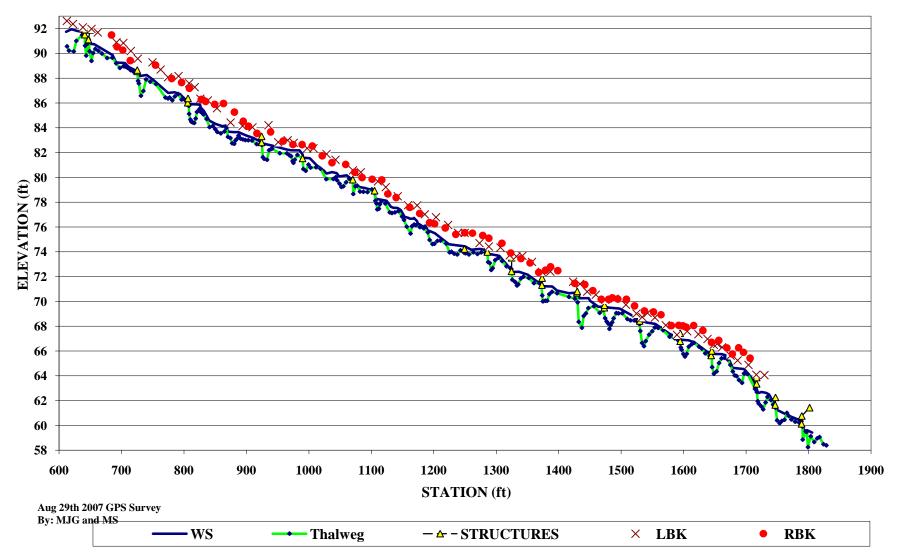
Rendezvous Mountain STA 6+00 - STA 19+00 2007 MONITORING - AS BUILT

Bankfull = -0.0254*STA+107.76 Water Surface = -0.0256*STA + 106.9

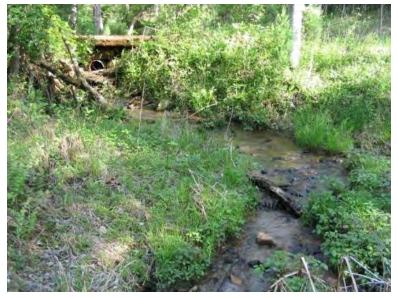
Phase 1 Culvert before replacement

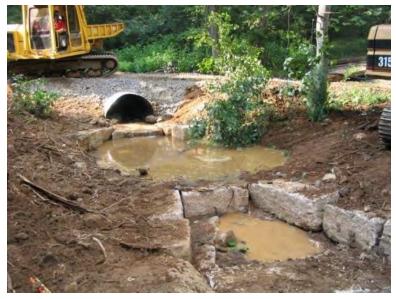
Phase 1 Culvert after replacement

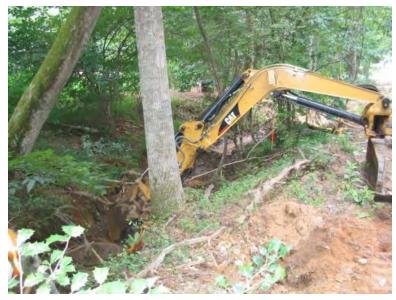
Mining cobble from the old channel

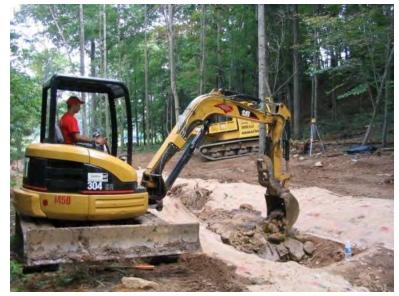
Placing cobble as part of a riffle

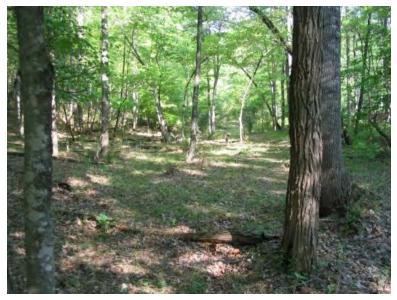
Phase 1 Upper Stream Before

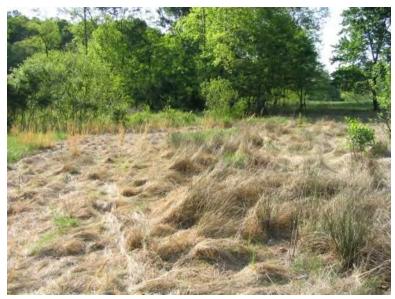
Phase 1 Wetland Before

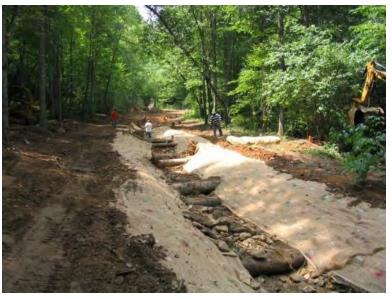
Phase 1 Upper Stream After

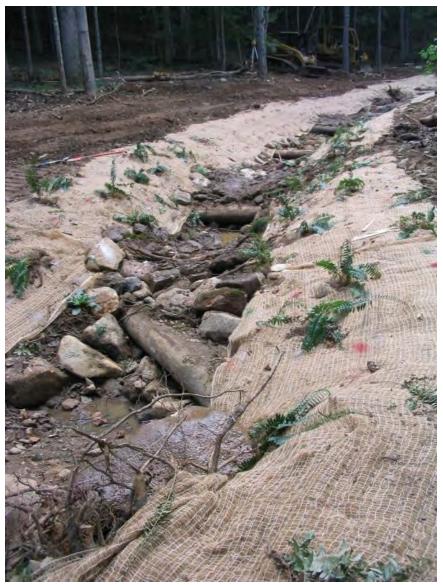
Phase 1 with Mined and transplants

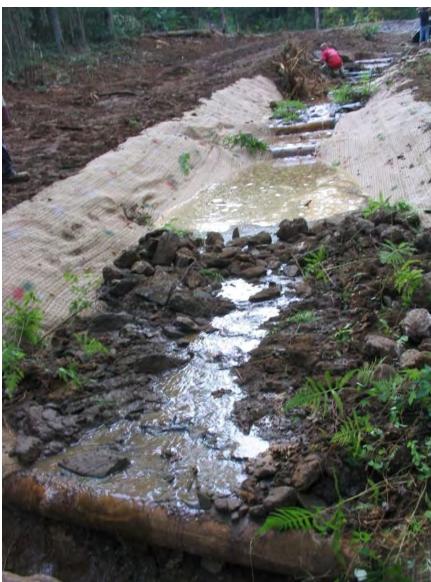
Phase 1 First flow

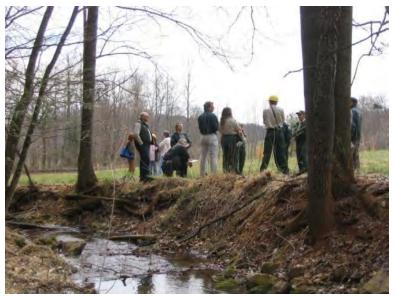
Phase 2 Upper Priority 1 Reach before

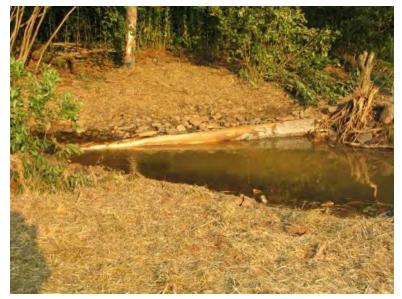
Phase 2 completed log vane

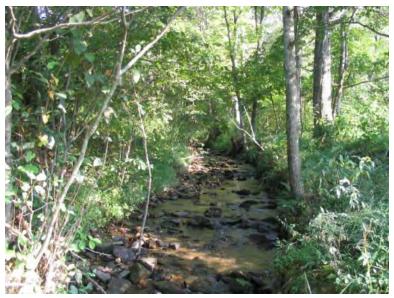
Phase 2 Priority 1 Reach before (no pools)

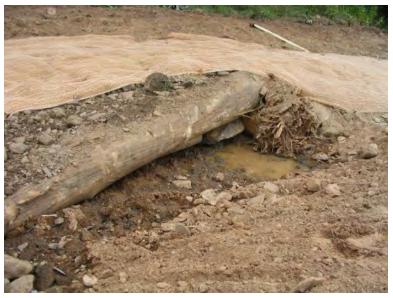
Phase 2 Log Vane Construction

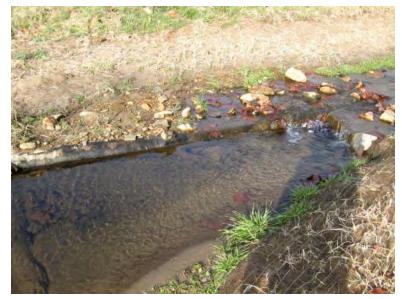
Phase 2 Completed Log Vane

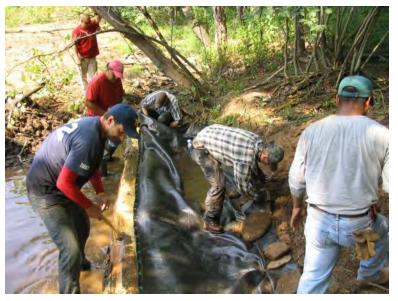
Geo textile backing on the vanes
