BMP Newsletter

Best Management Practices for Water Quality & Soil Conservation

An Assessment of Forestry BMPs in North Carolina

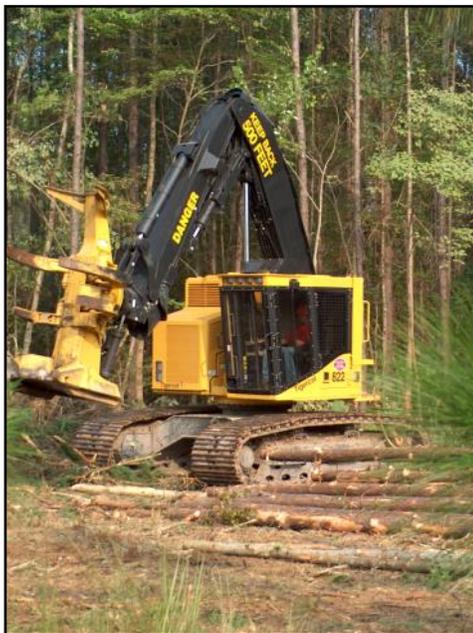
This issue's cover photo was taken in the Piedmont during one of the detail site examinations conducted by NCFS for the BMP implementation assessment. Tracked feller-bunchers can be used to selectively harvest trees in a streamside management zone (SMZ). This type of felling is generally safer than hand felling and tends to have lesser ground disturbance near streams because of its ability to extend the felling arm into the SMZ.

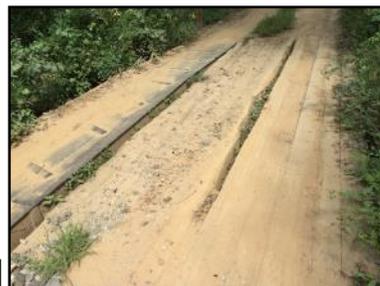
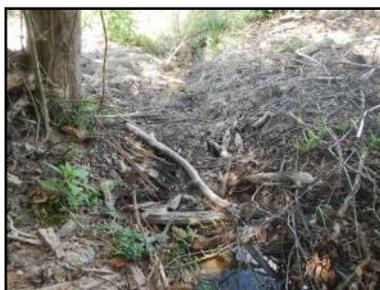
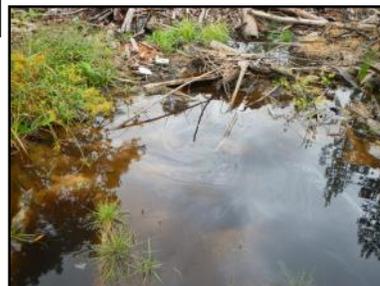
Examples of water quality risks. Visible sediment (above); Water flow inhibited by debris (left); Chemicals that could potentially leach to groundwater (below).

Note that these particular risks were addressed and resolved following NCFCS policy and procedures.

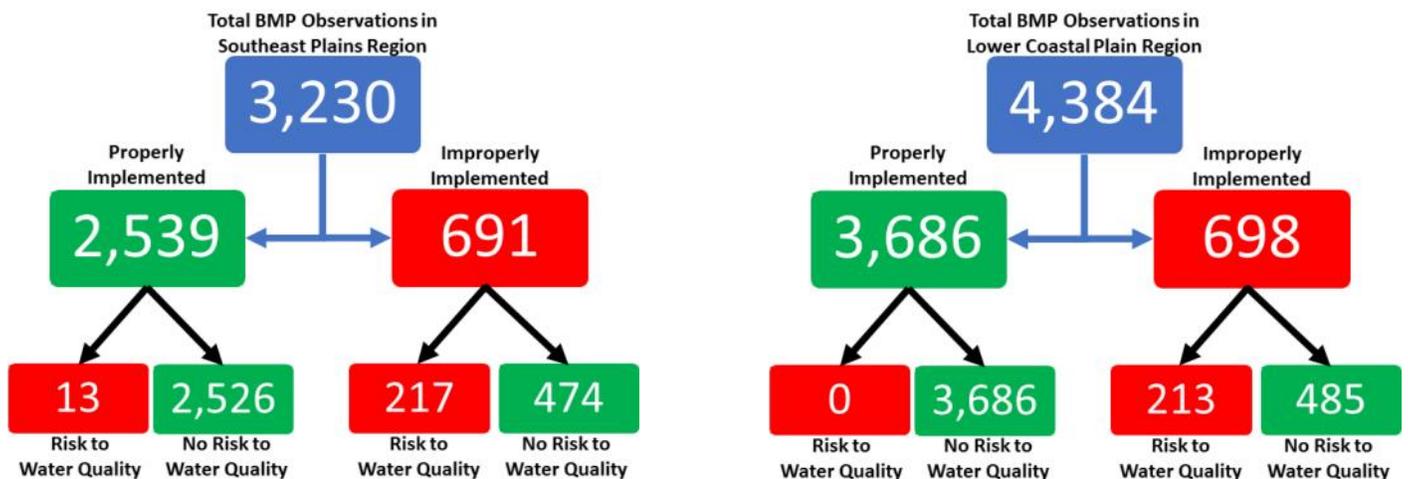
The total number of BMP observations broken down by properly and improperly implemented and further by risk and no risk to water quality is pictured below. Overall BMP implementation rate was 79 percent in the Southeast Plains and 84 percent in the Lower Coastal Plains. About 7 percent and 5 percent of observation were categorized as a potential risk to water quality in the Southeast Plains and Lower Coastal Plains, respectively. Note that when properly implemented, risks to water quality were less than **0.6 percent** in the Southeast Plains region and **0 percent** in the Lower Coastal Plain region.
