Area of Concern – Site: P24

Name & Location: Tributary at Turkey Knob Trail

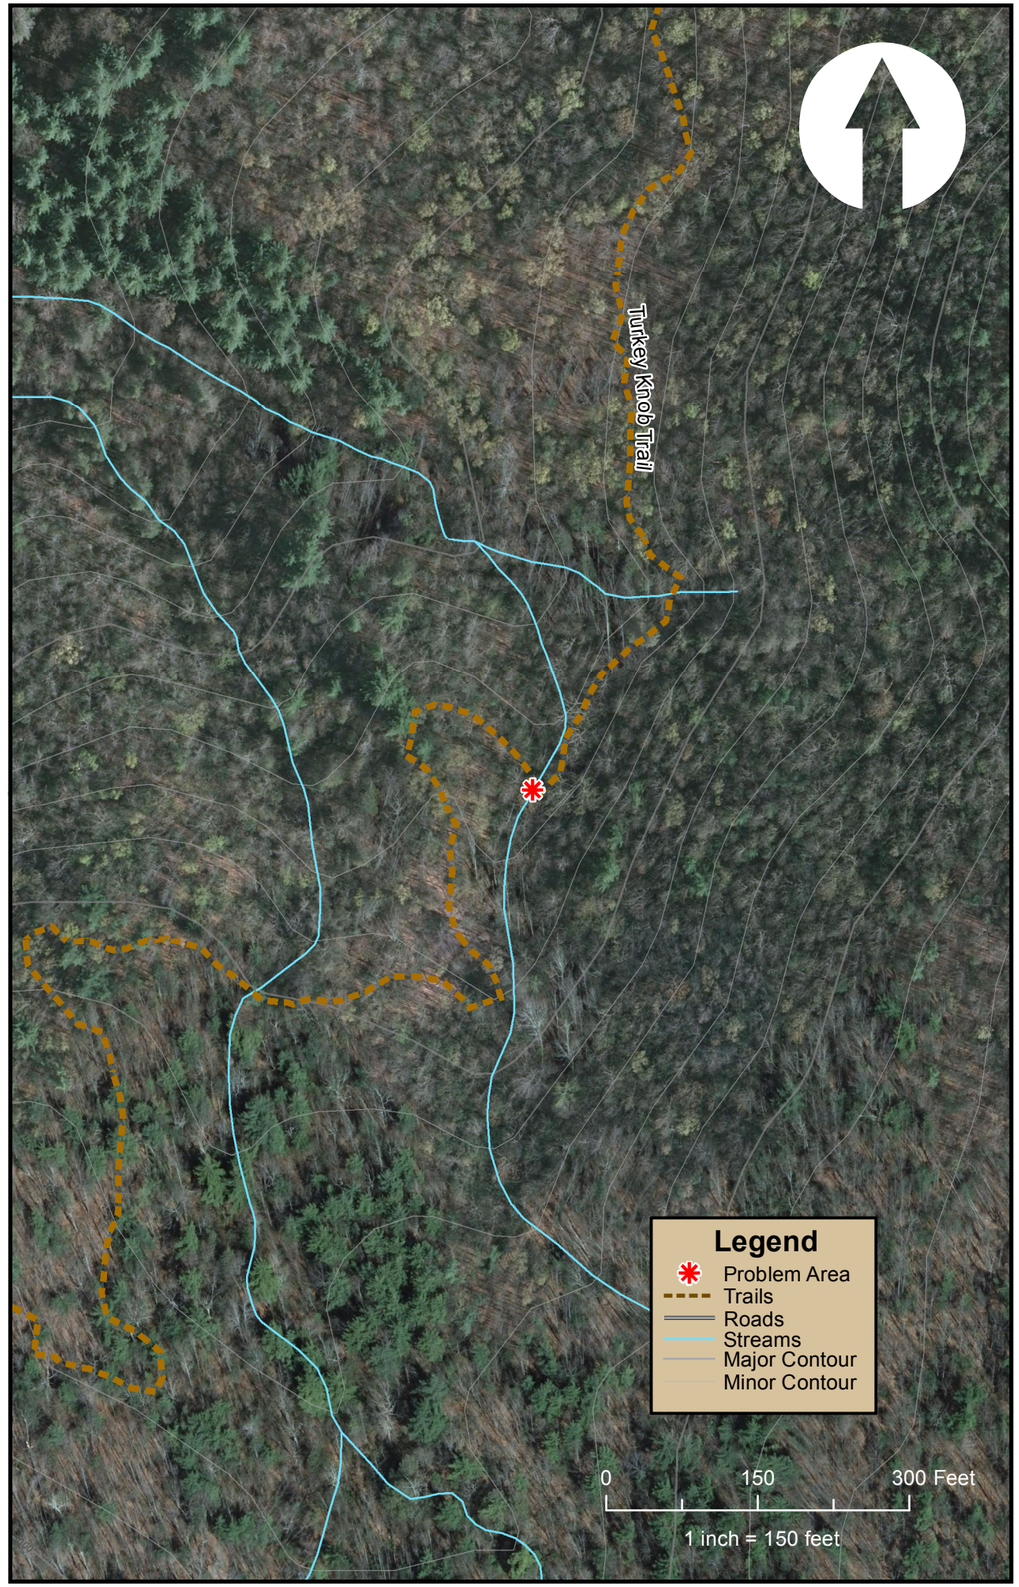
2. **Trail/ Road Impact (trail/ road name):** Turkey Knob Trail
   - ☐ stormwater input
   - ☐ bridge
   - ☒ unstable trail crossing
   - ☐ safety hazard
   - ☐ missing vegetation
   - ☒ sediment input
   - ☐ utilities
   - ☒ erosion
   - ☒ human impact (hiking/biking)
   - ☐ equine/dog impacts

Hardened trail crossing, though surrounding trail has minor erosion and serves as sediment source.

- ☒ relocate trail/close trail/road
- ☒ vegetation/ shoreline planting
- ☐ stormwater treatment
- ☐ human/ animal exclusion
- ☐ signs
- ☐ maintenance
- ☒ trail/road crossing improvement
- ☐ mechanical grading
- ☐ animal watering
- ☐ culvert rehabilitation/ replacement
- ☐ culvert daylighting
- ☐ bridge replacement/improvement
