Area of Concern – Site: P27

Map Grid Location: I 7 Site visit date/ team): 8/30/15/ JZ Drainage Area (Sq. Mi.): 0.42

Name & Location: Tributary at Grassy Meadow Trail

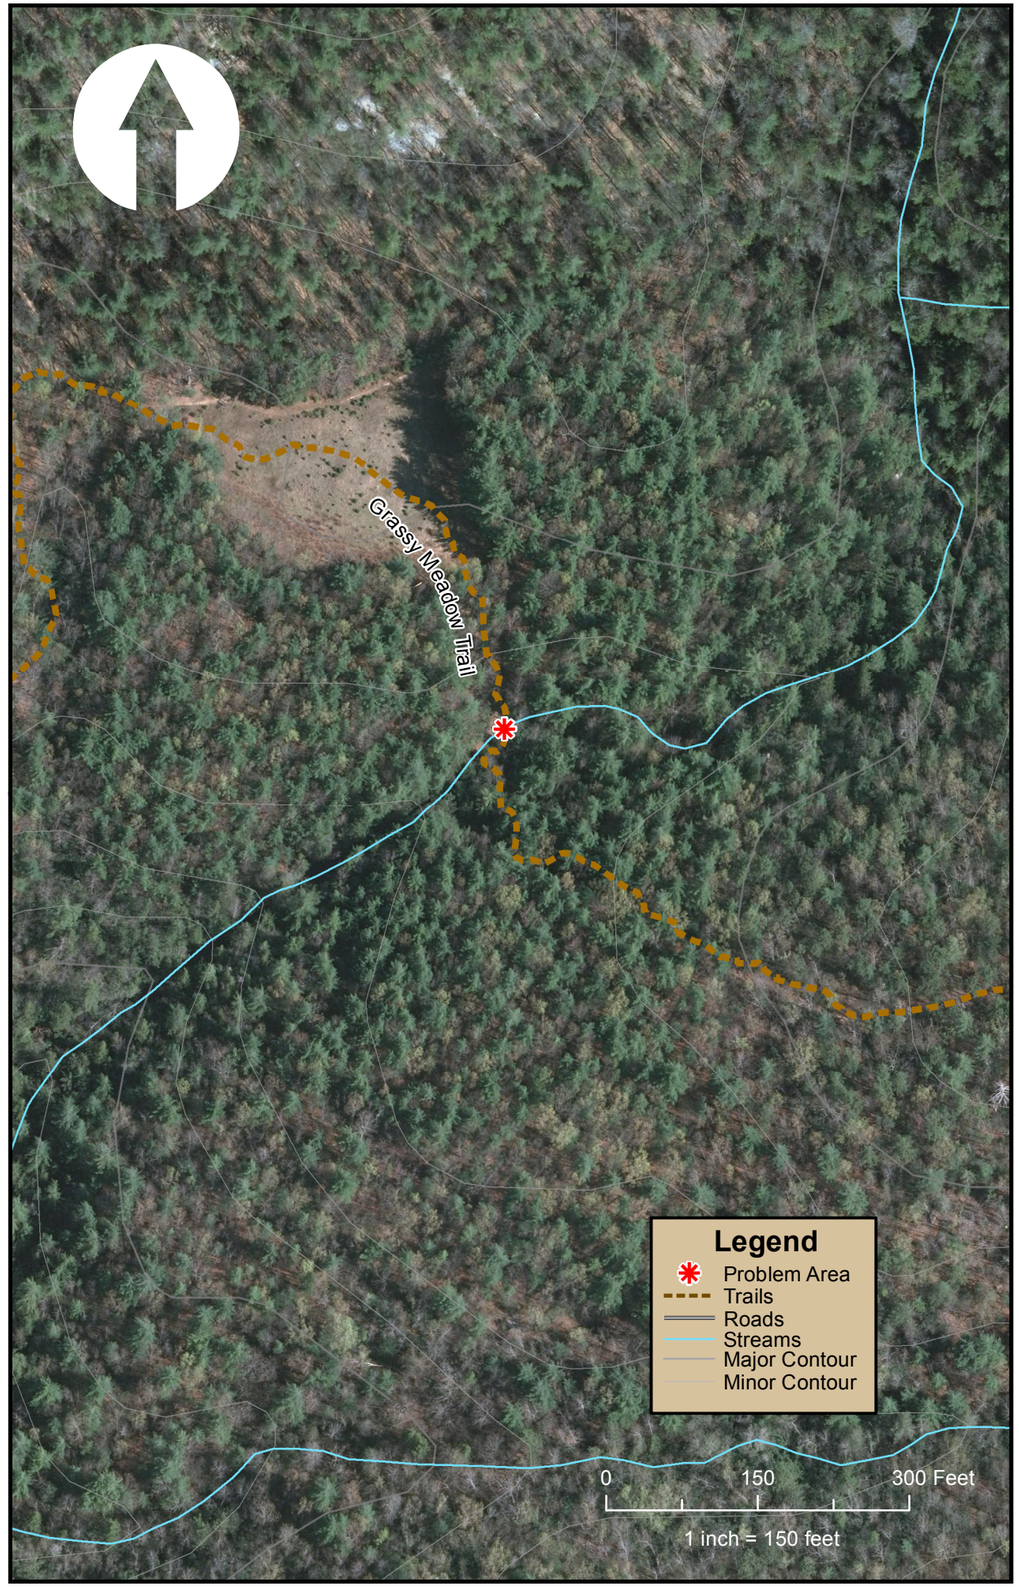
- ☒ stormwater input
- ☐ bridge
- ☐ unstable trail crossing
- ☐ safety hazard
- ☐ missing vegetation
- ☒ sediment input
- ☐ utilities
- ☐ erosion
- ☒ human impact (hiking/biking)
- ☐ equine/dog impacts

Trail crossing serves as source of fine sediment, though crossing itself is stable on bedrock. Potentially install sediment traps/ diversions on trail.

- ☐ relocate trail/close trail/road
- ☐ vegetation/ shoreline planting
- ☐ stormwater treatment
- ☐ human/ animal exclusion
- ☐ signs
- ☐ maintenance
- ☒ trail/road crossing improvement
- ☐ mechanical grading
- ☐ animal watering
- ☐ culvert rehabilitation/ replacement
- ☐ culvert daylighting
- ☐ bridge replacement/improvement
