Area of Concern – Site: P05

Name & Location: Drainage across Little River Trail

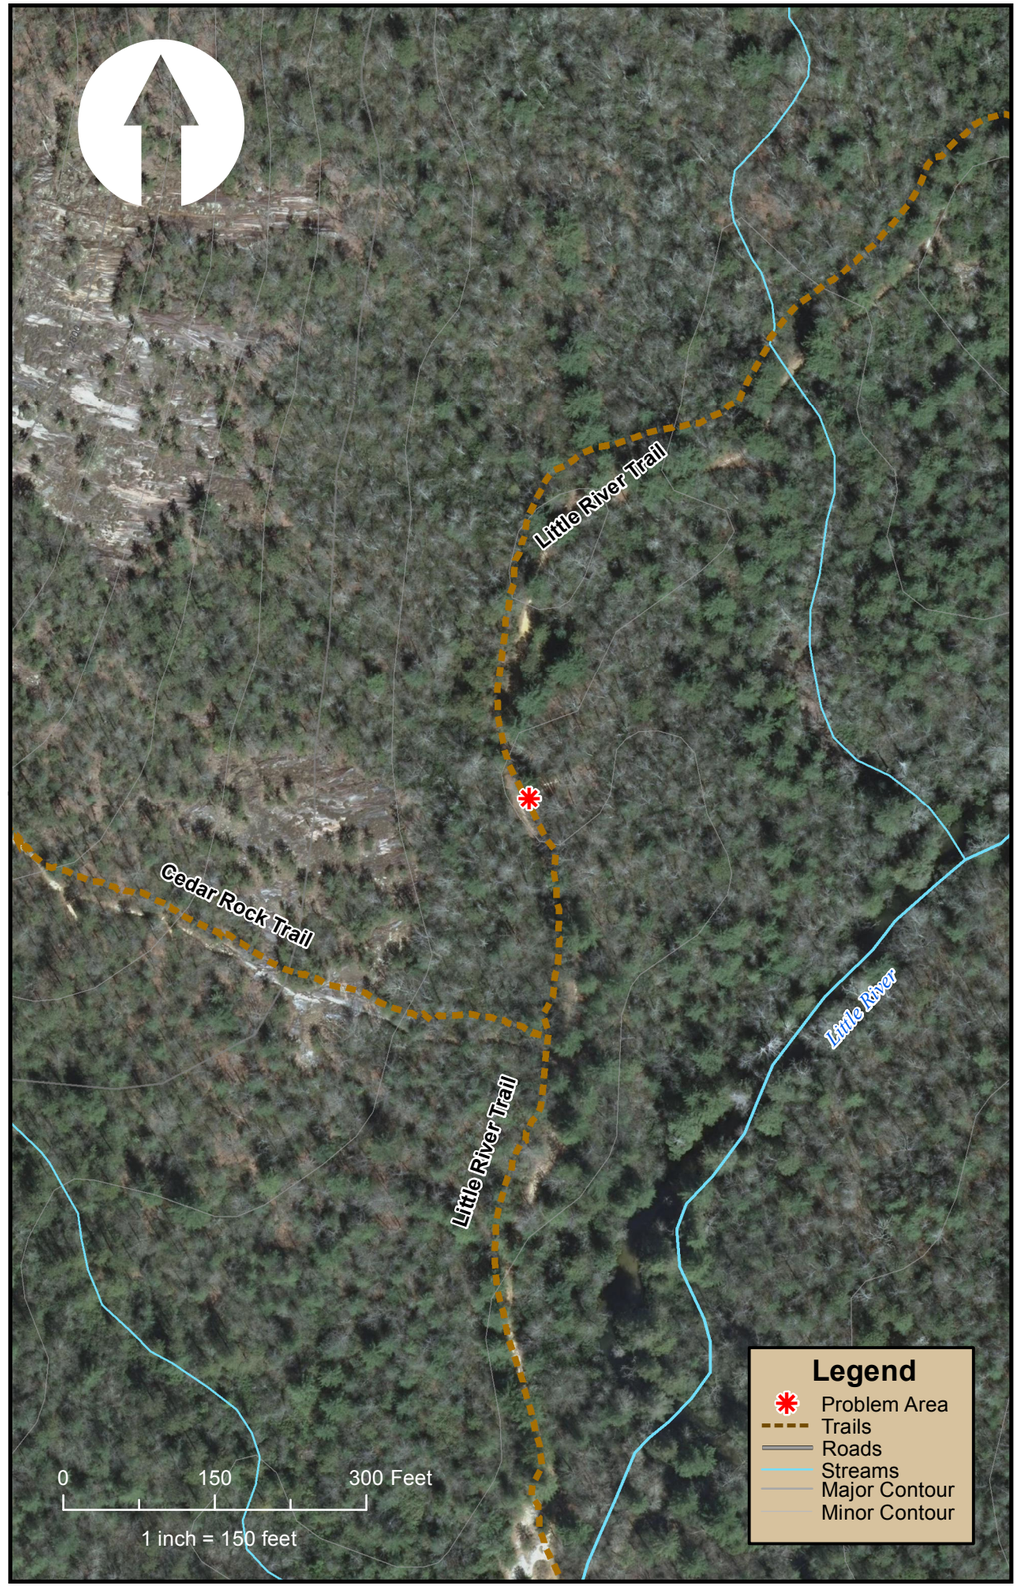
☐stormwater input ☒sediment input
☐bridge ☐utilities
☒unstable trail crossing ☒erosion
☐safety hazard ☒human impact (hiking/biking)
☐missing vegetation ☐equine/dog impacts

Stormwater drainage crosses Little River Trail, with trail serving as sediment source to Little River.

☐relocate trail/close trail/road ☒trail/road crossing improvement
☐vegetation/ shoreline planting ☐mechanical grading
☐stormwater treatment ☐animal watering
☐human/ animal exclusion ☐culvert rehabilitation/ replacement
☐signs ☐culvert daylighting
☐maintenance ☐bridge replacement/improvement
