Area of Concern – Site: P08

Map Grid Location: D11 Site visit date/ team): 4/13/15/ BK, JZ Drainage Area (Sq. Mi.): < 0.1
Name & Location: Drainage across Burnt Mountain Trail

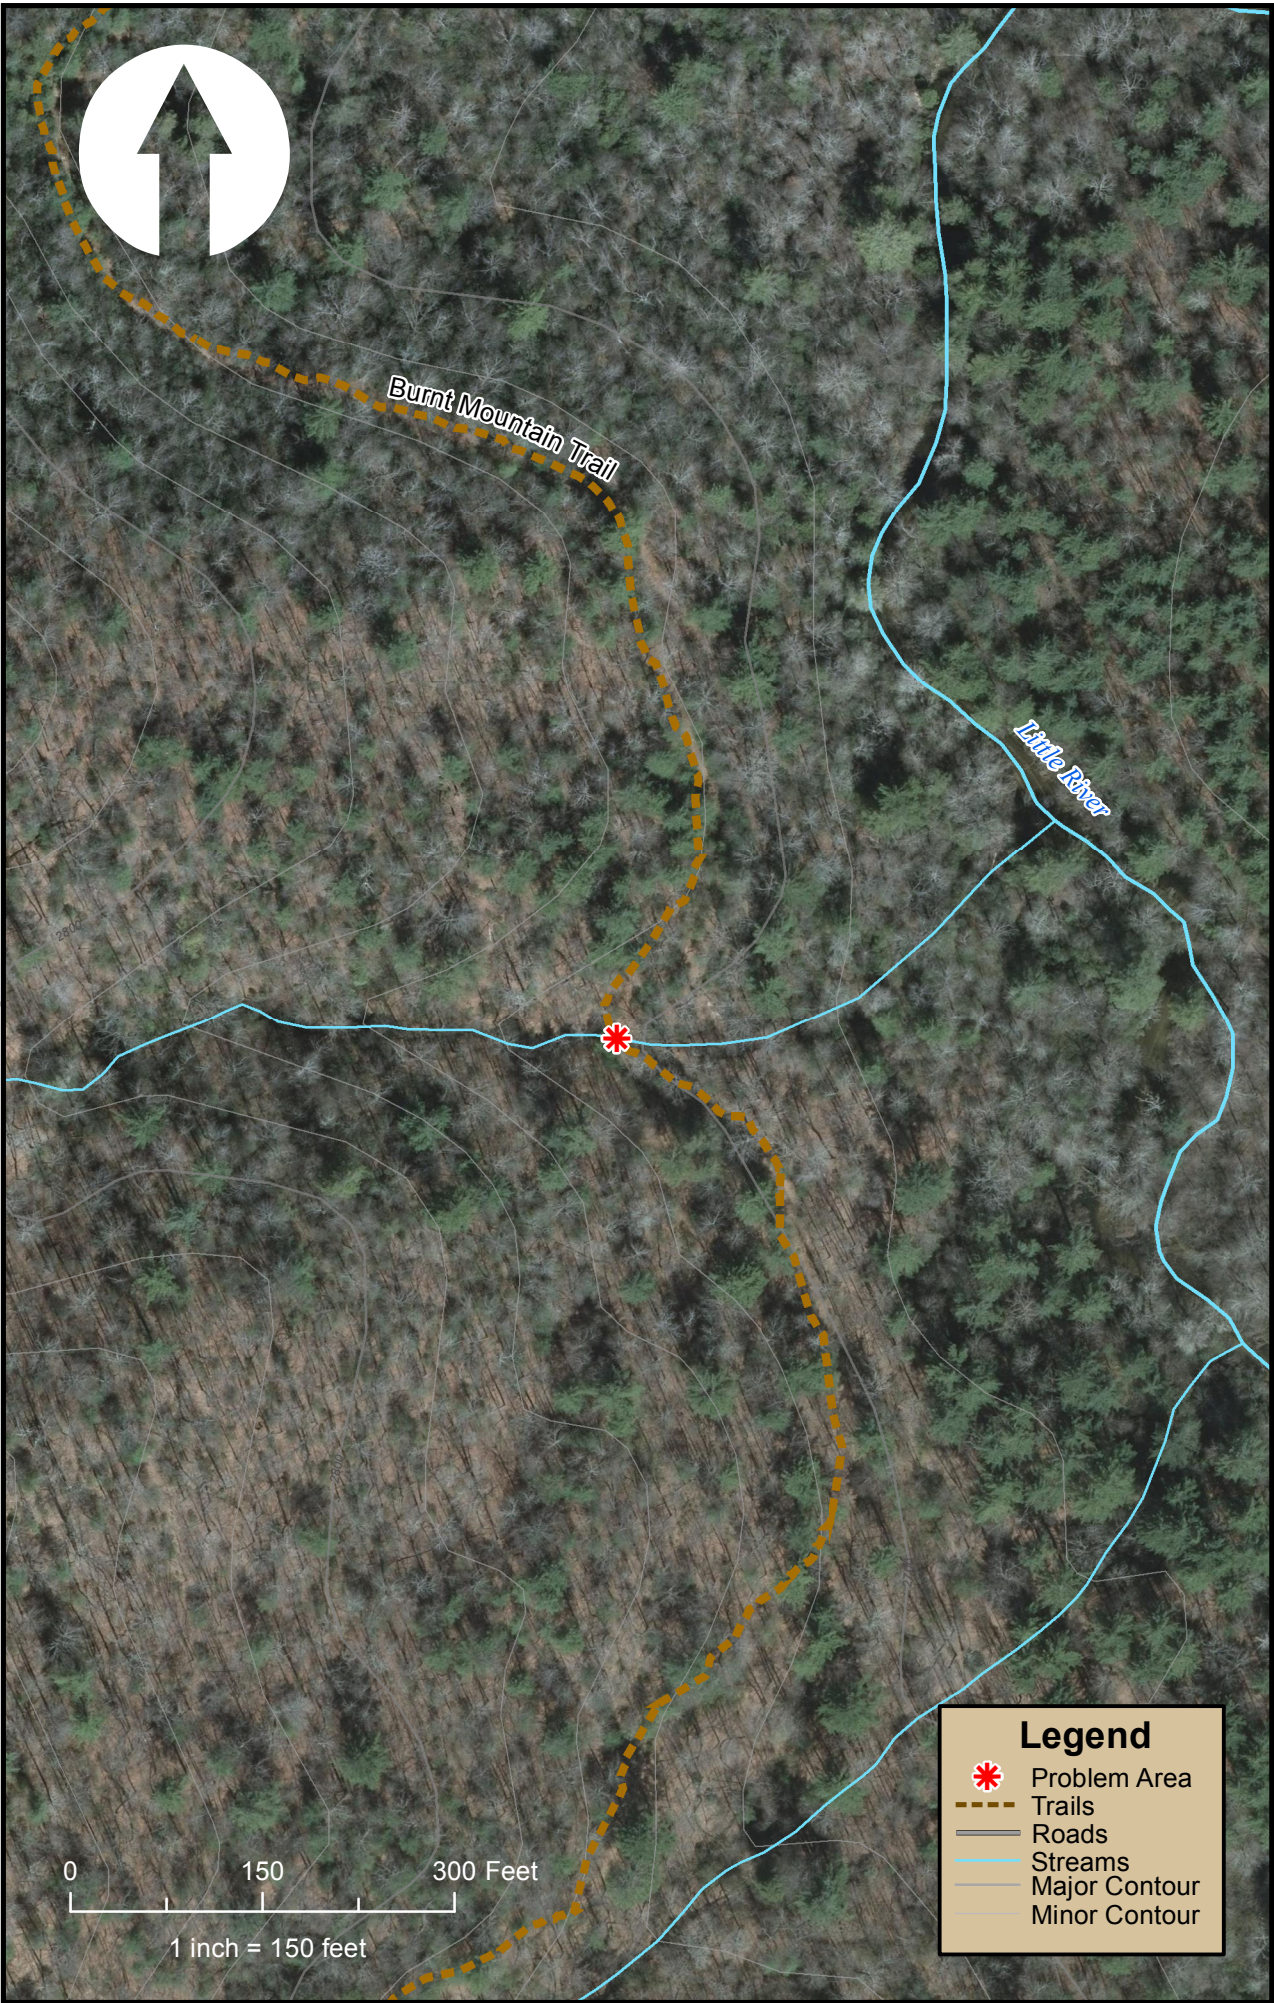
1. **Culvert (diameter/material/length):** 12”/ CPP
- | | |

| <input checked="" type="checkbox"/> clogged | <input type="checkbox"/> aquatic organism passage/ perched |
| <input type="checkbox"/> crushed | <input checked="" type="checkbox"/> erosion (upstream/ downstream) |
| <input type="checkbox"/> lack of natural bed | <input checked="" type="checkbox"/> piping |

| <input type="checkbox"/> human/ animal exclusion | <input checked="" type="checkbox"/> culvert rehabilitation/ replacement |
