Area of Concern – Site: P10

Map Grid Location: D11 Site visit date/ team): 4/13/15/ BK, JZ Drainage Area (Sq. Mi.): < 0.1
Name & Location: Drainage across Burnt Mountain Trail

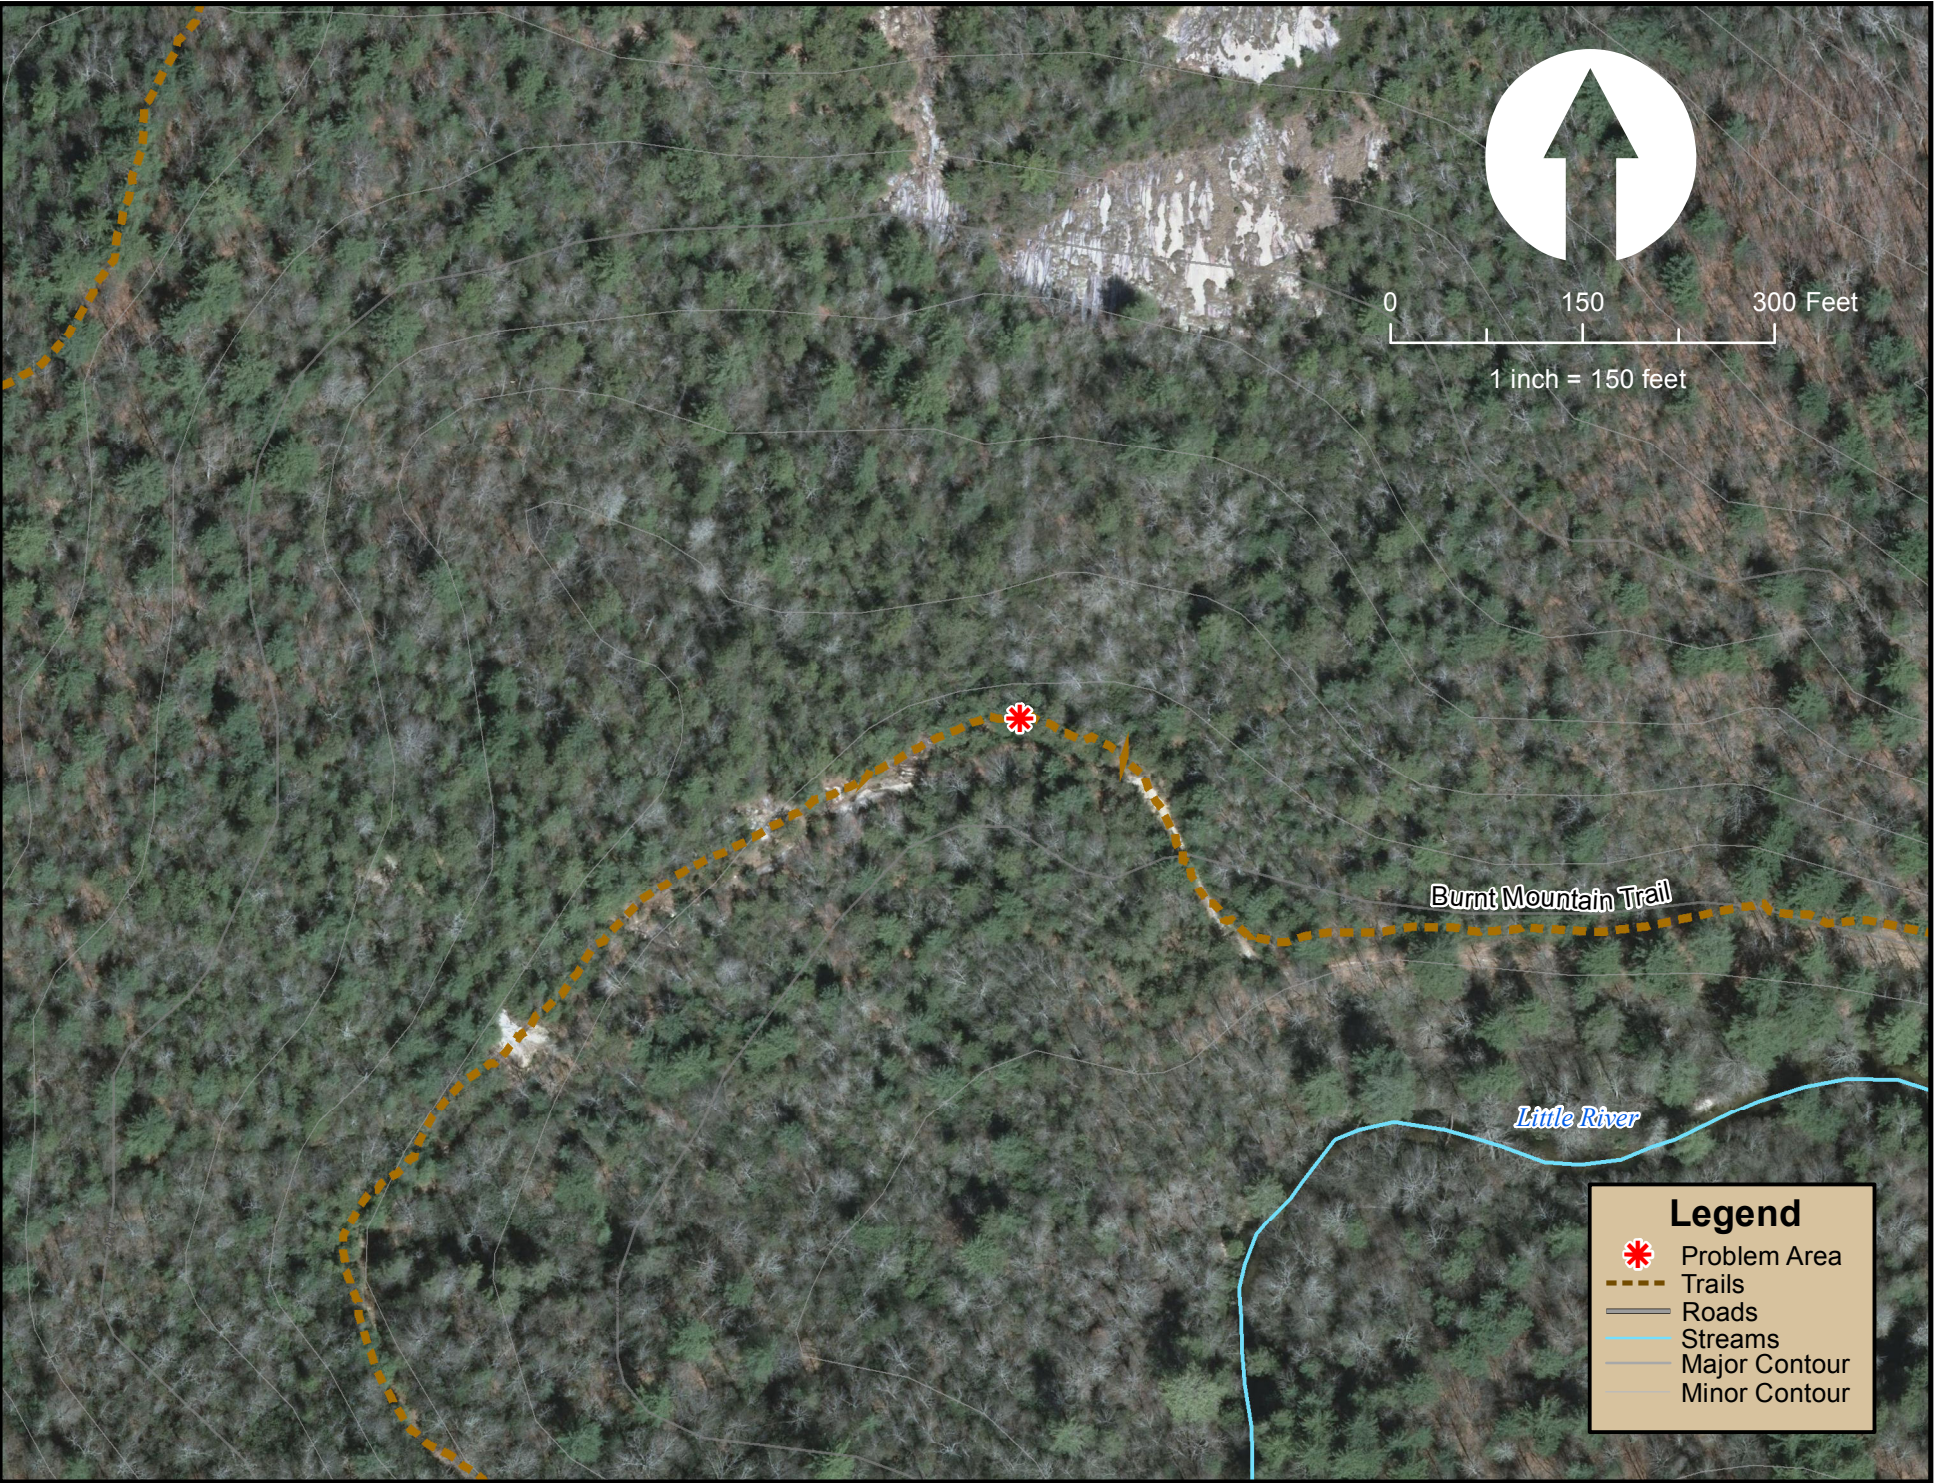
1. **Culvert (diameter/material/length):** 12”/ CPP
☐clogged ☐aquatic organism passage/ perched
☐crushed ☒erosion (upstream/ downstream)
☐lack of natural bed ☐piping
☐safety hazard ☐overtopping
2. **Trail/ Road Impact (trail/ road name):** _____
☐stormwater input ☐sediment input
☐bridge ☐utilities
☐unstable trail crossing ☐erosion
☐safety hazard ☐human impact (hiking/biking)
☐missing vegetation ☐equine/dog impacts
3. **Upland/ Stormwater**
☐nonpoint source pollution ☐upland erosion
☐pollutant point source ☐unvegetated upland area
4. **Lake/Pond/ Reservoir (reservoir name):** _____
☐erosion ☐lack of vegetation
☐equine impact ☐human impact (hiking/biking)
☐safety hazard ☐water quality (temperature, algae, geese, fecal)
5. **Other Problem Area(s)**(list contributing factors)

Comments
Stream banks eroded upstream/ downstream of culvert. Trail currently intact.

- Potential Solutions**
☐relocate trail/close trail/road ☒trail/road crossing improvement
☐vegetation/ shoreline planting ☐mechanical grading
☐stormwater treatment ☐animal watering
☐human/ animal exclusion ☒culvert rehabilitation/ replacement
☐signs ☐culvert daylighting
☐maintenance ☐bridge replacement/improvement
