Area of Concern – Site: P12

Map Grid Location: E10 Site visit date/ team): 4/13/15/ BK, JZ Drainage Area (Sq. Mi.): < 0.1
 Name & Location: Tributary at Corn Mill Shoals Trail

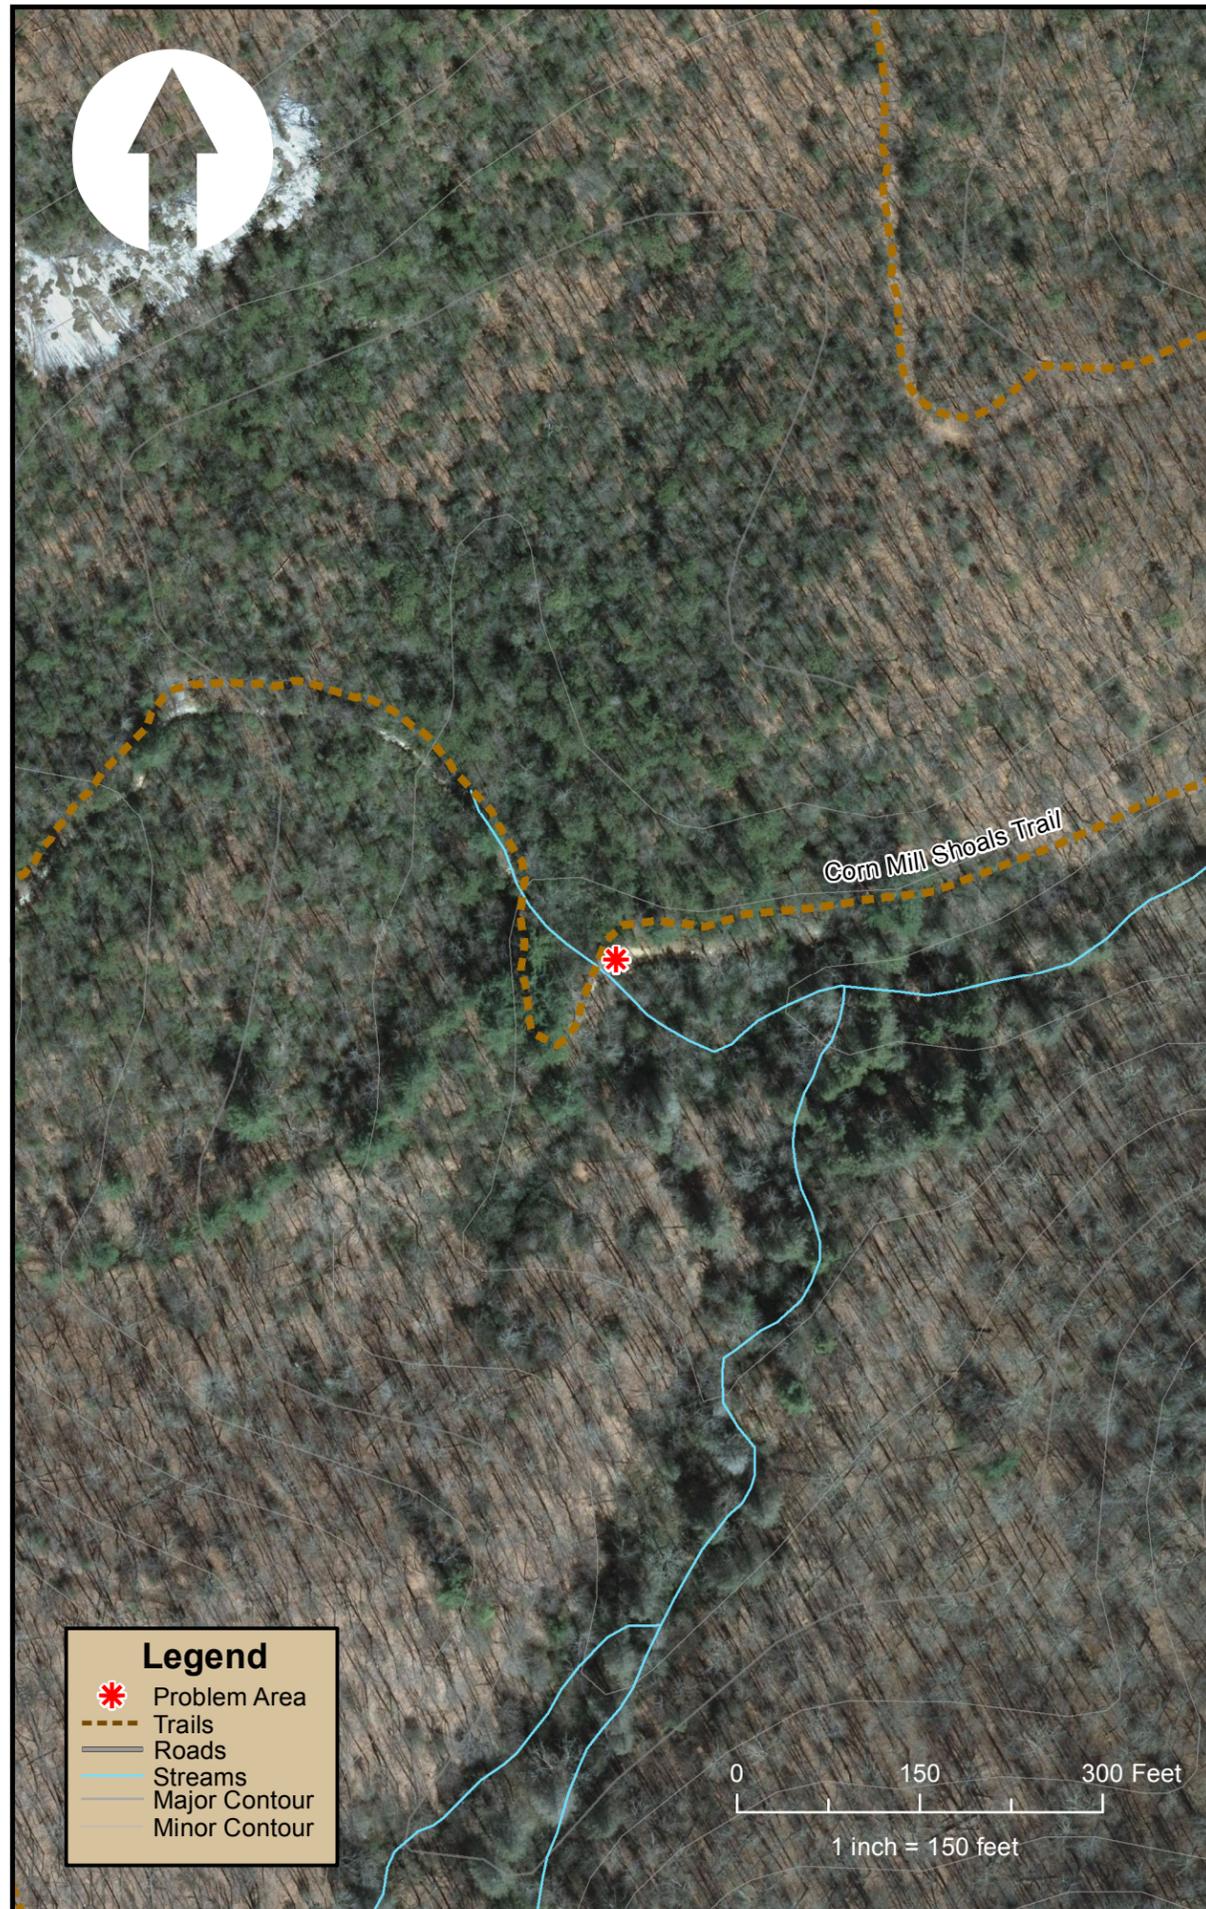
1. **Culvert (diameter/material/length):** 24" / CPP

<input type="checkbox"/> clogged	<input checked="" type="checkbox"/> aquatic organism passage/ perched
<input type="checkbox"/> crushed	<input type="checkbox"/> erosion (upstream/ downstream)
<input type="checkbox"/> lack of natural bed	<input type="checkbox"/> piping
<input type="checkbox"/> safety hazard	<input type="checkbox"/> overtopping
2. **Trail/ Road Impact (trail/ road name):** Corn Mill Shoals Trail

<input checked="" type="checkbox"/> stormwater input	<input checked="" type="checkbox"/> sediment input
<input type="checkbox"/> bridge	<input type="checkbox"/> utilities
<input type="checkbox"/> unstable trail crossing	<input type="checkbox"/> erosion
<input type="checkbox"/> safety hazard	<input type="checkbox"/> human impact (hiking/biking)
<input type="checkbox"/> missing vegetation	<input type="checkbox"/> equine/ dog impacts
3. **Upland/ Stormwater**

Culvert appears to be in good condition, though perched at downstream end. Trail serves as sediment source to stream, with sediment traps full.

| <input checked="" type="checkbox"/> relocate trail/close trail/road | <input checked="" type="checkbox"/> trail/road crossing improvement |
| <input checked="" type="checkbox"/> maintenance | <input type="checkbox"/> bridge replacement/improvement |
