Area of Concern – Site: P14

Map Grid Location: F9 Site visit date/ team): 8/31/15/ JZ Drainage Area (Sq. Mi.): 0.1
 Name & Location: Tributary at Shelter Rock Trail

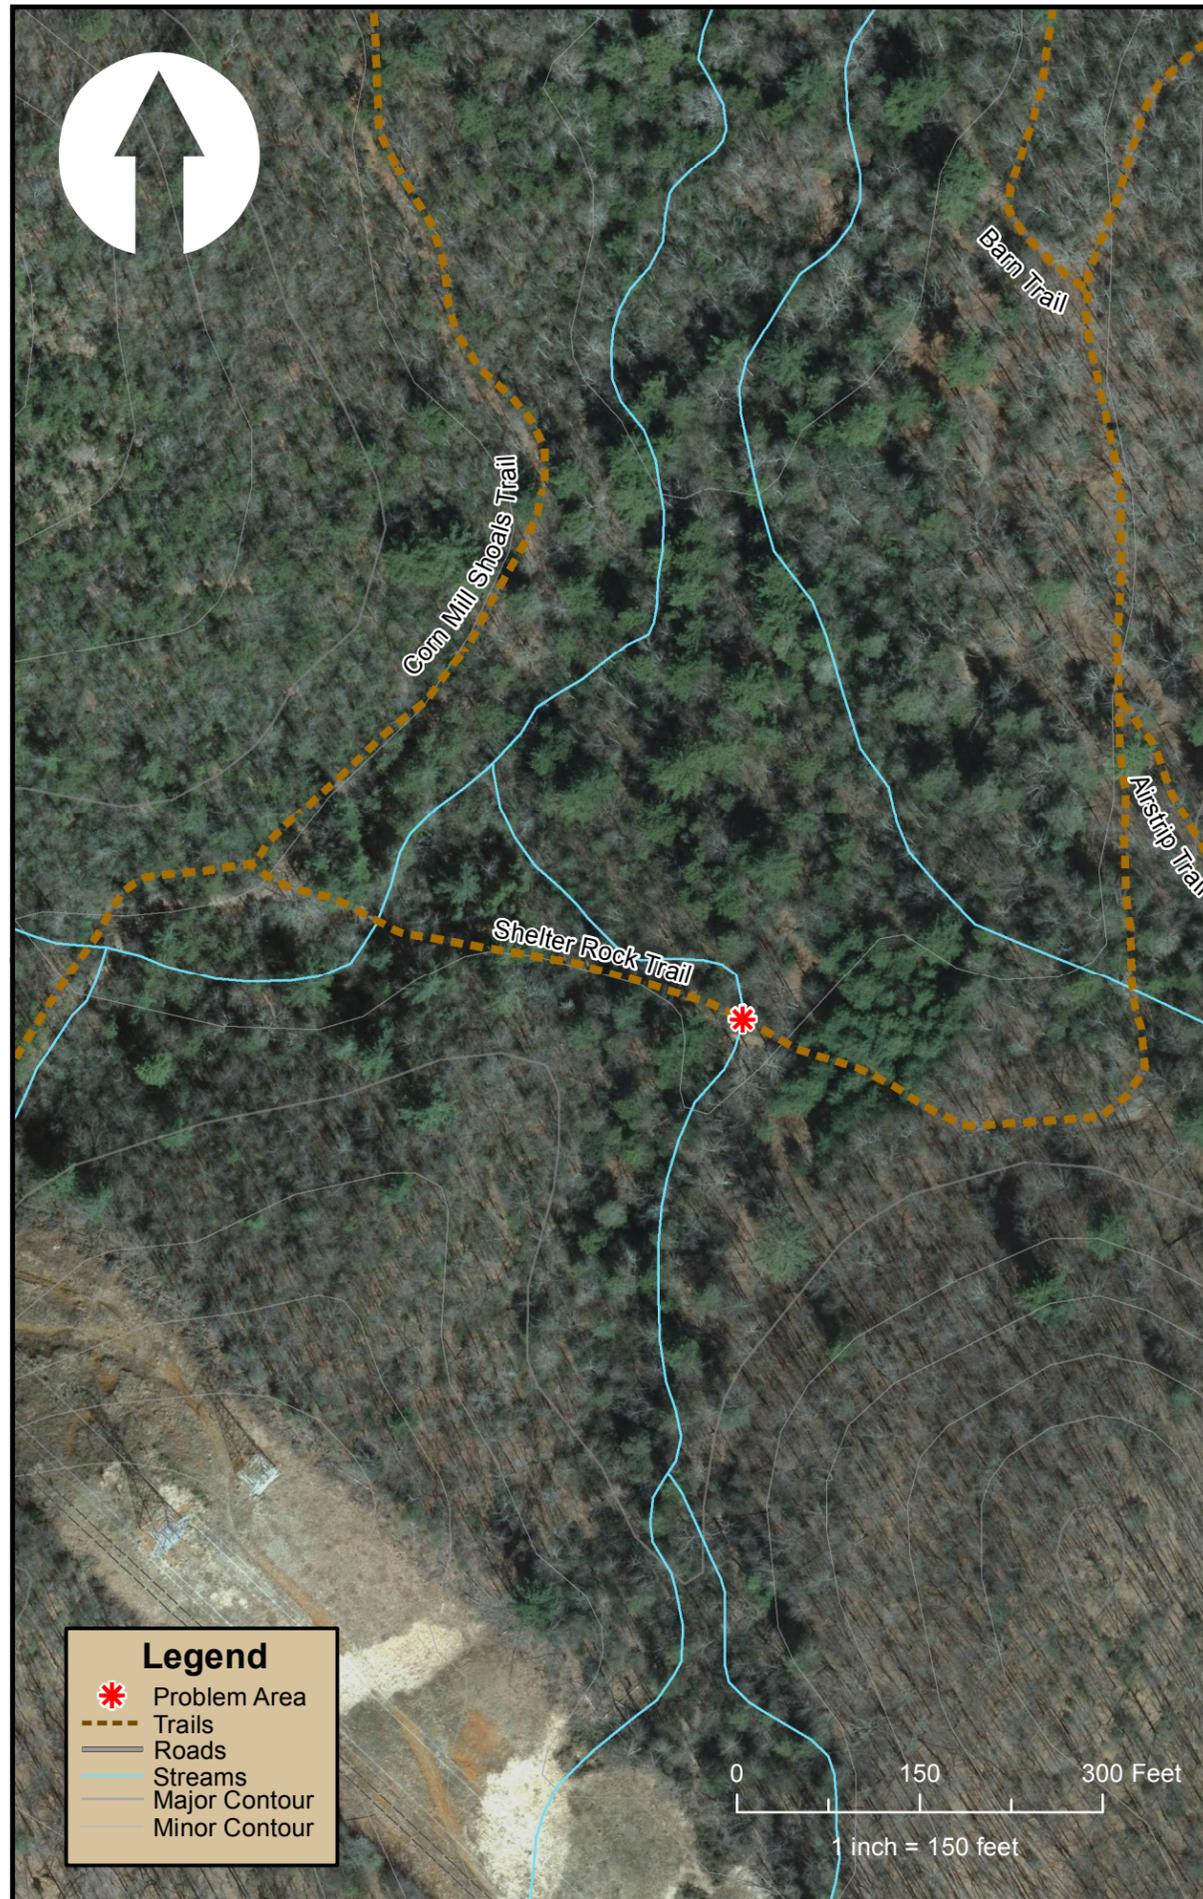
Comments
 Culvert exists and appears to be in good condition. Bare area between trail and stream caused/ exacerbated by human access and stormwater.

| <input checked="" type="checkbox"/> vegetation/ shoreline planting | <input type="checkbox"/> mechanical grading |
| <input checked="" type="checkbox"/> human/ animal exclusion | <input type="checkbox"/> culvert rehabilitation/ replacement |
