## Area of Concern – Site: P15

Map Grid Location: F9 Site visit date/ team): 8/31/15/ JZ Drainage Area (Sq. Mi.): 0.07  
 Name & Location: Tributary at Shelter Rock Trail

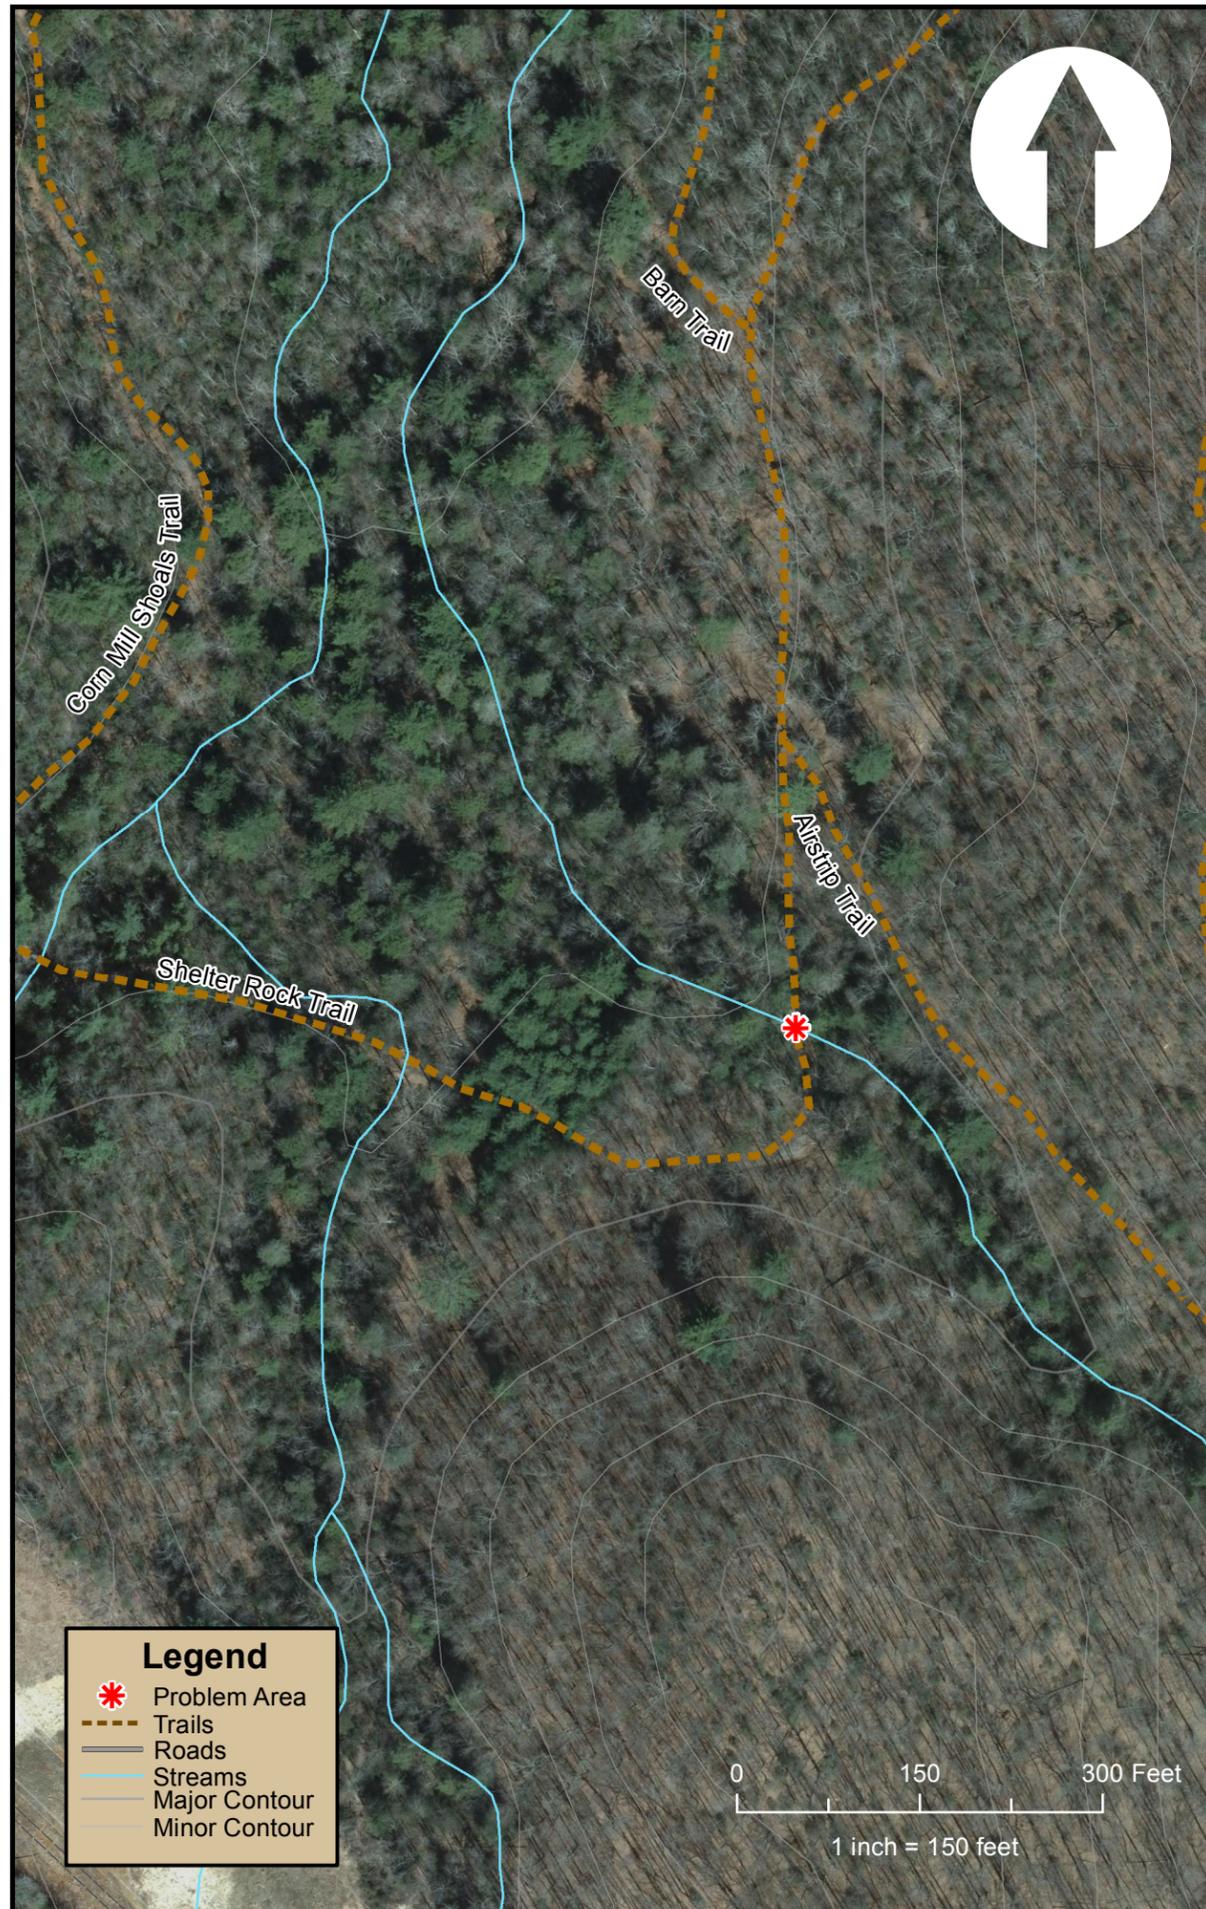
2. **Trail/ Road Impact (trail/ road name):** Shelter Rock Trail

<input checked="" type="checkbox"/> stormwater input	<input type="checkbox"/> sediment input
<input type="checkbox"/> bridge	<input type="checkbox"/> utilities
<input type="checkbox"/> unstable trail crossing	<input type="checkbox"/> erosion
<input type="checkbox"/> safety hazard	<input checked="" type="checkbox"/> human impact (hiking/biking)
<input checked="" type="checkbox"/> missing vegetation	<input type="checkbox"/> equine/dog impacts

**Comments**  
 Culvert exists and appears to be in good condition. Bare area between trail and stream caused/ exacerbated by human access and stormwater.

| <input checked="" type="checkbox"/> human/ animal exclusion | <input type="checkbox"/> culvert rehabilitation/ replacement |
