Area of Concern – Site: P19

Map Grid Location: G11 Site visit date/ team): 8/17/15/ JZ Drainage Area (Sq. Mi.): 2.58
 Name & Location: Reasonover Creek at Reasonover Creek Trail

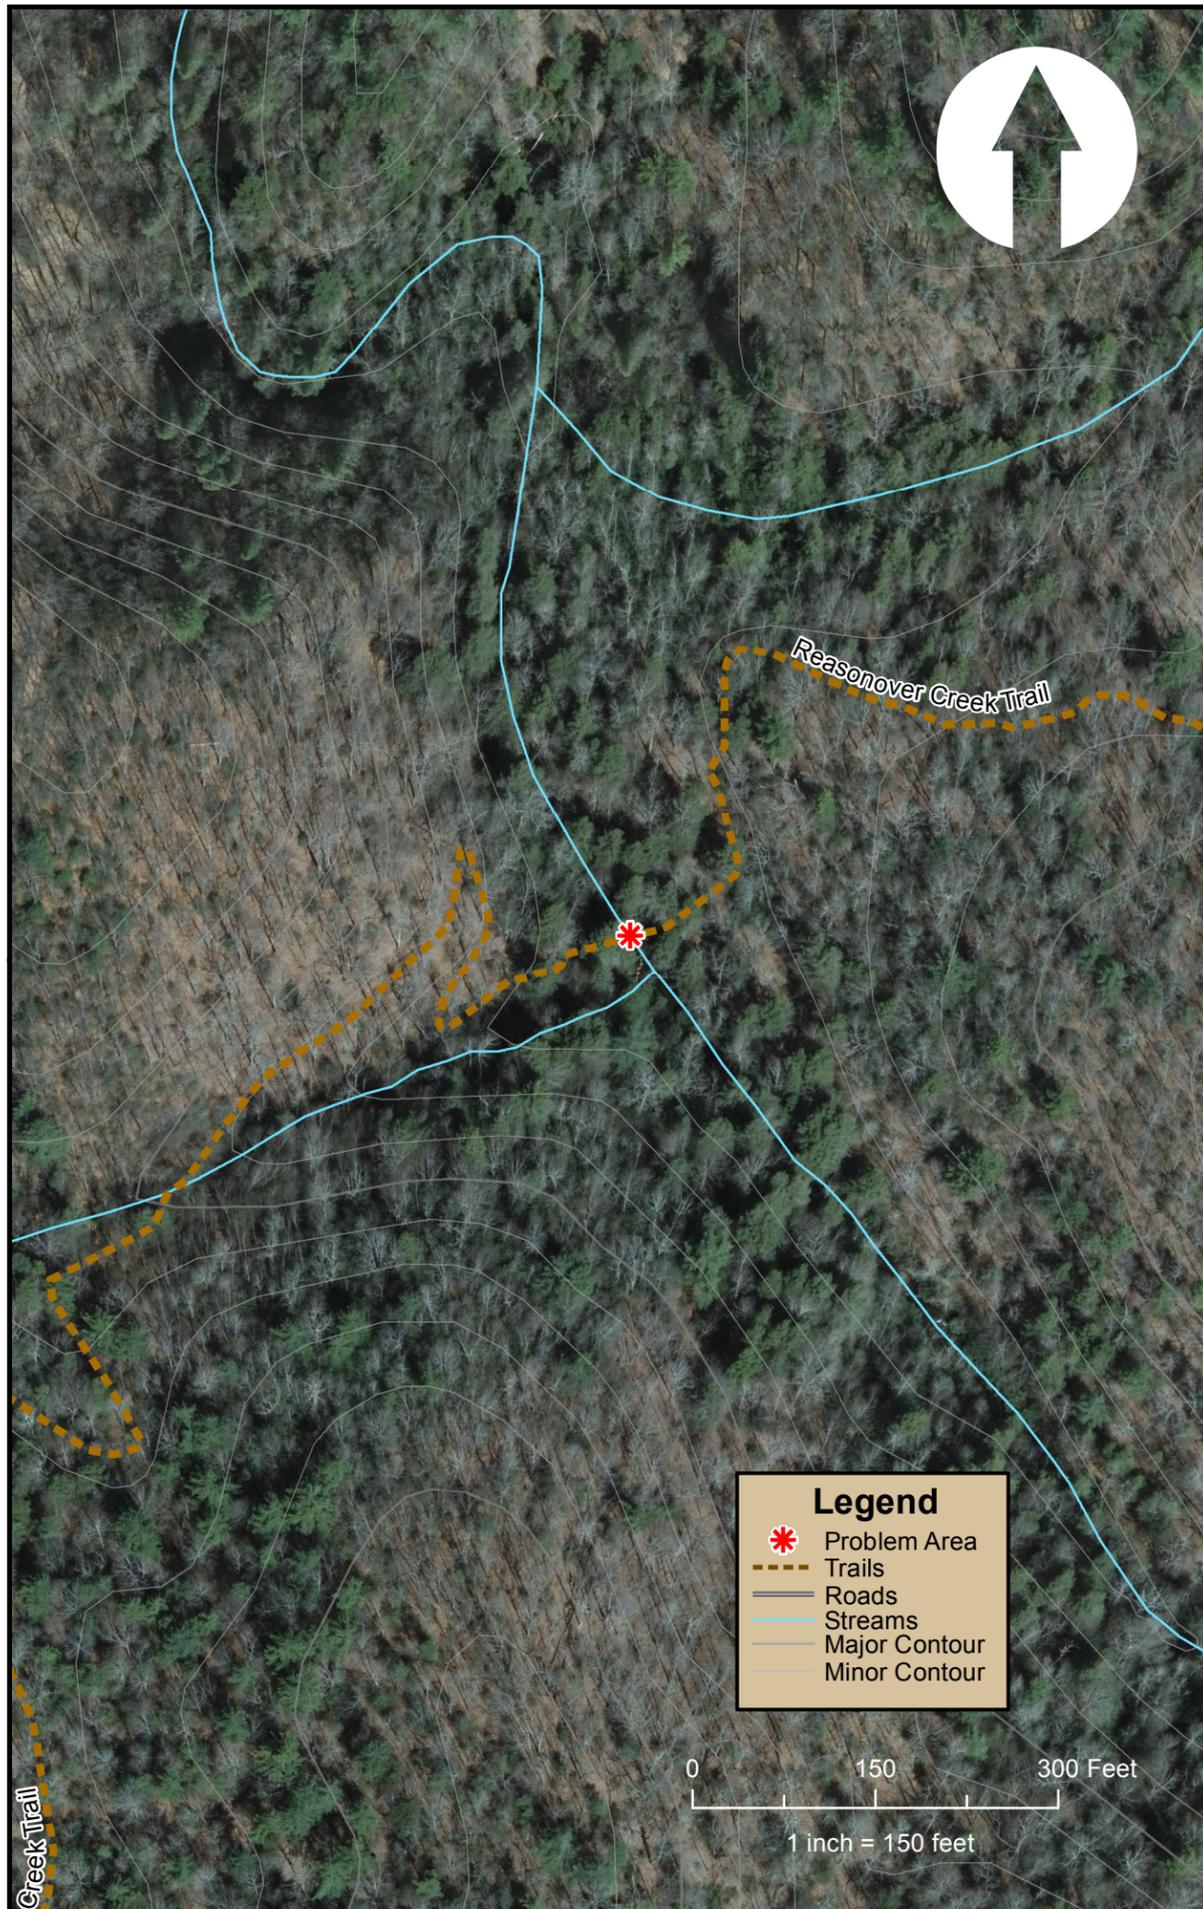
1. **Culvert (diameter/material/length):** _____
 clogged aquatic organism passage/ perched
 crushed erosion (upstream/ downstream)
 lack of natural bed piping
 safety hazard overtopping
2. **Trail/ Road Impact (trail/ road name):** Reasonover Creek Trail
 stormwater input sediment input
 bridge utilities
 unstable trail crossing erosion
 safety hazard human impact (hiking/biking)
 missing vegetation equine/dog impacts
3. **Upland/ Stormwater**
 nonpoint source pollution upland erosion
 pollutant point source unvegetated upland area
4. **Lake/Pond/ Reservoir (reservoir name):** _____
 erosion lack of vegetation
 equine impact human impact (hiking/biking)
 safety hazard water quality (temperature, algae, geese, fecal)
5. **Other Problem Area(s)** (list contributing factors)

Trail crosses at confluence with tributary; hardened trail each side of Reasonover Creek. Left bank: very minor bank erosion and erosion along trail. Right bank: unvegetated area.

| <input type="checkbox"/> relocate trail/close trail/road | <input checked="" type="checkbox"/> trail/road crossing improvement |
| <input checked="" type="checkbox"/> vegetation/ shoreline planting | <input type="checkbox"/> mechanical grading |
