Area of Concern – Site: P23

Map Grid Location: F10 Site visit date/ team): 8/19/15/ JZ Drainage Area (Sq. Mi.): < 0.1  
Name & Location: Tributary at Reasonover Creek Trail

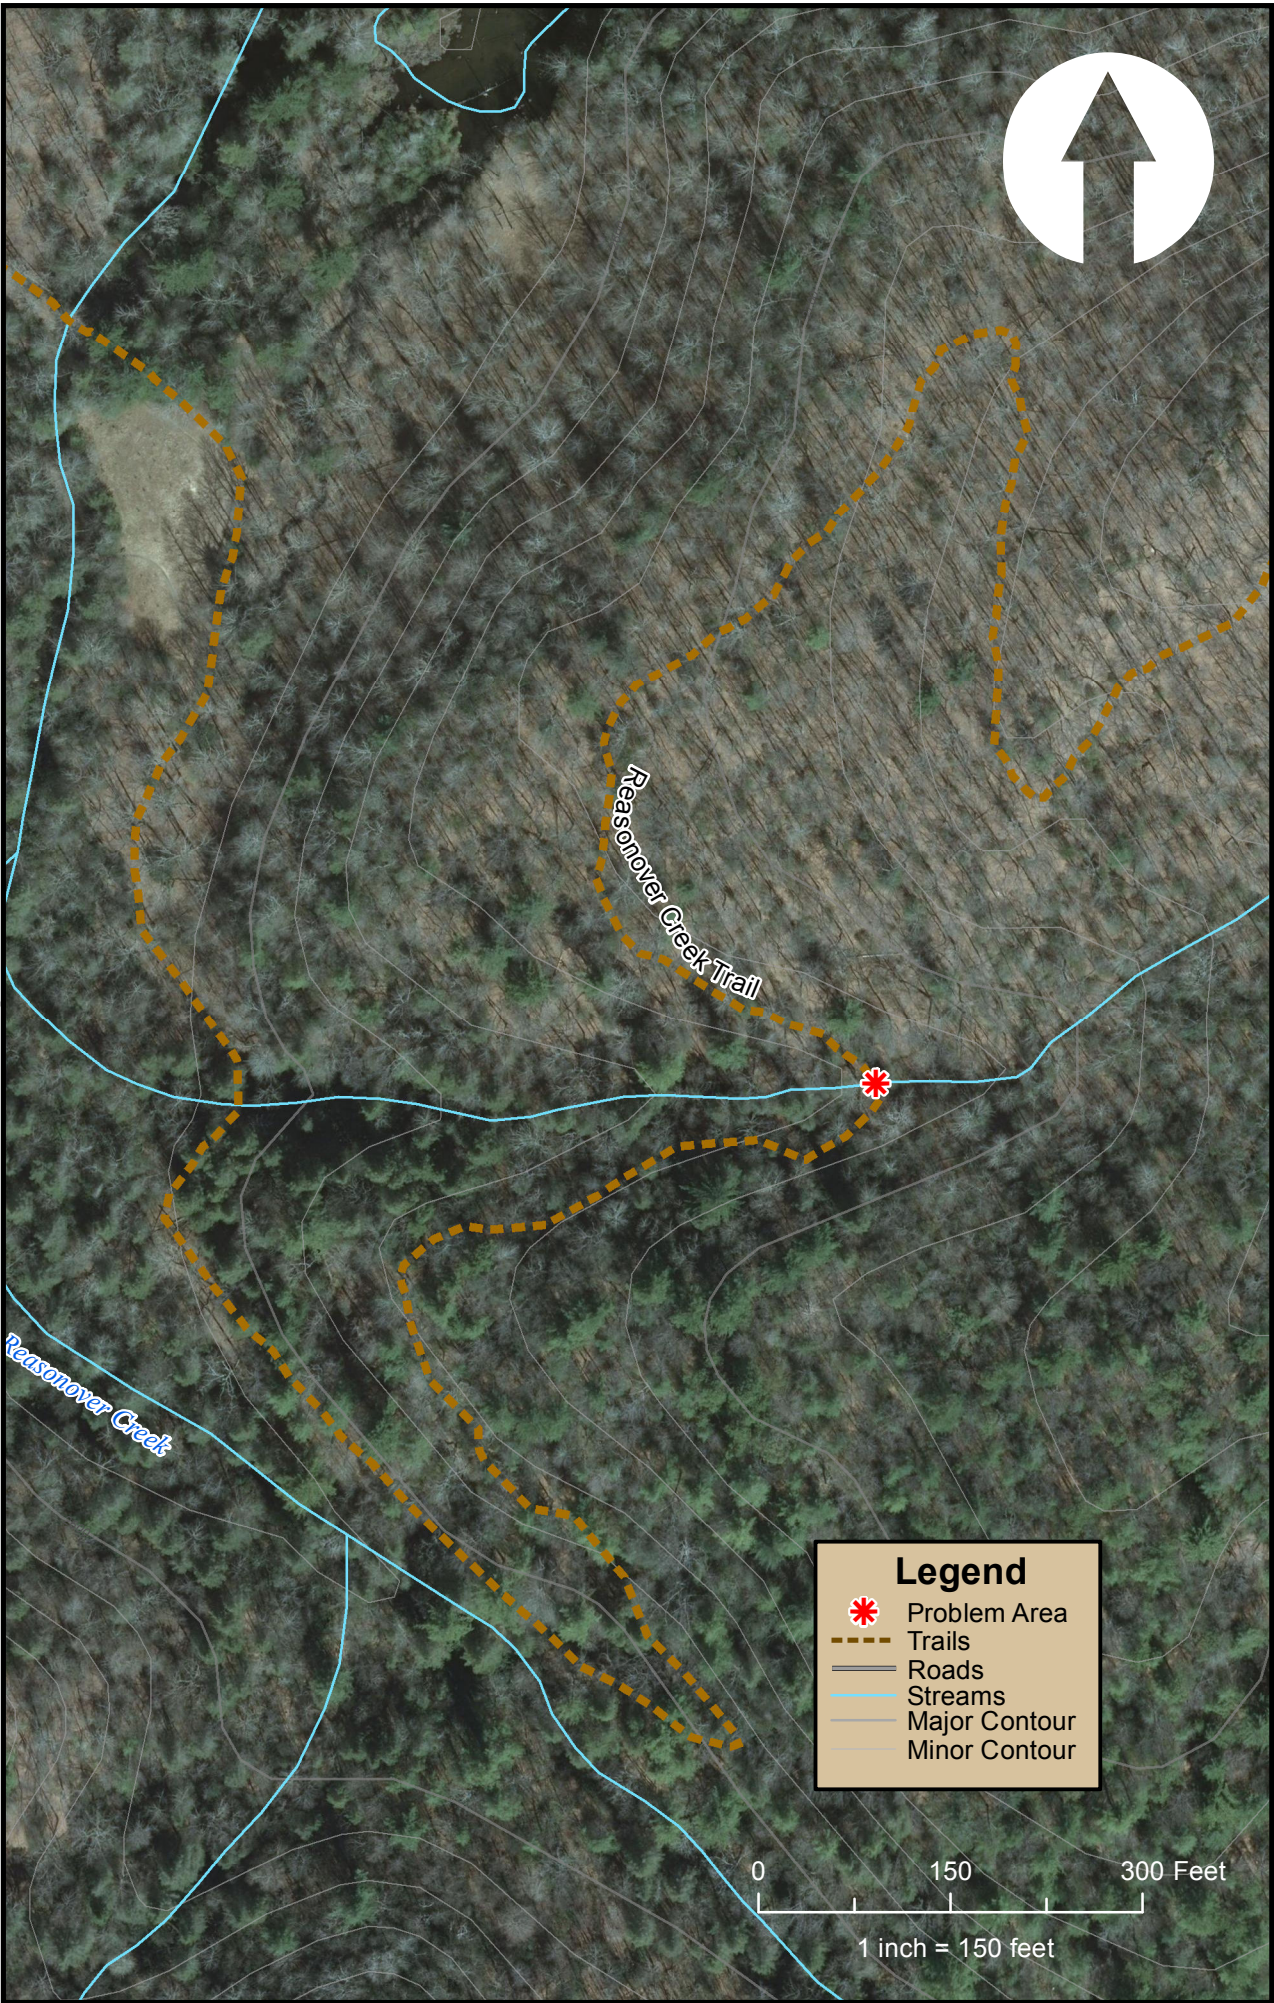
1. Culvert (diameter/material/length): 12”/ CPP  
☒clogged ☐aquatic organism passage/ perched  
☐crushed ☐erosion (upstream/ downstream)  
☐lack of natural bed ☐piping  
☐safety hazard ☐overtopping
2. Trail/ Road Impact (trail/ road name): \_\_\_\_\_  
☐stormwater input ☐sediment input  
☐bridge ☐utilities  
☐unstable trail crossing ☐erosion  
☐safety hazard ☐human impact (hiking/biking)  
☐missing vegetation ☐equine/dog impacts
3. Upland/ Stormwater \_\_\_\_\_  
☐nonpoint source pollution ☐upland erosion  
☐pollutant point source ☐unvegetated upland area
4. Lake/Pond/ Reservoir (reservoir name): \_\_\_\_\_  
☐erosion ☐lack of vegetation  
☐equine impact ☐human impact (hiking/biking)  
☐safety hazard ☐water quality (temperature, algae, geese, fecal)
5. Other Problem Area(s)list contributing factors)

Comments  
Culvert appears to be clogged. Trail currently stable, but potential exists for overtopping.

| <input type="checkbox"/> human/ animal exclusion | <input checked="" type="checkbox"/> culvert rehabilitation/ replacement |
| <input checked="" type="checkbox"/> maintenance | <input type="checkbox"/> bridge replacement/improvement |
