Area of Concern – Site: P43

Map Grid Location: I 3 Site visit date/ team): 8/20/15/ JZ Drainage Area (Sq. Mi.): < 0.1
 Name & Location: Tributary at Switchback Trail

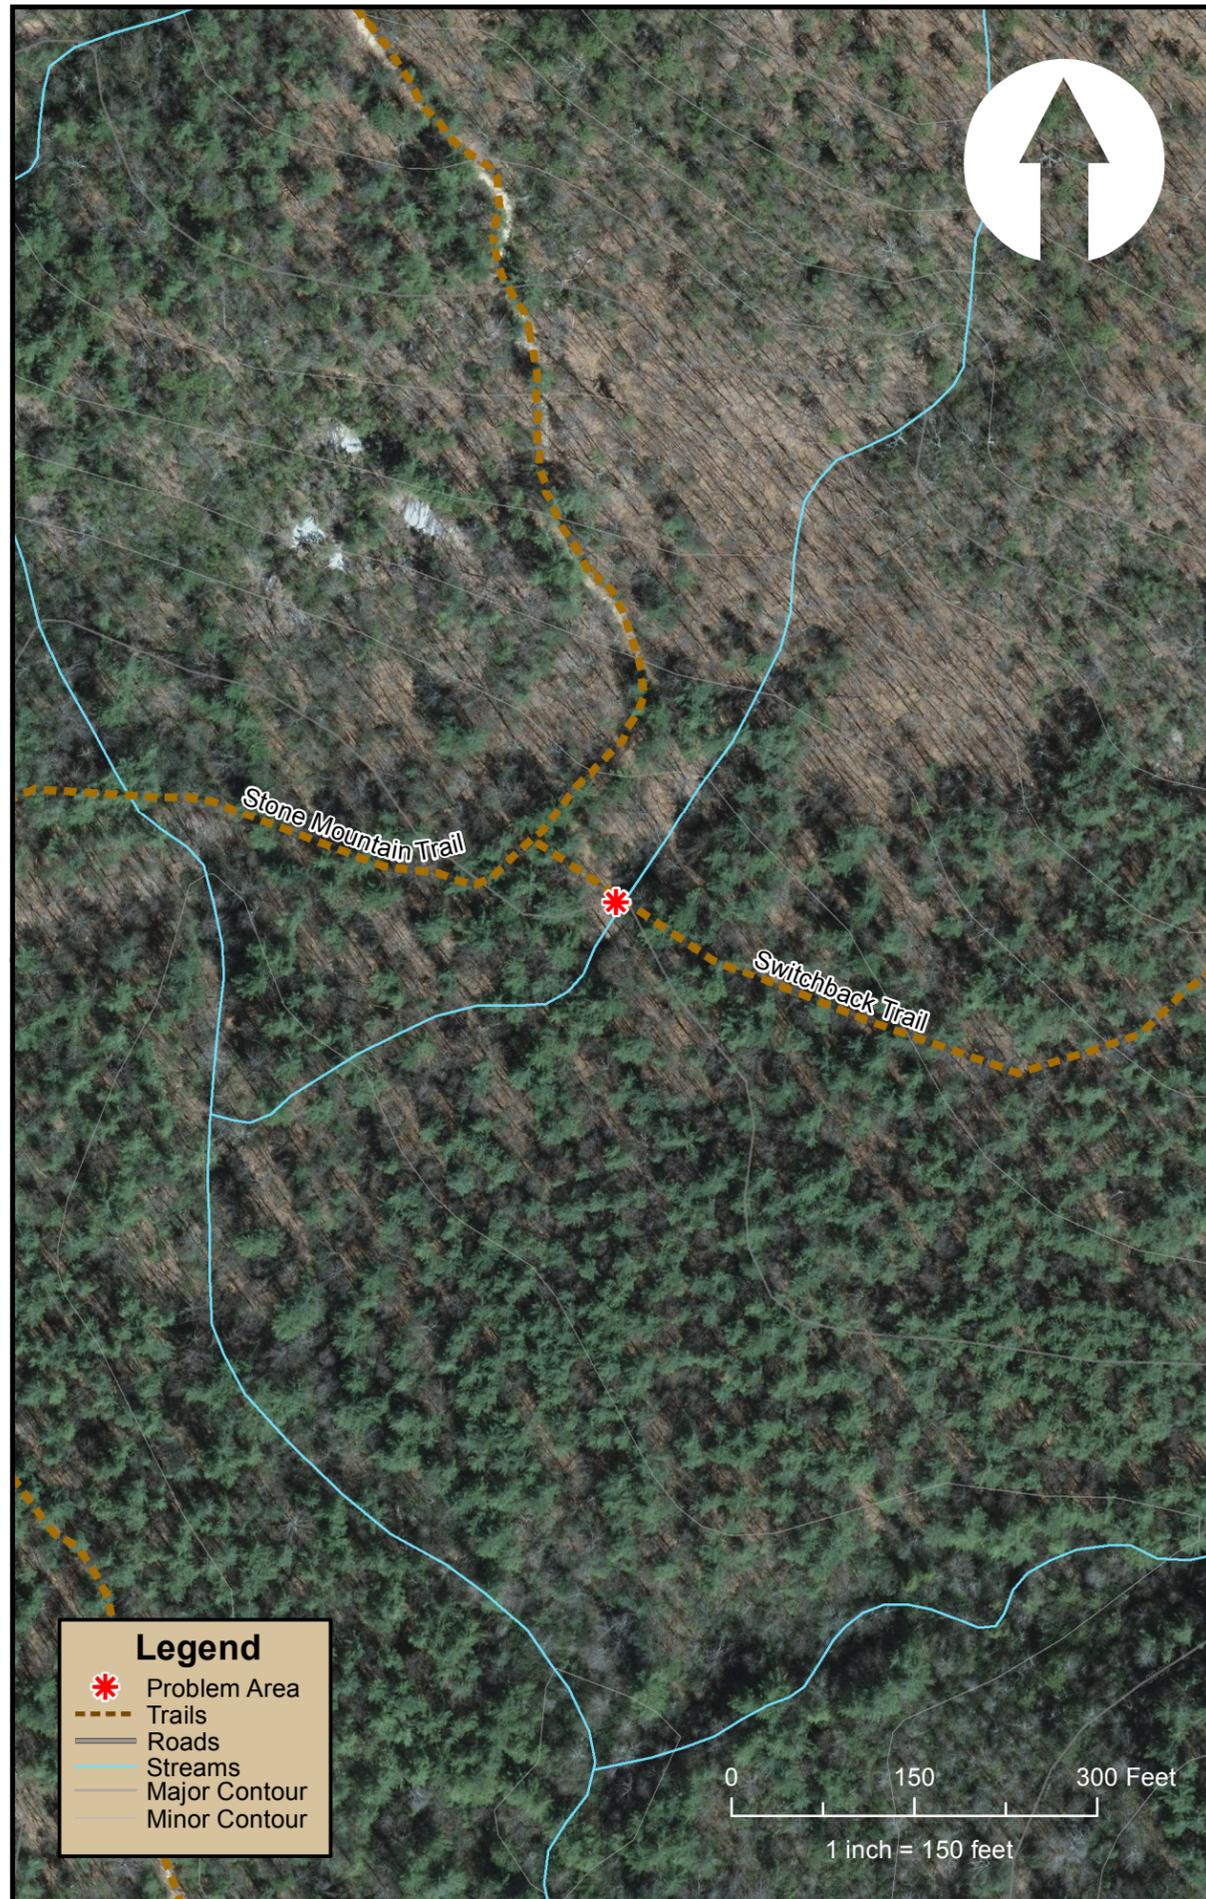
1. **Culvert (diameter/material/length):** 8"/ CPP

| <input type="checkbox"/> crushed | <input checked="" type="checkbox"/> erosion (upstream/ downstream) |
| <input type="checkbox"/> lack of natural bed | <input checked="" type="checkbox"/> piping |
| <input checked="" type="checkbox"/> safety hazard | <input type="checkbox"/> overtopping |

Comments
 Culvert failure by piping, leading to trail and downstream channel erosion.

| <input type="checkbox"/> human/ animal exclusion | <input checked="" type="checkbox"/> culvert rehabilitation/ replacement |
