### Area of Concern – Site: P48

Map Grid Location: F11 Site visit date/ team): 8/17/15/ JZ Drainage Area (Sq. Mi.): \_\_\_\_\_  
 Name & Location: Fawn Lake

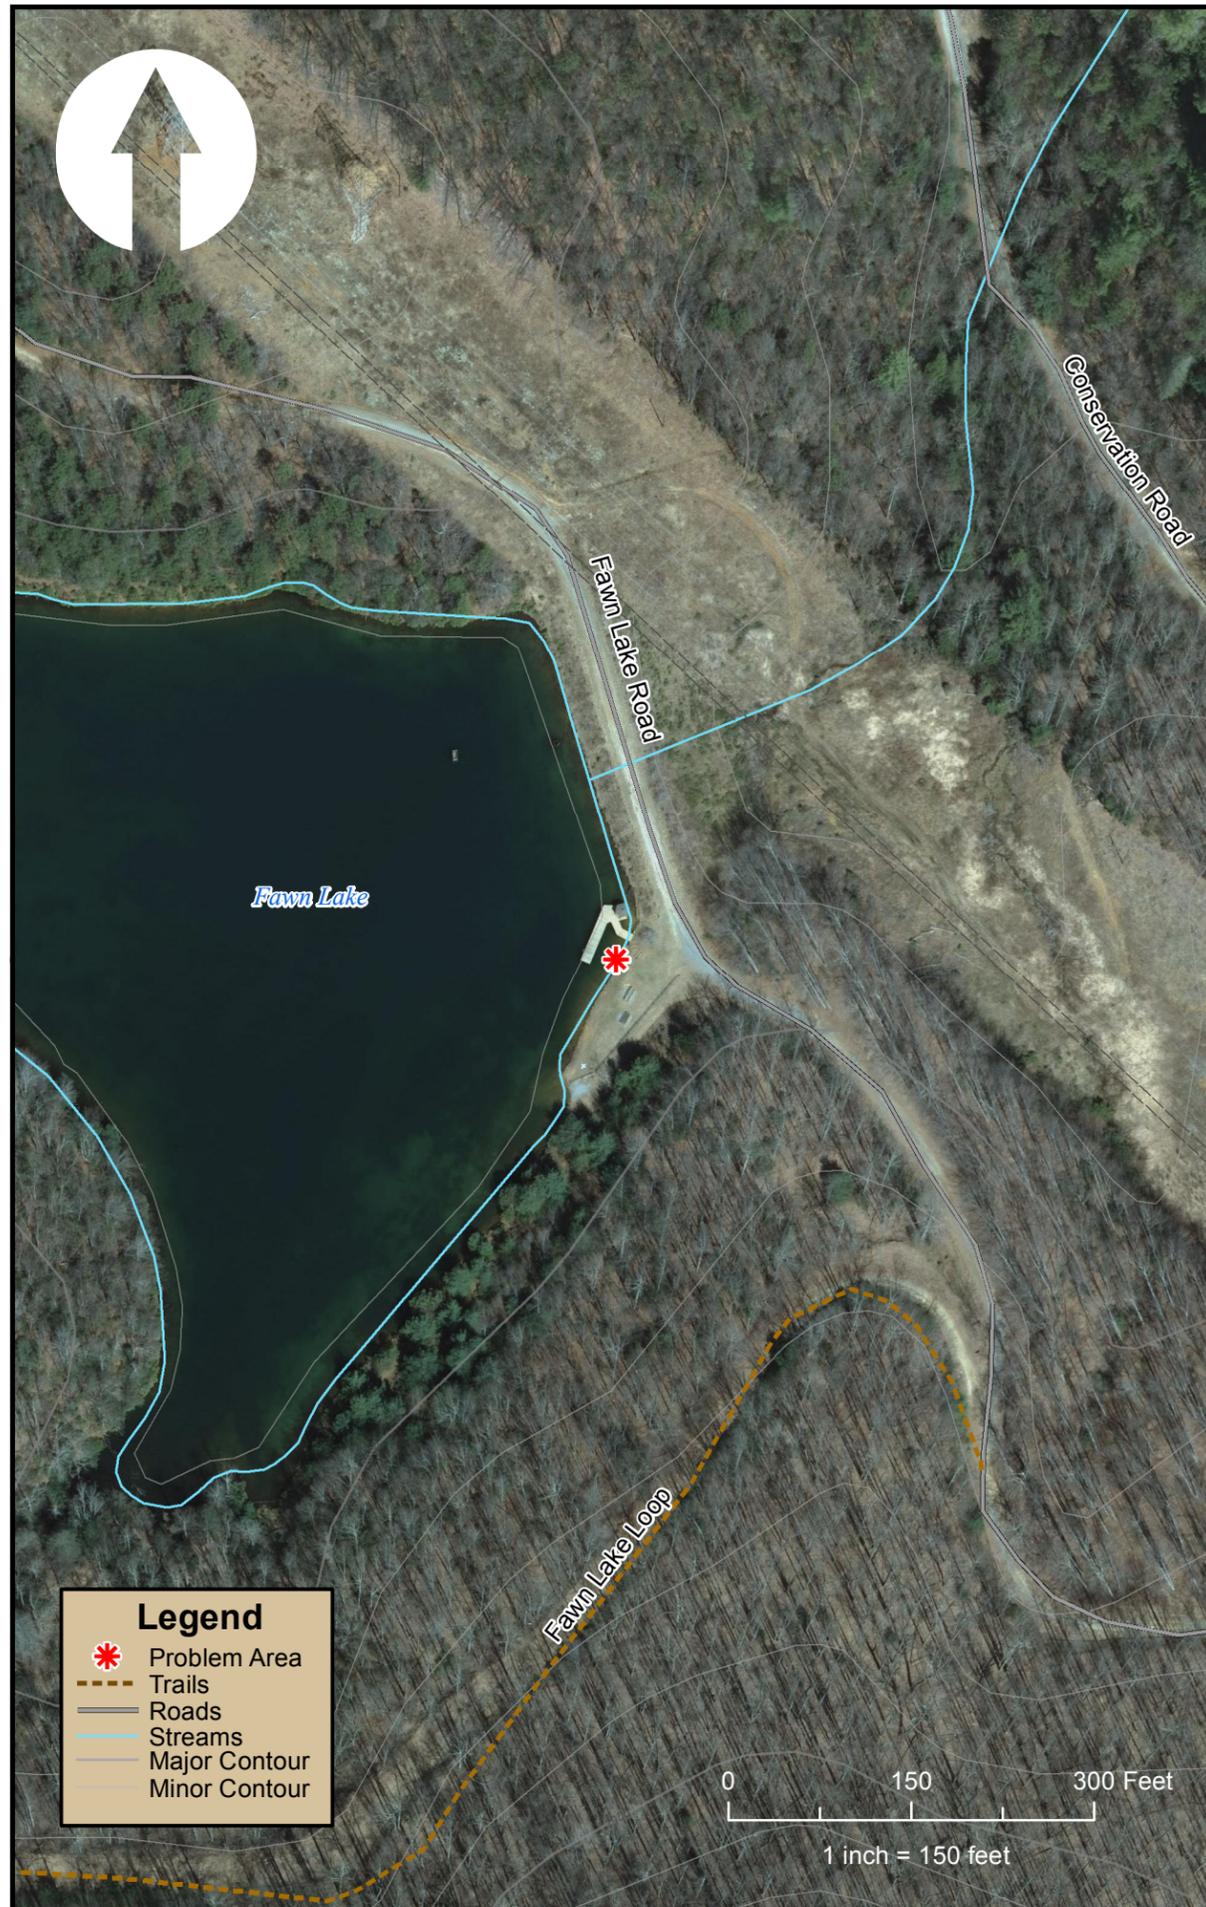
**Comments**  
 Shoreline of lake unvegetated and partially eroding at human access area; vegetation could be improved between lake and Fawn Lake Road.

- Potential Solutions**
- relocate trail/close trail/road  trail/road crossing improvement
  - vegetation/ shoreline planting  mechanical grading
  - stormwater treatment  animal watering
  - human/ animal exclusion  culvert rehabilitation/ replacement
  - signs  culvert daylighting
  - maintenance  bridge replacement/improvement
