Area of Concern – Site: P49

Map Grid Location: G11 Site visit date/ team): 8/19/15/ JZ Drainage Area (Sq. Mi.):
 Name & Location: Power lines at Fawn Lake Road

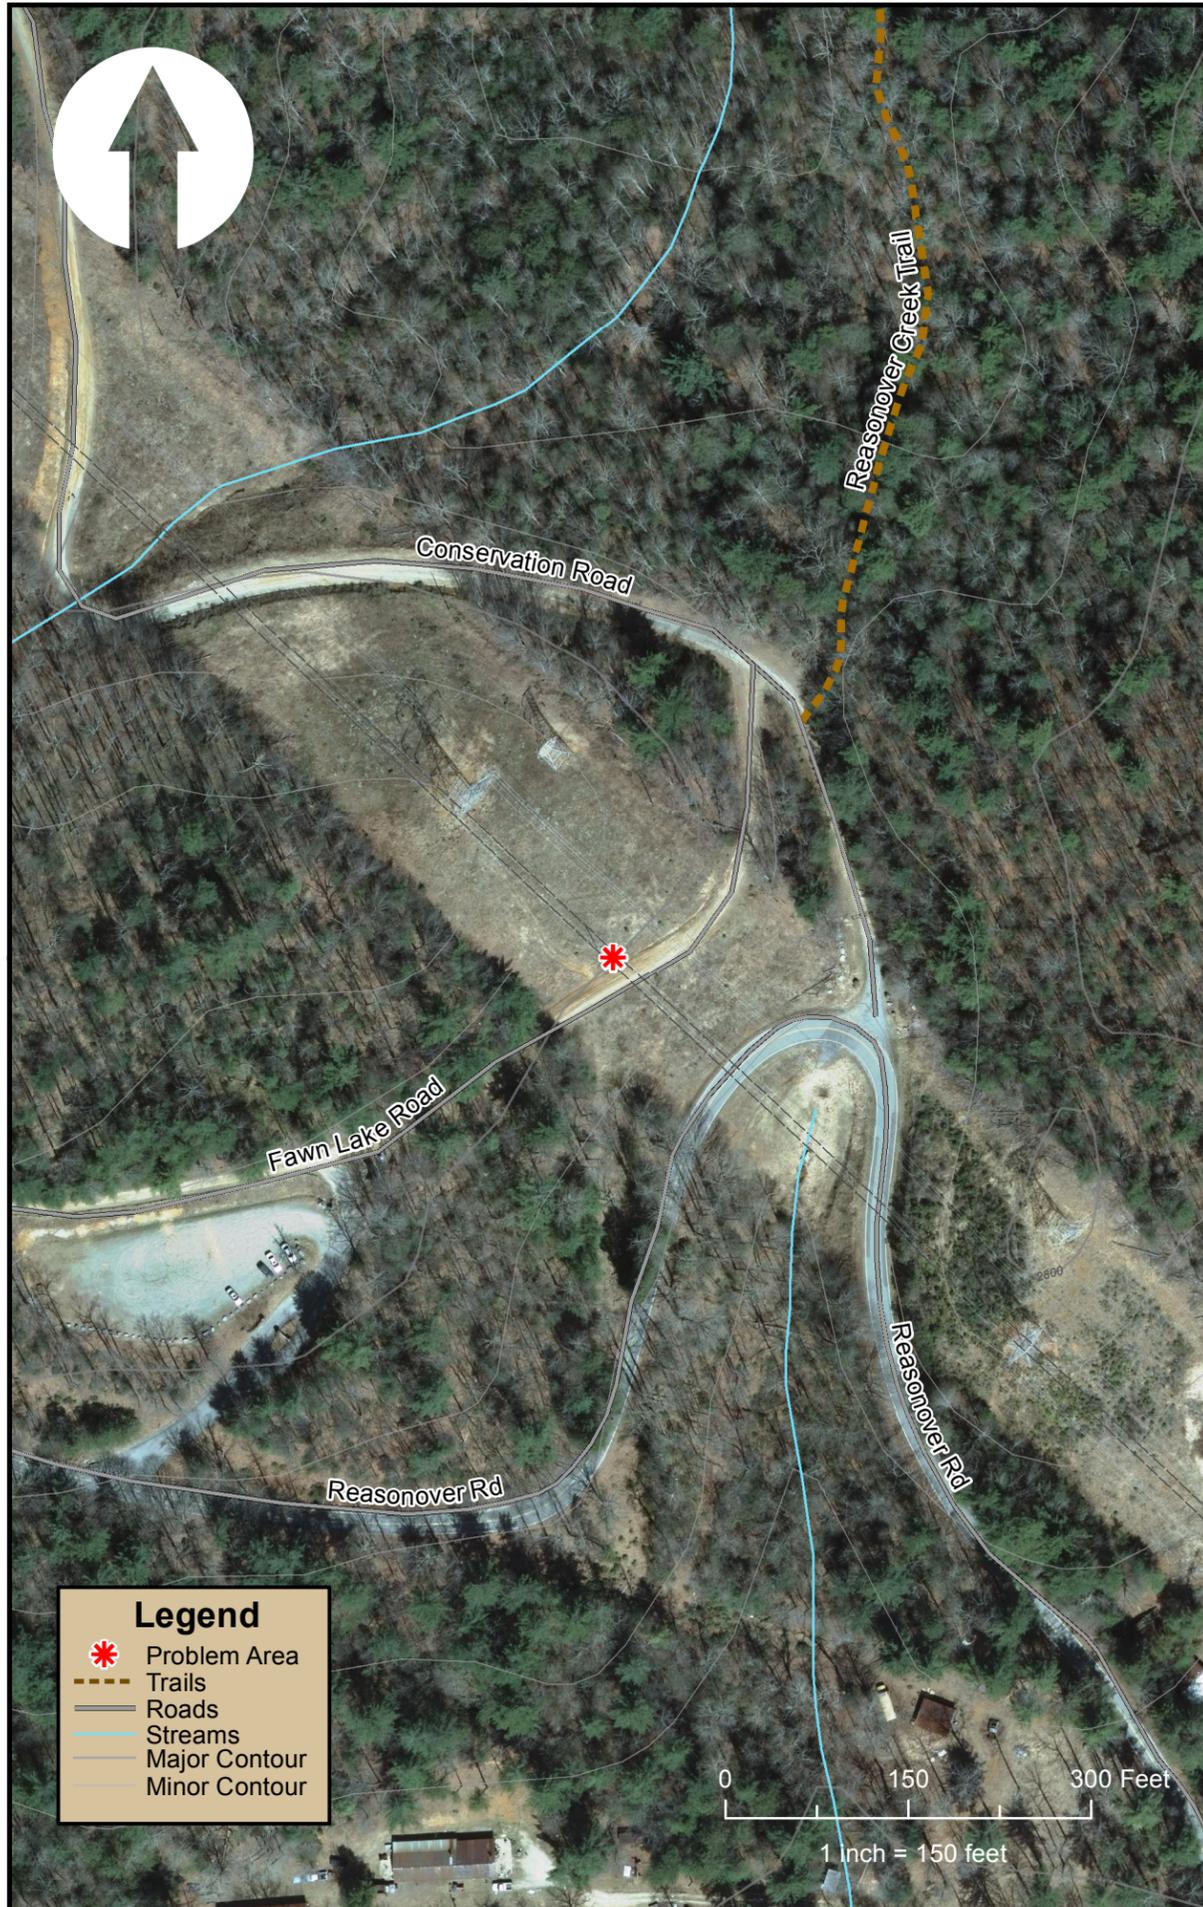
2. **Trail/ Road Impact (trail/ road name):** Fawn Lake Road
 stormwater input sediment input
 bridge utilities
 unstable trail crossing erosion
 safety hazard human impact (hiking/biking)
 missing vegetation equine/ dog impacts

| <input checked="" type="checkbox"/> vegetation/ shoreline planting | <input checked="" type="checkbox"/> mechanical grading |
