Stream Condition – Site: S02

Map Grid Location: E9 Site visit date/ team): 4/13/15 / BK, JZ Drainage Area (Sq. Mi.): 18.3

Stream name & Location: Little River above Bridal Veil Falls

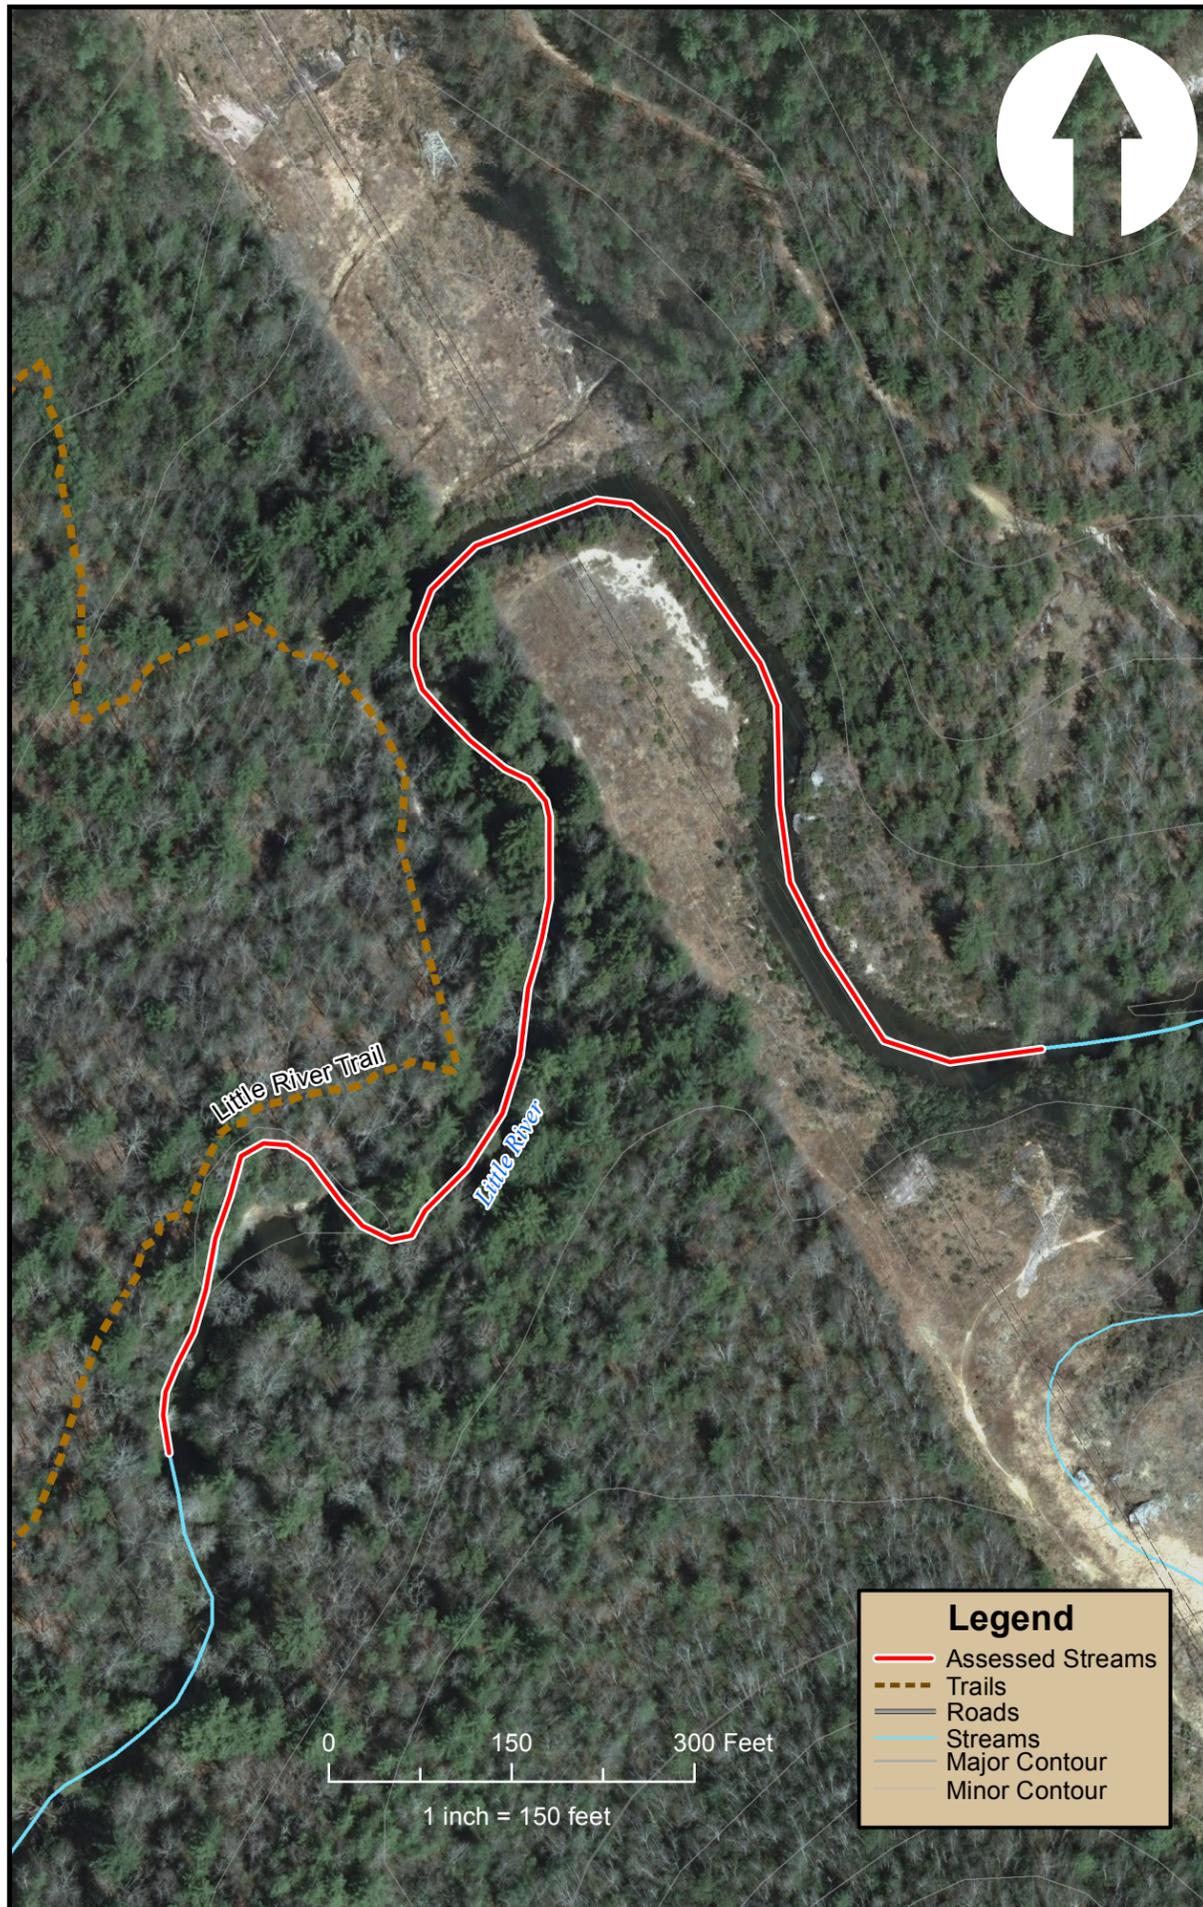
| 1. Site and Watershed Conditions | 2 |
| <input checked="" type="checkbox"/> stormwater input | <input checked="" type="checkbox"/> sediment input |
| <input checked="" type="checkbox"/> trampled banks | <input type="checkbox"/> equine/dog impacts |
| <input type="checkbox"/> trail crossing | <input checked="" type="checkbox"/> trail in buffer |
| <input type="checkbox"/> bridge/culvert/armoring | <input checked="" type="checkbox"/> utilities |
| 2. Channel Morphology and Condition | 2 |
| <input type="checkbox"/> straightened | <input checked="" type="checkbox"/> eroding banks |
| <input type="checkbox"/> head-cutting | <input checked="" type="checkbox"/> lack of bedform diversity |
| <input type="checkbox"/> high bed scour | <input checked="" type="checkbox"/> excessive sediment deposition |
| 3. Floodplain Morphology | 2 |
| <input checked="" type="checkbox"/> incised channel | <input checked="" type="checkbox"/> entrenched channel |

| <input checked="" type="checkbox"/> preservation/ exclusion | <input type="checkbox"/> culvert rehabilitation/ replacement |
