Stream Condition – Site: S05

Map Grid Location: F10 Site visit date/ team): 8/17/15 / JZ Drainage Area (Sq. Mi.): 0.06
Stream name & Location: Tributary at Conservation Road
Streambed Substrate: silt Length (ft): +/- 515 Bankfull Width (ft): +/- 10

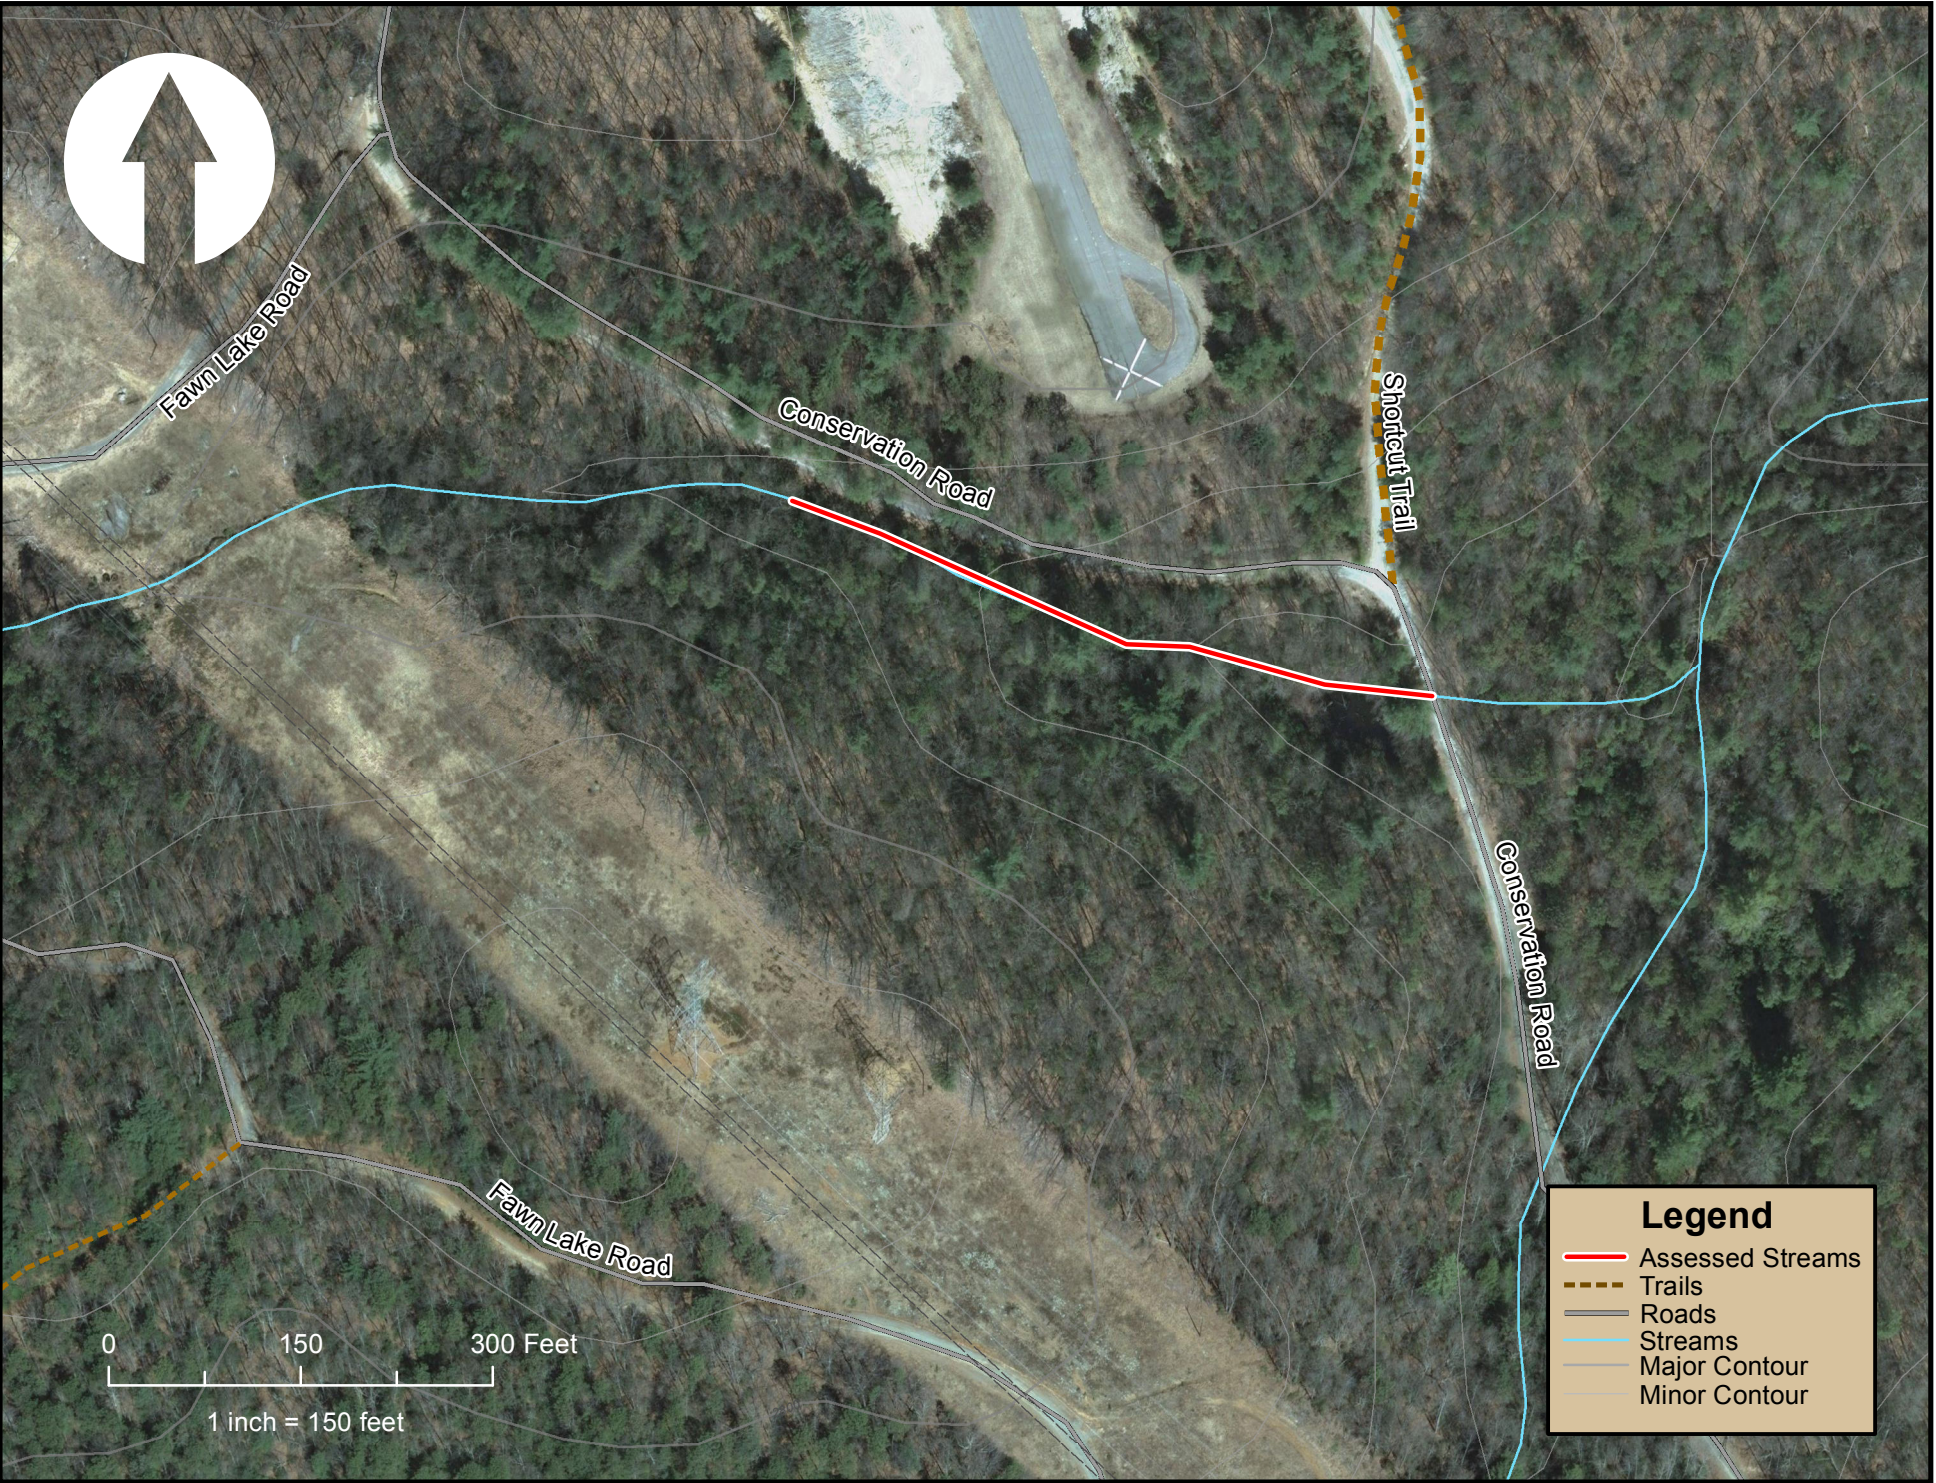
1. Site and Watershed Conditions	2
<input checked="" type="checkbox"/> stormwater input	<input checked="" type="checkbox"/> sediment input
<input type="checkbox"/> trampled banks	<input type="checkbox"/> equine/dog impacts
<input type="checkbox"/> trail crossing	<input type="checkbox"/> trail in buffer
<input checked="" type="checkbox"/> bridge/culvert/armoring	<input type="checkbox"/> utilities

2. Channel Morphology and Condition	1
<input checked="" type="checkbox"/> overwide	<input type="checkbox"/> incised
<input type="checkbox"/> straightened	<input type="checkbox"/> eroding banks
<input type="checkbox"/> head-cutting	<input checked="" type="checkbox"/> lack of bedform diversity
<input type="checkbox"/> high bed scour	<input type="checkbox"/> excessive sediment deposition

4. Vegetation	3
<input type="checkbox"/> narrow buffer width	<input type="checkbox"/> invasive plants (banks/floodplain)
<input checked="" type="checkbox"/> poor overstory/tree cover	<input type="checkbox"/> bare areas/mineral soil (banks/floodplain)

Culvert clogged upstream of Conservation Road, creating large area of backwater in channel; woody vegetation has died as a result.

<input type="checkbox"/> relocate/close trail	<input type="checkbox"/> trail crossing improvement
<input checked="" type="checkbox"/> vegetation planting	<input type="checkbox"/> mechanical grading
<input type="checkbox"/> in-stream structures	<input type="checkbox"/> watershed improvements
<input type="checkbox"/> preservation/ exclusion	<input checked="" type="checkbox"/> culvert rehabilitation/ replacement
<input checked="" type="checkbox"/> maintenance	<input type="checkbox"/> signs
