Stream Condition – Site: S06

Map Grid Location: G11 Site visit date/ team): 8/17/15 / JZ Drainage Area (Sq. Mi.): 0.06  
Stream name & Location: Tributary to Reasonover Creek  
Streambed Substrate: Clay, fine gravel, bedrock Length (ft): +/- 200 Bankfull Width (ft): +/- 10

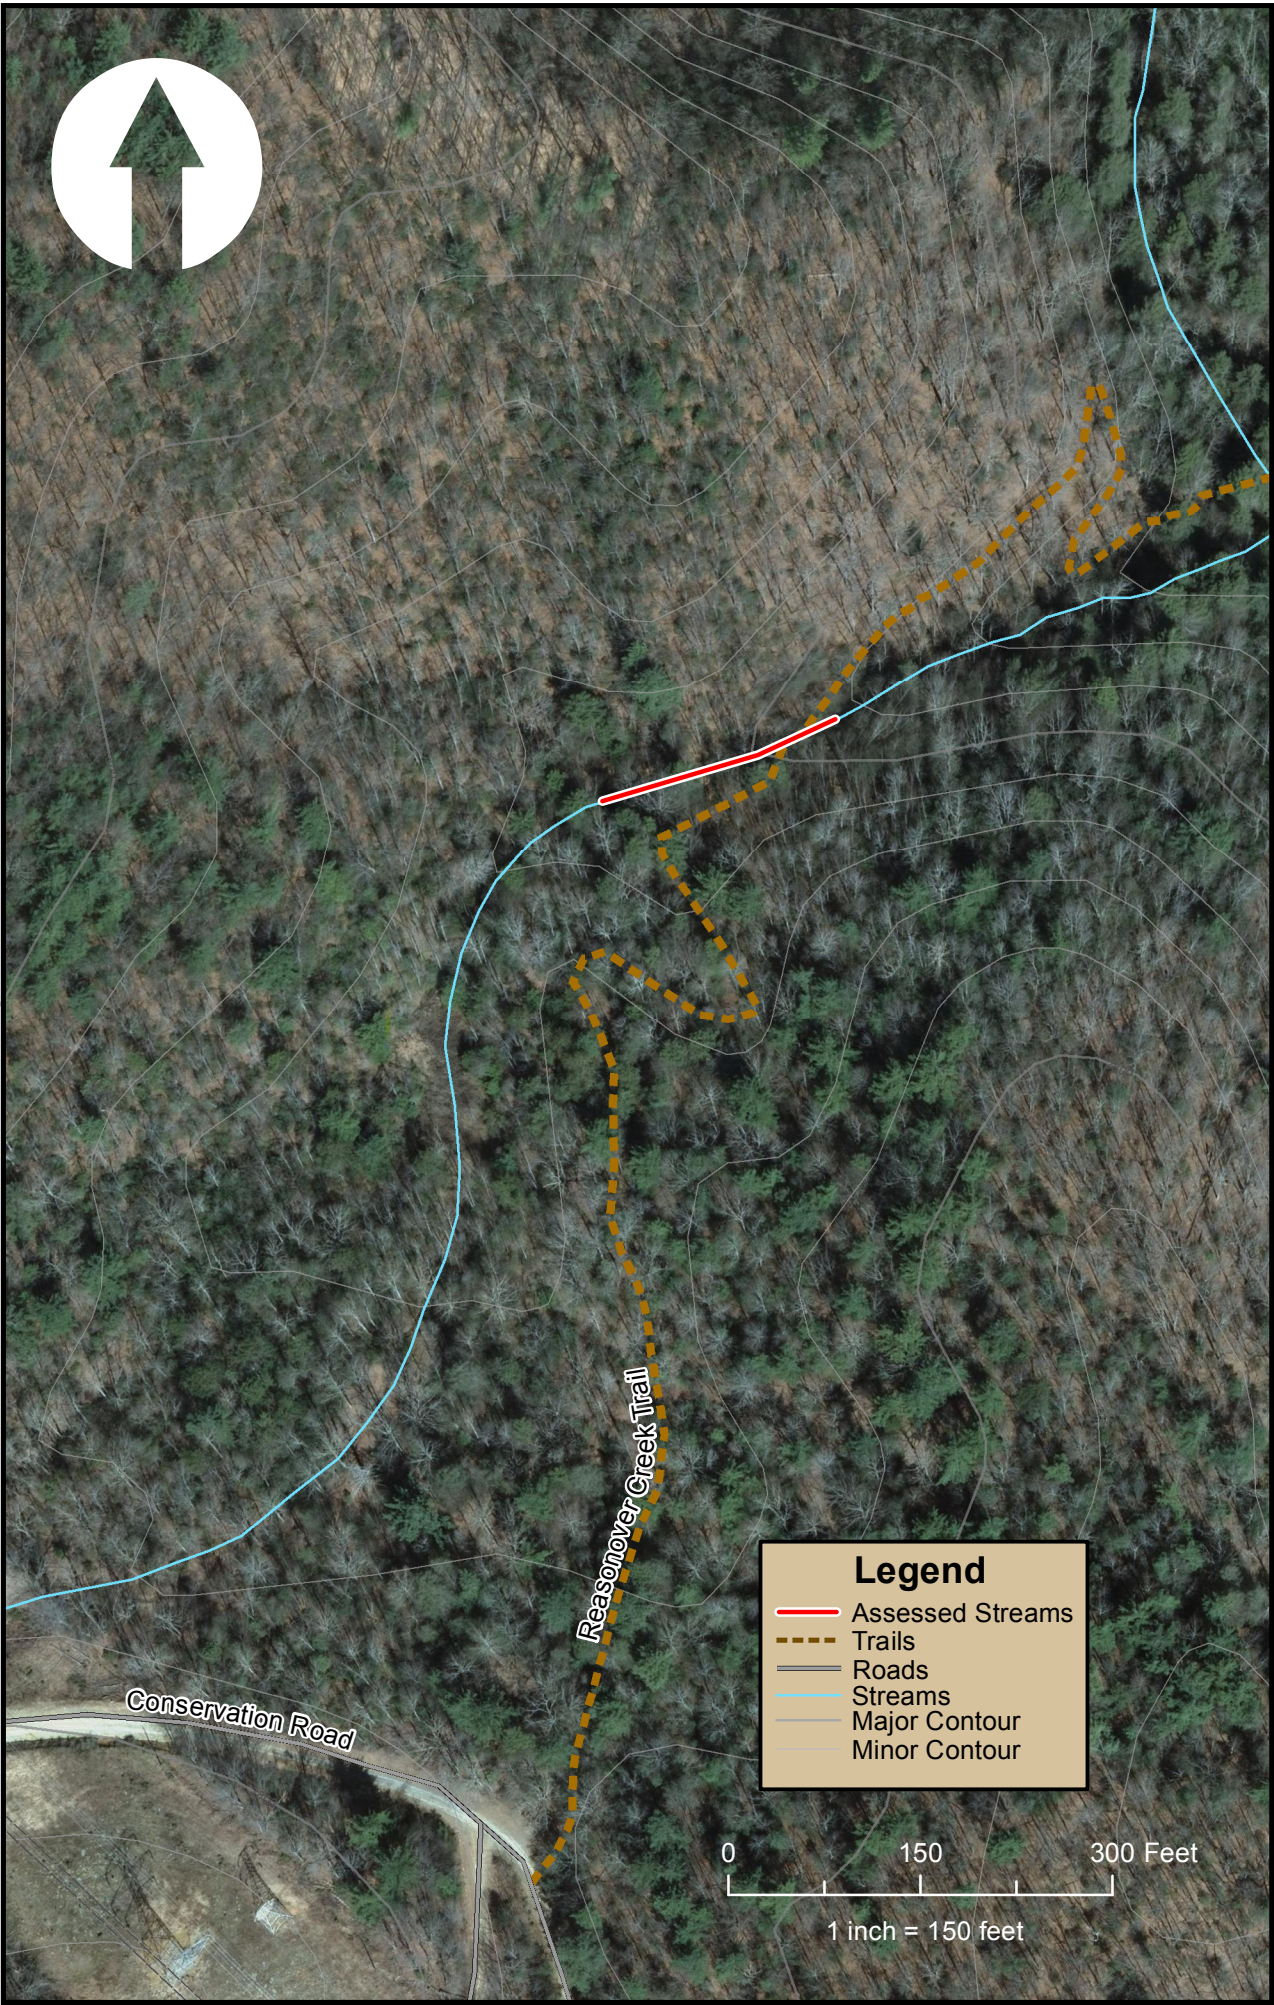
**Score (of 20) and Rating**(Poor 0-7; Fair 8-12; Good 13-17; Excellent 18-20) **12**

Eroding left bank just downstream of bedrock grade control, fine sediment deposition in channel; trail near channel serves as sediment source.

<input checked="" type="checkbox"/> relocate/close trail	<input type="checkbox"/> trail crossing improvement
<input checked="" type="checkbox"/> vegetation planting	<input type="checkbox"/> mechanical grading
<input checked="" type="checkbox"/> in-stream structures	<input type="checkbox"/> watershed improvements
<input type="checkbox"/> preservation/ exclusion	<input type="checkbox"/> culvert rehabilitation/ replacement
<input type="checkbox"/> maintenance	<input type="checkbox"/> signs
