Stream Condition – Site: S09

Map Grid Location: H6 Site visit date/ team): 8/26/15 / JZ Drainage Area (Sq. Mi.): 4.11
Stream name & Location: Grassy Creek along Sandy Trail
Streambed Substrate: Silt, sand, cobble Length (ft): +/- 150 Bankfull Width (ft): +/- 25

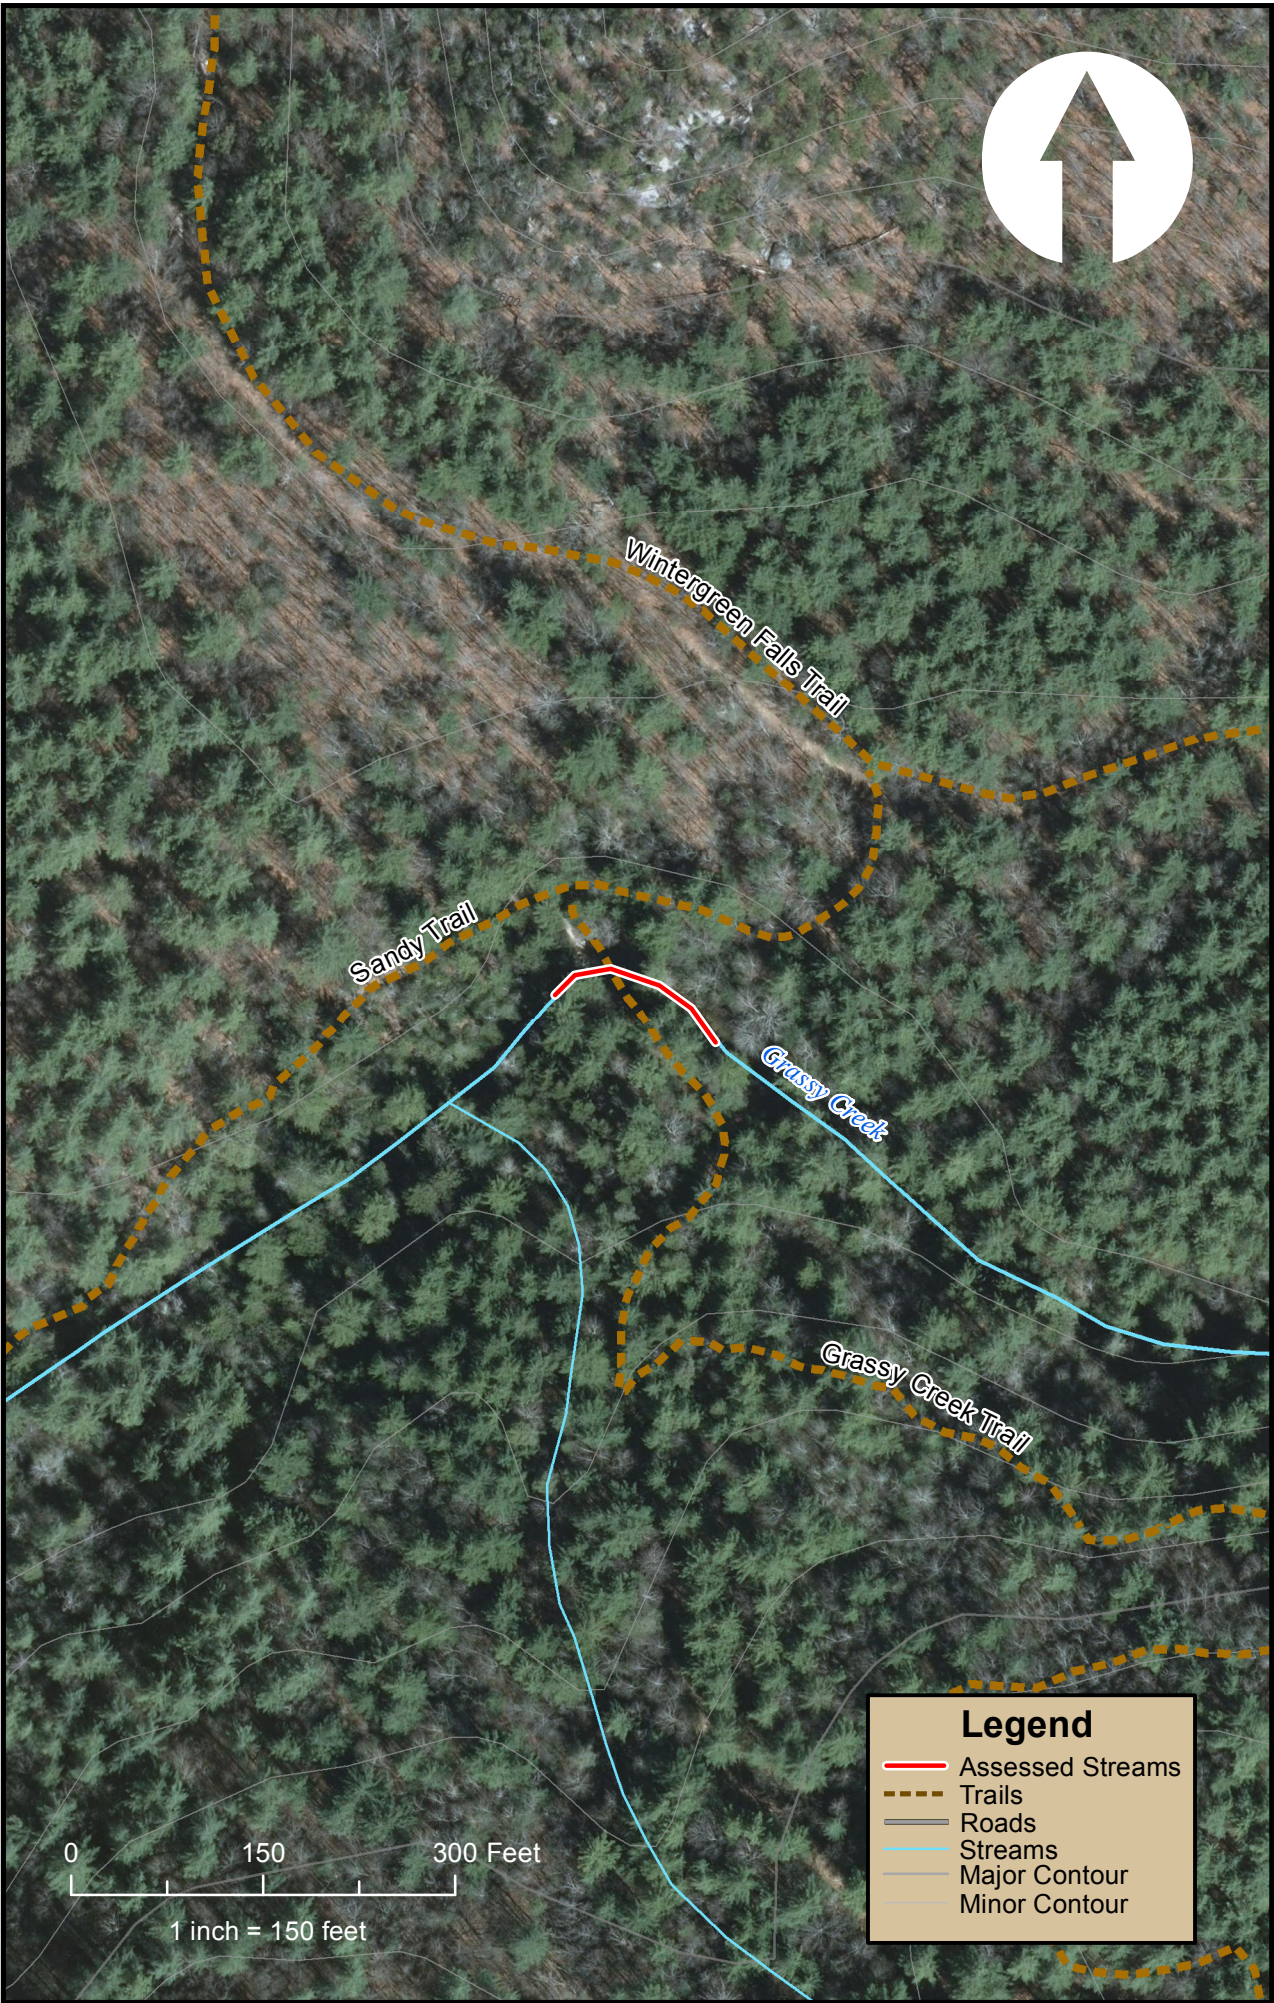
1. Site and Watershed Conditions	2
<input type="checkbox"/> stormwater input	<input checked="" type="checkbox"/> sediment input
<input type="checkbox"/> trampled banks	<input type="checkbox"/> equine/dog impacts
<input type="checkbox"/> trail crossing	<input checked="" type="checkbox"/> trail in buffer
<input type="checkbox"/> bridge/culvert/armoring	<input type="checkbox"/> utilities

2. Channel Morphology and Condition	2
<input checked="" type="checkbox"/> overwide	<input type="checkbox"/> incised
<input type="checkbox"/> straightened	<input checked="" type="checkbox"/> eroding banks
<input type="checkbox"/> head-cutting	<input checked="" type="checkbox"/> lack of bedform diversity
<input type="checkbox"/> high bed scour	<input checked="" type="checkbox"/> excessive sediment deposition

3. Floodplain Morphology	3
<input type="checkbox"/> incised channel	<input checked="" type="checkbox"/> entrenched channel
<input type="checkbox"/> floodplain fill/ levees	<input type="checkbox"/> irregular/ obstructed floodplain

4. Vegetation	2
<input checked="" type="checkbox"/> narrow buffer width	<input type="checkbox"/> invasive plants (banks/floodplain)
<input checked="" type="checkbox"/> poor overstory/tree cover	<input checked="" type="checkbox"/> bare areas/mineral soil (banks/floodplain)

Score (of 20) and Rating(Poor 0-7; Fair 8-12; Good 13-17; Excellent 18-20) **11**

Potential Solutions	
<input checked="" type="checkbox"/> relocate/close trail	<input type="checkbox"/> trail crossing improvement
<input checked="" type="checkbox"/> vegetation planting	<input type="checkbox"/> mechanical grading
<input checked="" type="checkbox"/> in-stream structures	<input type="checkbox"/> watershed improvements
<input type="checkbox"/> preservation/ exclusion	<input type="checkbox"/> culvert rehabilitation/ replacement
<input type="checkbox"/> maintenance	<input type="checkbox"/> signs
