Stream Condition – Site: S11

Map Grid Location: F8 Site visit date/ team): 8/31/15 / JZ Drainage Area (Sq. Mi.): 6.70
Stream name & Location: Reasonover Creek below Lake Julia
Streambed Substrate: bedrock Length (ft): +/- 630 Bankfull Width (ft): +/- 50

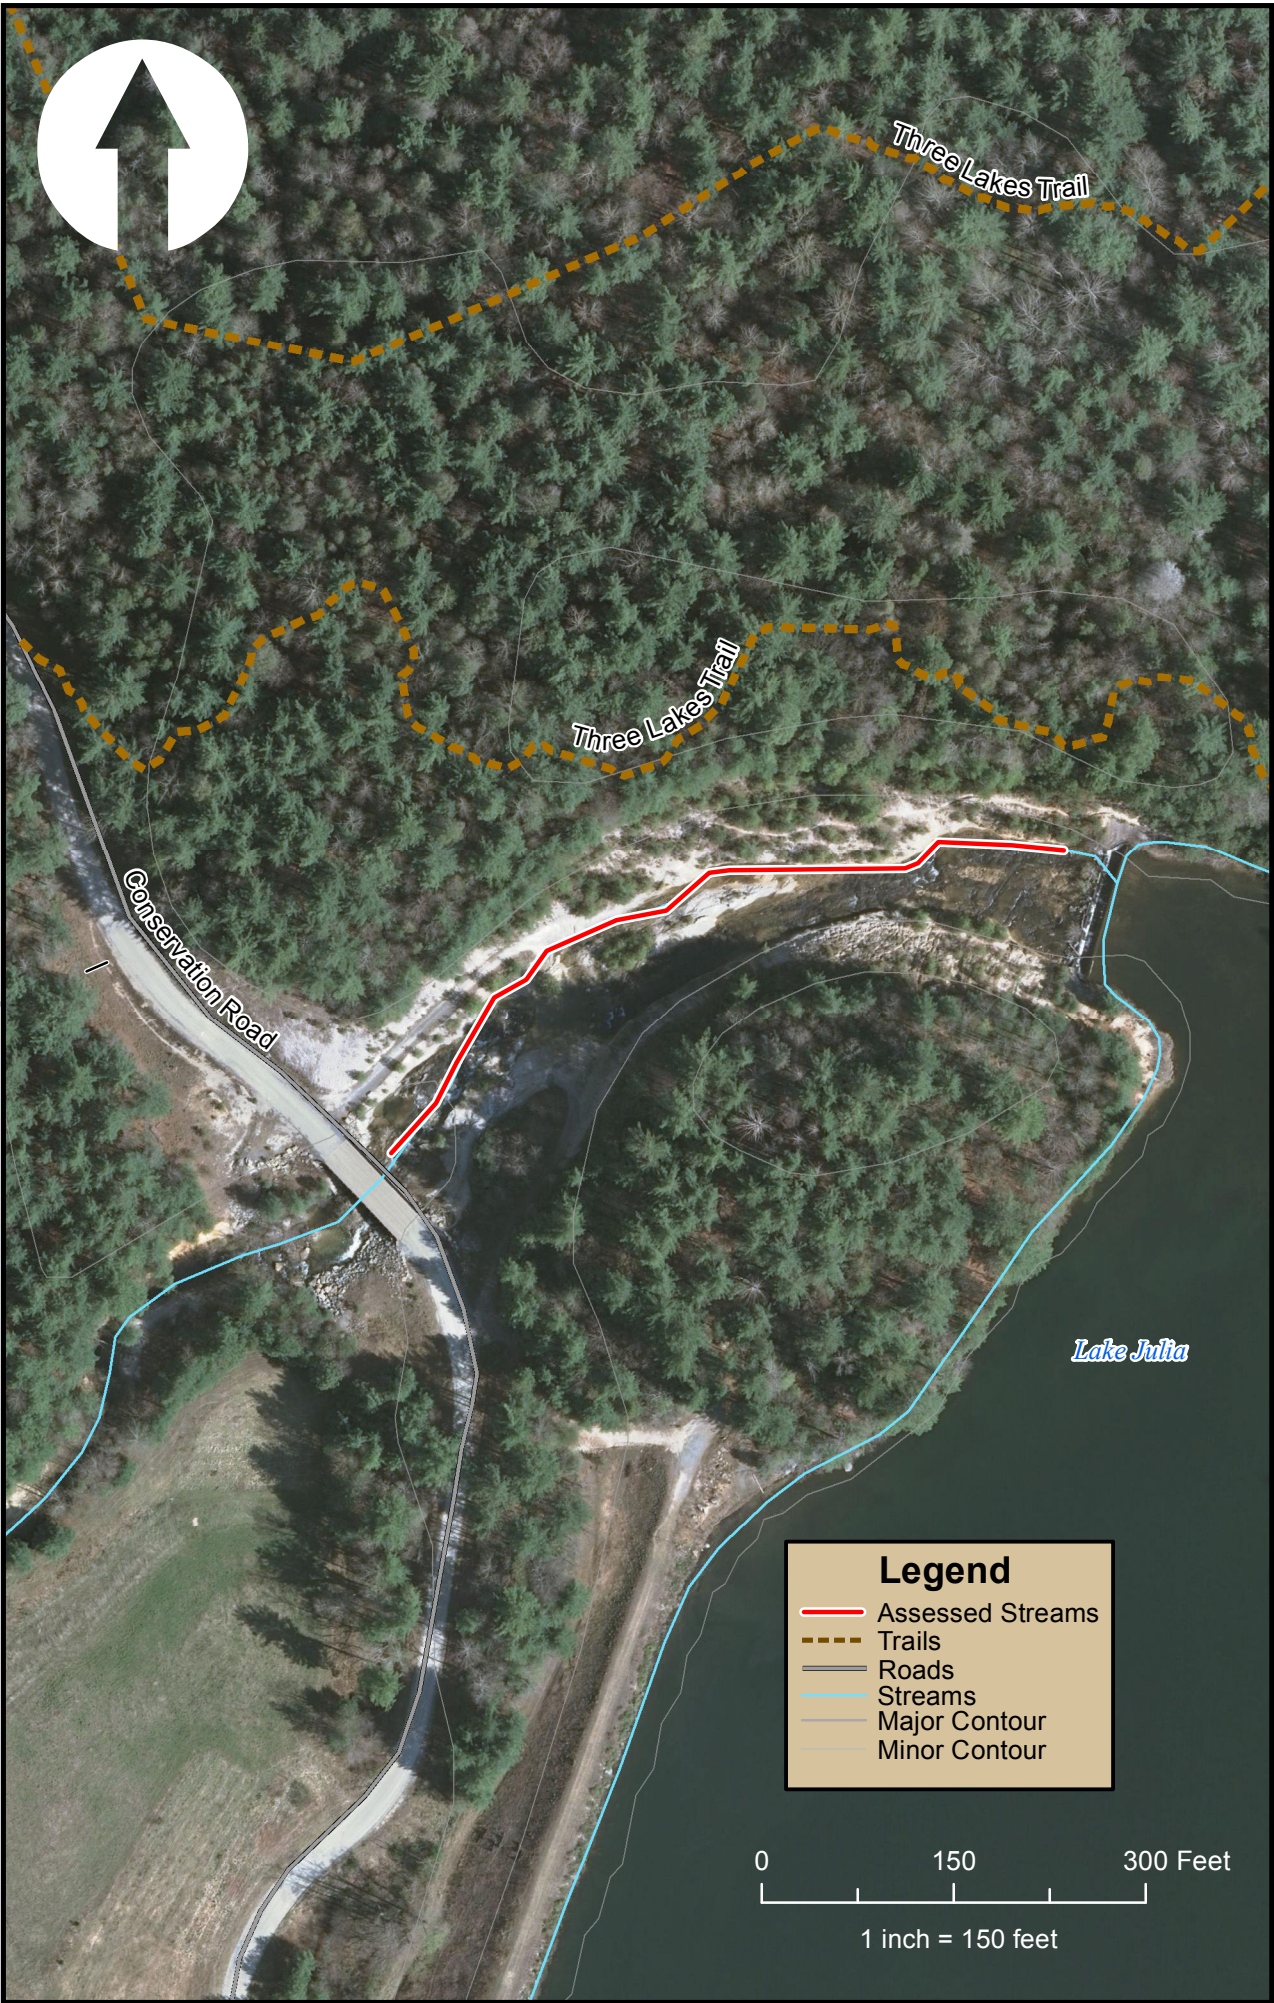
1. Site and Watershed Conditions	1
<input type="checkbox"/> stormwater input	<input checked="" type="checkbox"/> sediment input
<input checked="" type="checkbox"/> trampled banks	<input checked="" type="checkbox"/> equine/dog impacts
<input type="checkbox"/> trail crossing	<input checked="" type="checkbox"/> trail in buffer
<input checked="" type="checkbox"/> bridge/culvert/armoring	<input type="checkbox"/> utilities

2. Channel Morphology and Condition	1
<input checked="" type="checkbox"/> overwide	<input type="checkbox"/> incised
<input type="checkbox"/> straightened	<input checked="" type="checkbox"/> eroding banks
<input type="checkbox"/> head-cutting	<input checked="" type="checkbox"/> lack of bedform diversity
<input type="checkbox"/> high bed scour	<input type="checkbox"/> excessive sediment deposition

3. Floodplain Morphology	2
<input type="checkbox"/> incised channel	<input checked="" type="checkbox"/> entrenched channel
<input type="checkbox"/> floodplain fill/ levees	<input type="checkbox"/> irregular/ obstructed floodplain

4. Vegetation	1
<input type="checkbox"/> narrow buffer width	<input type="checkbox"/> invasive plants (banks/floodplain)
<input checked="" type="checkbox"/> poor overstory/tree cover	<input checked="" type="checkbox"/> bare areas/mineral soil (banks/floodplain)

Score (of 20) and Rating(Poor 0-7; Fair 8-12; Good 13-17; Excellent 18-20) **5**

Potential Solutions	
<input type="checkbox"/> relocate/close trail	<input type="checkbox"/> trail crossing improvement
<input checked="" type="checkbox"/> vegetation planting	<input checked="" type="checkbox"/> mechanical grading
<input checked="" type="checkbox"/> in-stream structures	<input type="checkbox"/> watershed improvements
<input type="checkbox"/> preservation/ exclusion	<input type="checkbox"/> culvert rehabilitation/ replacement
<input type="checkbox"/> maintenance	<input type="checkbox"/> signs
