Stream Condition – Site: S15

Map Grid Location: H3 Site visit date/ team): 8/26/15 / JZ Drainage Area (Sq. Mi.): 0.14

Stream name & Location: Shoal Creek

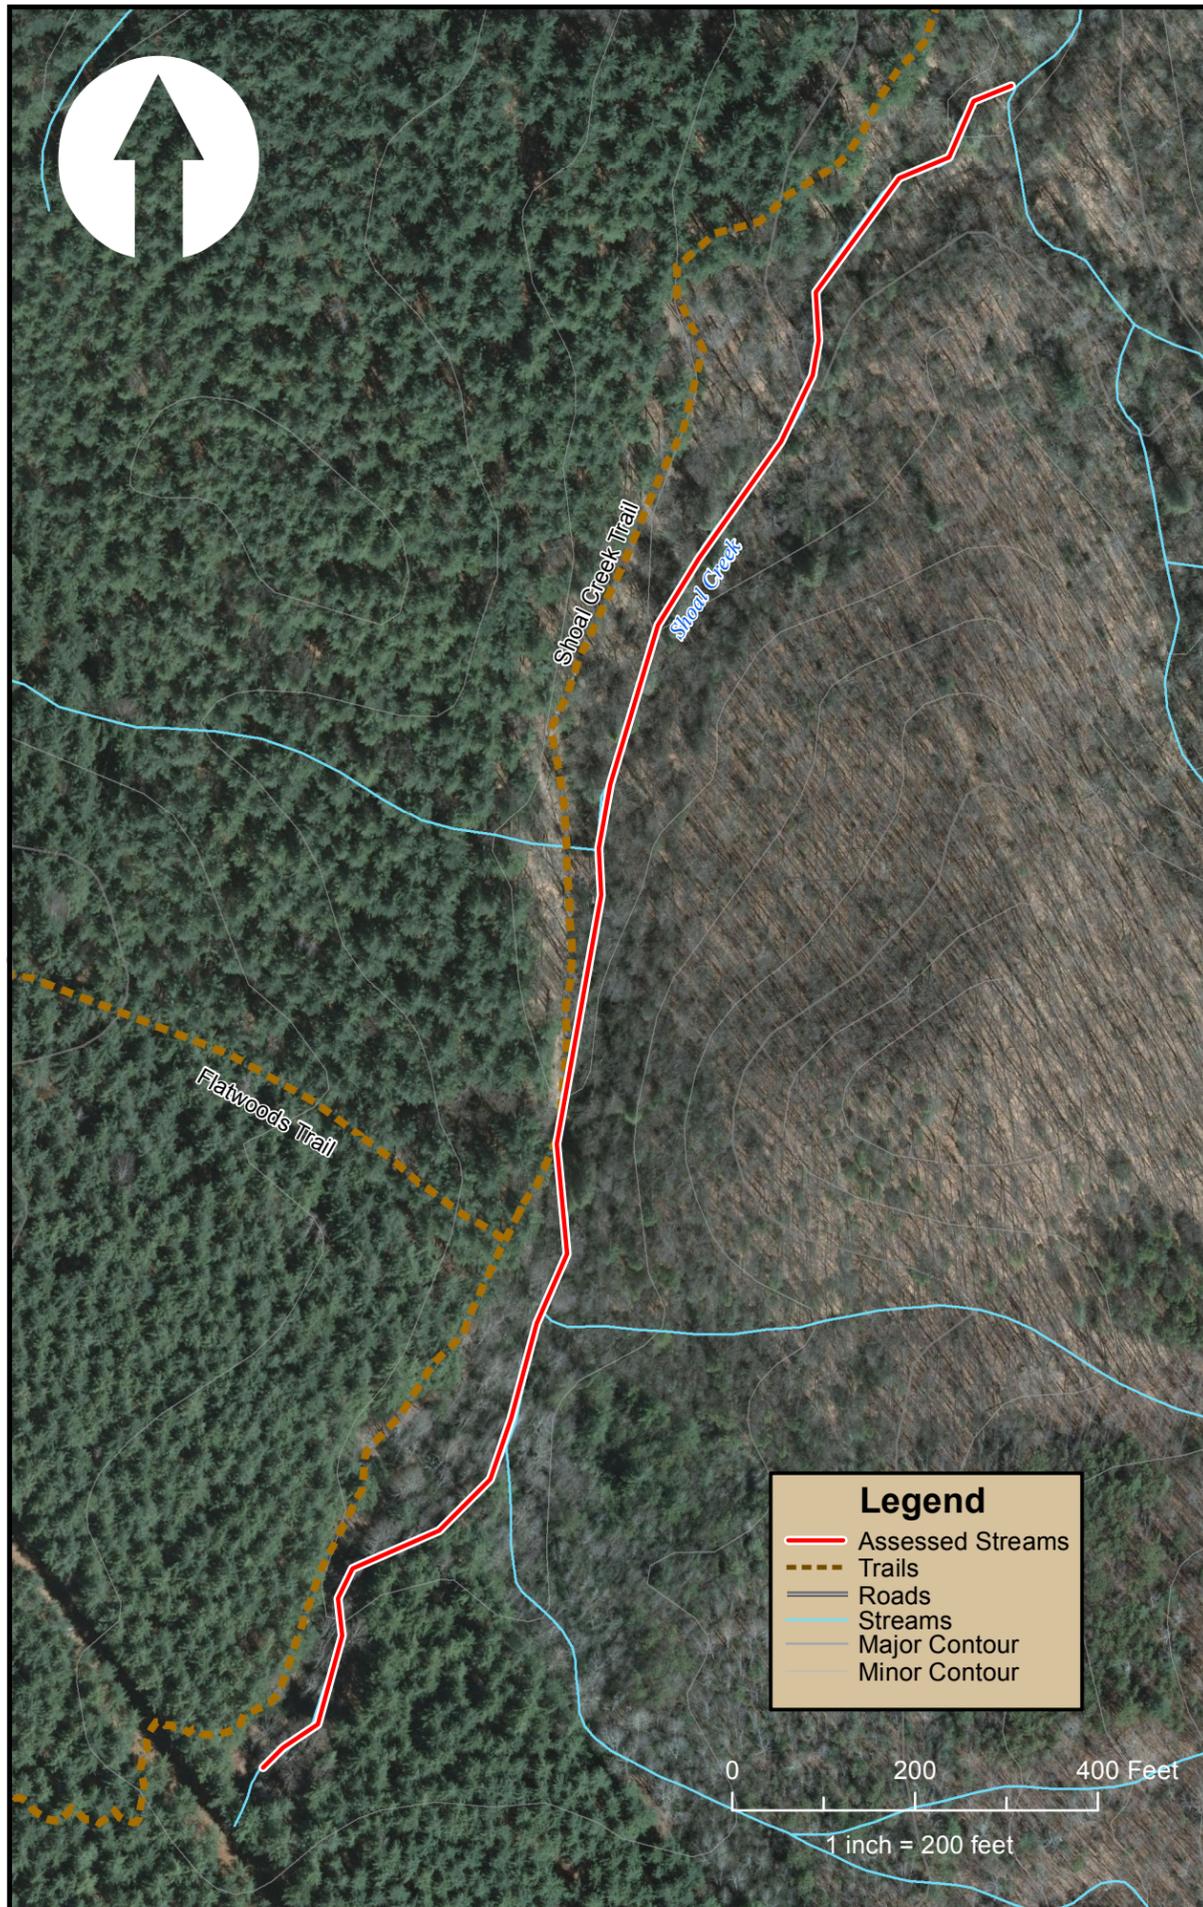
1. Site and Watershed Conditions	1
<input type="checkbox"/> stormwater input <input type="checkbox"/> trampled banks <input type="checkbox"/> trail crossing <input type="checkbox"/> bridge/culvert/armoring	<input type="checkbox"/> sediment input <input type="checkbox"/> equine/dog impacts <input checked="" type="checkbox"/> trail in buffer <input checked="" type="checkbox"/> utilities

2. Channel Morphology and Condition	1
<input type="checkbox"/> overwide <input type="checkbox"/> straightened <input checked="" type="checkbox"/> head-cutting <input type="checkbox"/> high bed scour	<input type="checkbox"/> incised <input checked="" type="checkbox"/> eroding banks <input type="checkbox"/> lack of bedform diversity <input checked="" type="checkbox"/> excessive sediment deposition

3. Floodplain Morphology	1
<input checked="" type="checkbox"/> incised channel <input checked="" type="checkbox"/> floodplain fill/ levees	<input checked="" type="checkbox"/> entrenched channel <input type="checkbox"/> irregular/ obstructed floodplain

4. Vegetation	2
<input checked="" type="checkbox"/> narrow buffer width <input checked="" type="checkbox"/> poor overstory/tree cover	<input type="checkbox"/> invasive plants (banks/floodplain) <input checked="" type="checkbox"/> bare areas/mineral soil (banks/floodplain)

| <input checked="" type="checkbox"/> preservation/ exclusion | <input type="checkbox"/> culvert rehabilitation/ replacement |
