Stream Condition – Site: S17

Map Grid Location: E5 Site visit date/ team): 8/19/15 / JZ Drainage Area (Sq. Mi): 35.6
Stream name & Location: Little River at Hooker Falls Road
Streambed Substrate: Boulder, bedrock Length (ft): +/- 810 Bankfull Width (ft): +/- 50

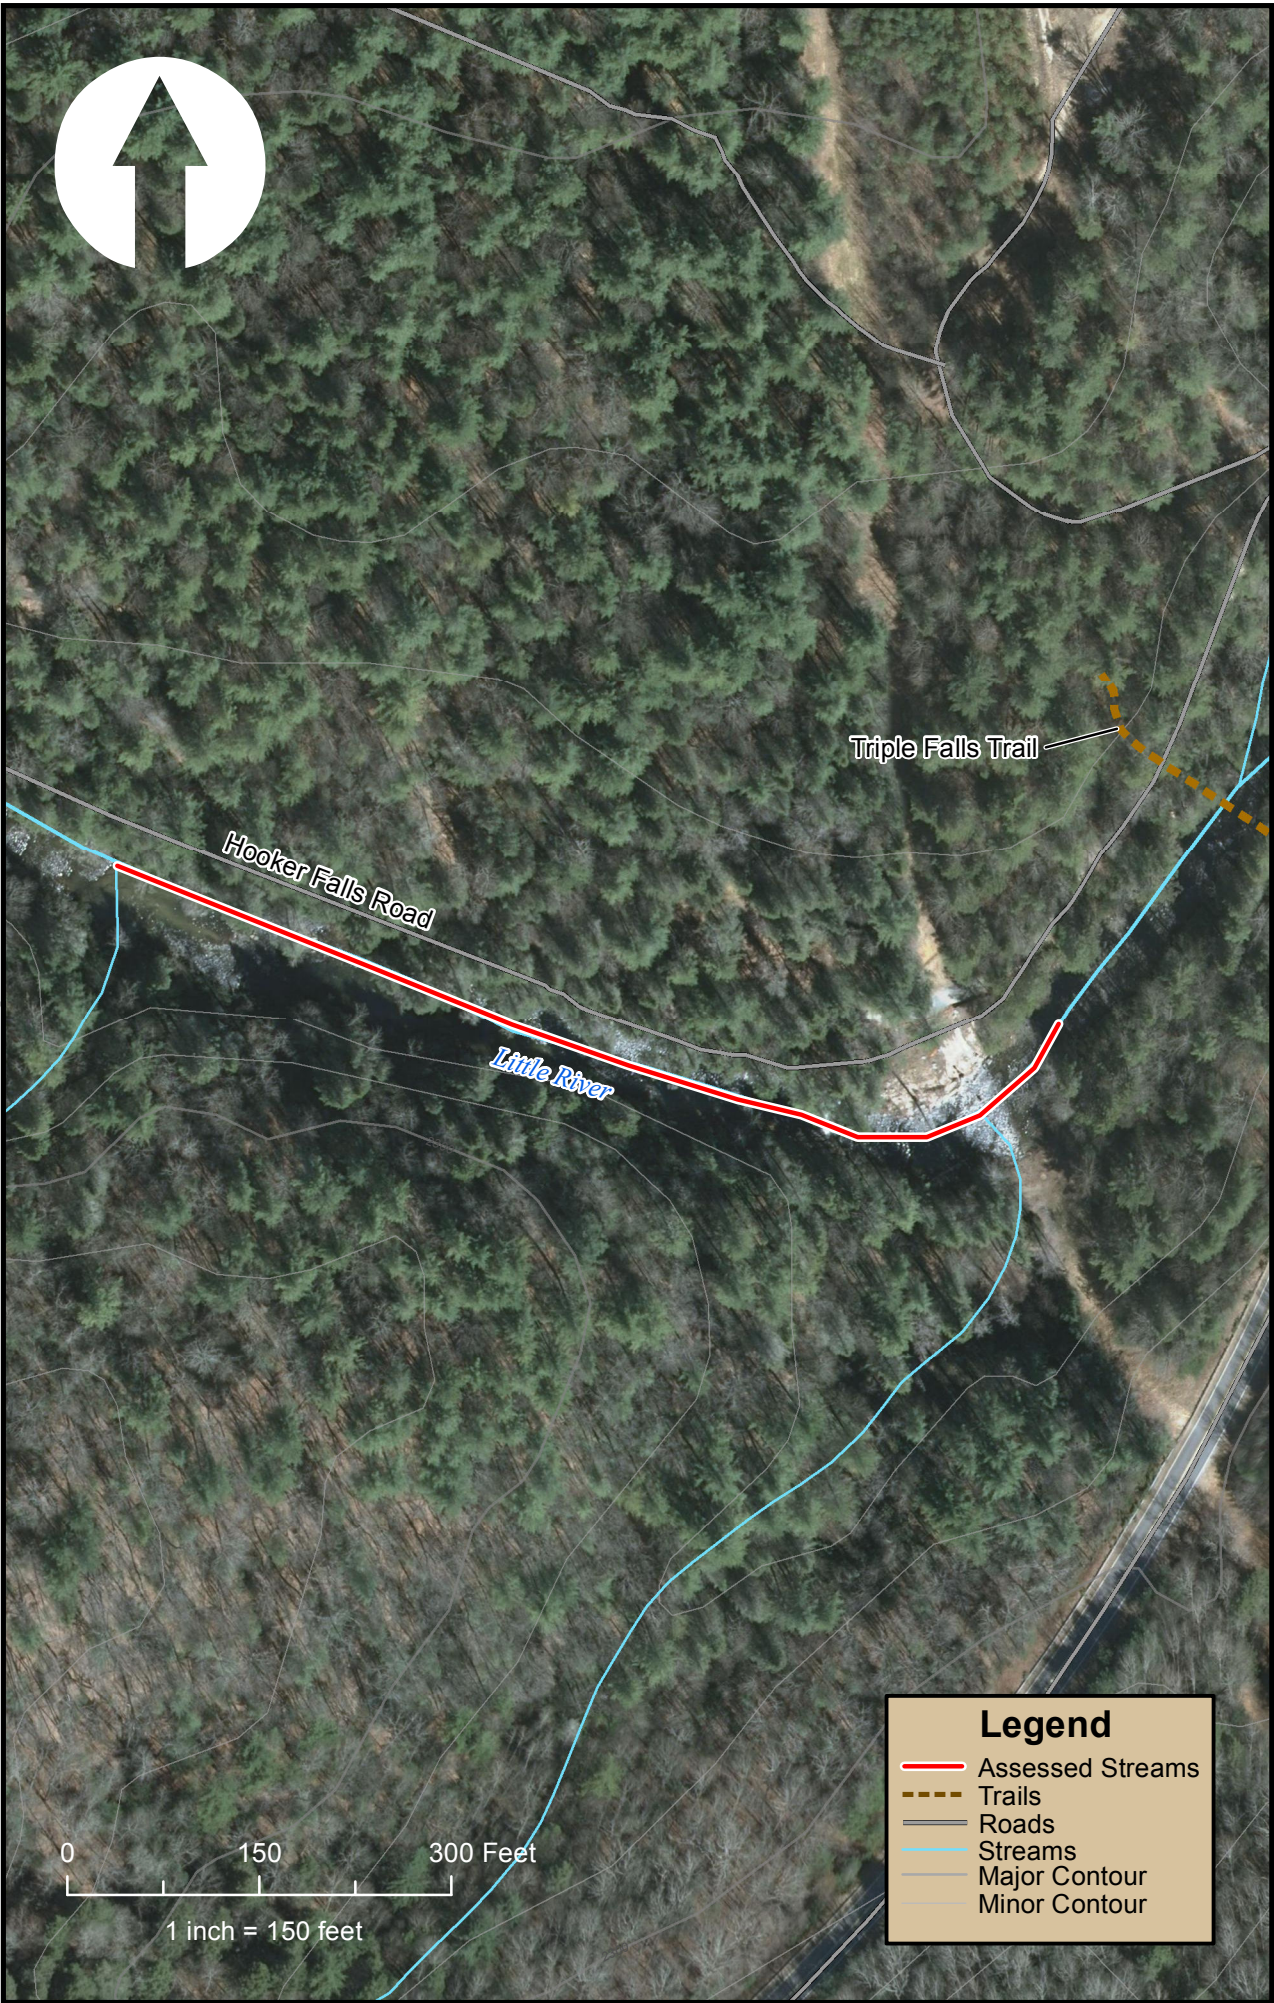
1. Site and Watershed Conditions	1
<input type="checkbox"/> stormwater input	<input checked="" type="checkbox"/> sediment input
<input checked="" type="checkbox"/> trampled banks	<input checked="" type="checkbox"/> equine/dog impacts
<input type="checkbox"/> trail crossing	<input checked="" type="checkbox"/> trail in buffer
<input type="checkbox"/> bridge/culvert/armoring	<input checked="" type="checkbox"/> utilities

2. Channel Morphology and Condition	2
<input type="checkbox"/> overwide	<input type="checkbox"/> incised
<input type="checkbox"/> straightened	<input checked="" type="checkbox"/> eroding banks
<input type="checkbox"/> head-cutting	<input type="checkbox"/> lack of bedform diversity
<input type="checkbox"/> high bed scour	<input checked="" type="checkbox"/> excessive sediment deposition

3. Floodplain Morphology	4
<input type="checkbox"/> incised channel	<input type="checkbox"/> entrenched channel
<input type="checkbox"/> floodplain fill/ levees	<input type="checkbox"/> irregular/ obstructed floodplain

4. Vegetation	2
<input checked="" type="checkbox"/> narrow buffer width	<input type="checkbox"/> invasive plants (banks/floodplain)
<input checked="" type="checkbox"/> poor overstory/tree cover	<input checked="" type="checkbox"/> bare areas/mineral soil (banks/floodplain)

<input checked="" type="checkbox"/> relocate/close trail	<input type="checkbox"/> trail crossing improvement
<input checked="" type="checkbox"/> vegetation planting	<input type="checkbox"/> mechanical grading
<input type="checkbox"/> in-stream structures	<input type="checkbox"/> watershed improvements
<input checked="" type="checkbox"/> preservation/ exclusion	<input type="checkbox"/> culvert rehabilitation/ replacement
<input type="checkbox"/> maintenance	<input checked="" type="checkbox"/> signs
